BRIEFING

Cottage Pool reservoir distress, September, 2008

Dams and Reservoirs
2009 **19**, No. 1, 3
DOI: 10.1680/
dare.2009.19.1.3

Tony Jones

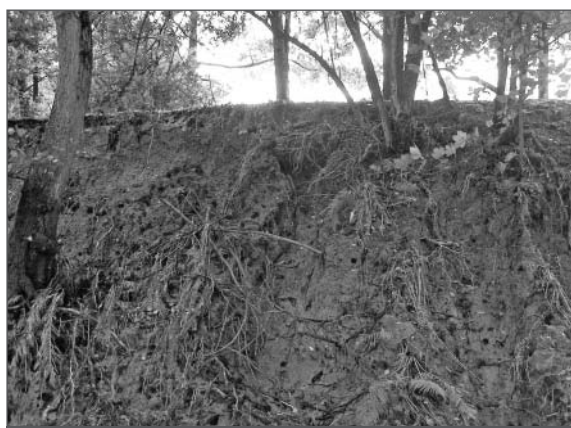
Paul and his team removed the obstructions, which started the process of lowering the water levels, and they also plugged a leak adjacent to the left hand spillway with cement filled bags. The embankment had been severely eroded by the overtopping water and the formation of deep gullies appeared to have been triggered by the presence of mature trees and bushes growing on the embankment (Figure 1). It was

Figure 1. Eroded downstream shoulder

estimated that the crest had been overtopped by 100–200 mm.

The dam appeared to be a homogeneous clay fill, and the remaining downstream shoulder material was still stiff and intact. There was no sign of leakage.

The embankment had been left in a perilous condition and emptying the reservoir was the best practical option. The 350 mm scour outlet was inoperable, but after jetting to remove silt the valve was opened, having an immediate effect on lowering the water levels (Figure 2). The area immediately downstream of the outlet was protected with sand and cement-filled bags to protect against scouring the outlet channel. Within 24 h the reservoir was empty, and the owner, who cut short his holiday, had managed to rescue his stock of fish.

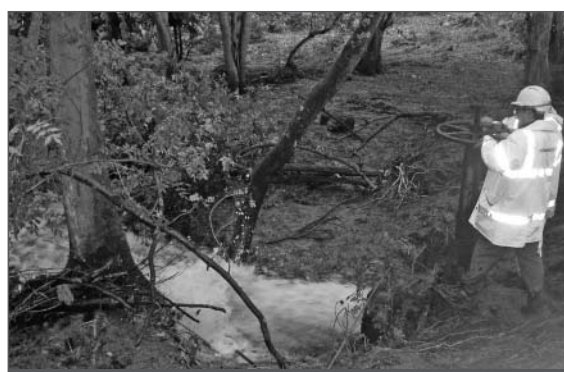
Figure 2. Scour outlet

This incident highlights the importance of having an operable and effective scour facility even on small reservoirs, and also further reinforces the need for a new Reservoirs Act based on the risk posed to communities, rather than the current legislation concerning only raised reservoirs with a volume of over 25 000 m³.
