# Technical visit: Black Esk reservoir enlargement

**Duncan Scott** MEng, CEng, MICE  
SSE plc Generation Engineering Centre, Perth, UK

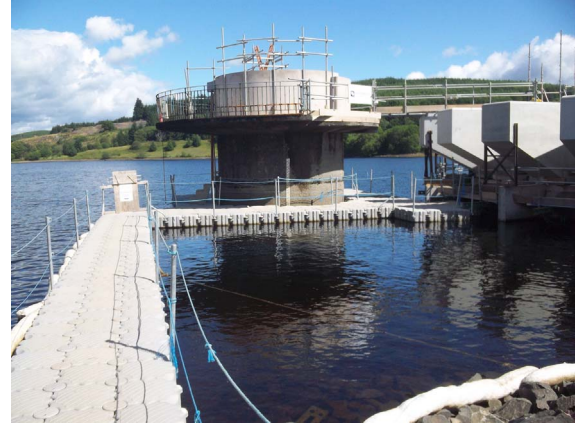
Figure 3. Floating pontoon access platform at valve tower and bellmouth spillway

At the bellmouth spillway and valve tower the excellent floating pontoon access platform was used to get around the raised valve tower and then into the top of the bellmouth itself (Figures 3 and 4). Scaffolding made safe access to this area

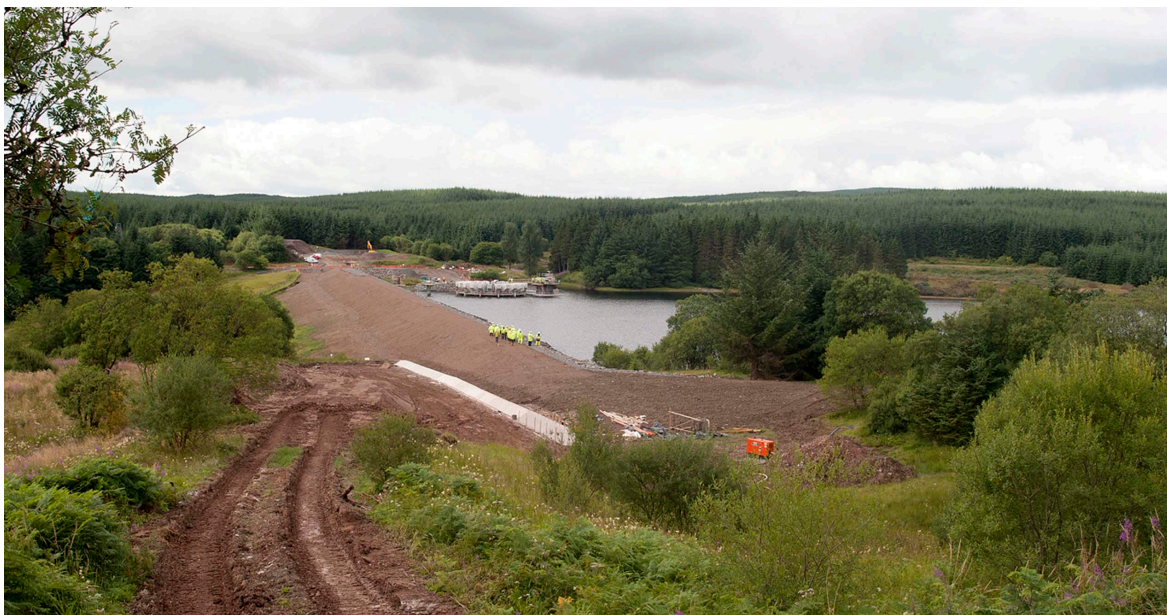
Figure 2. General view of site during tour, with one tour group on the dam crest and the other on the bellmouth and valve tower at the far side

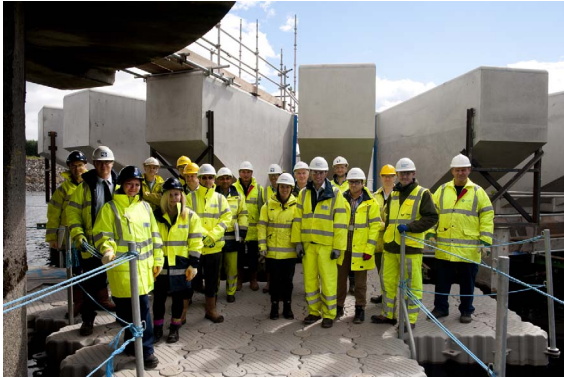
**Figure 4.** One of the two tour groups up close with the new piano-key spillway

straightforward and provided a fine position from which to see the precast piano-key elements up close.
