Discussion.

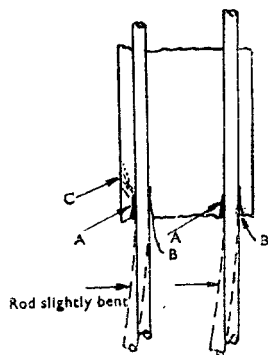
Fig. 13.

Fig. 13 showed a section of a pile. It appeared to be rather drastic treatment to beat off the initial rust with a heavy sledge-hammer, especially

because there was always a tendency for the bar to bend slightly and to crush the concrete on side (A) rather badly and to leave a gap on side (B); moreover, the use of a heavy sledge-hammer might cause minute cracks at (C), which would never be filled by gunite. Similar remarks applied to beating off damaged concrete with a sledge-hammer. That treatment was too drastic, because it might bruise the surface of the concrete into cracks so fine that the concrete did not come away, but through which moisture would percolate in years to come and corrosion continue.

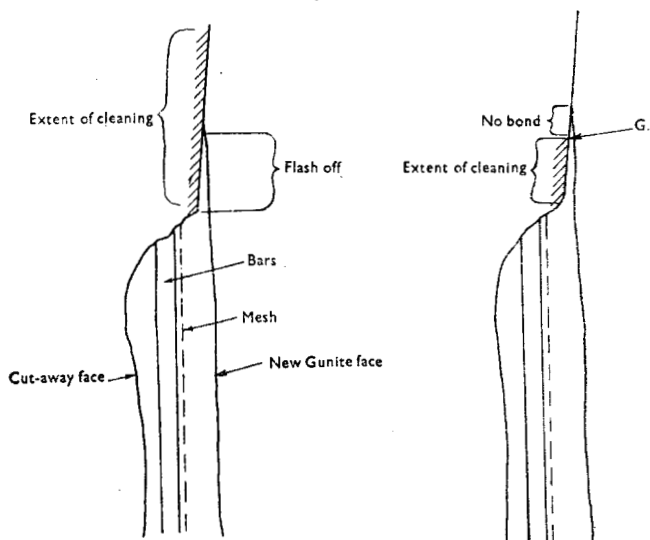
Figs. 17.

Mr. Carter had shown a construction at the edges such as that illustrated in *Fig. 13*, but, so far as the work at Southampton was concerned, there was so much to do that he could not slow it down for any such detail as that. For cutting away, however, he would in most cases proceed as shown in *Fig. 17*. The gun-spray was not a pencil-point spray but a rather broad spray, and one could not finish off as at F in *Fig. 14*. The gunite would overlap and there would be a flash-off possibly 6 inches in width. He wished to emphasize that the surface on which the flash-off came should be clean. If it were left in the condition brought about by the sea and oil, a good bond would not be obtained and cracking away would start at G (*Figs. 17*). The crack might not do any harm at the time, but future failures might commence to build up there. Mr. Carter had asked

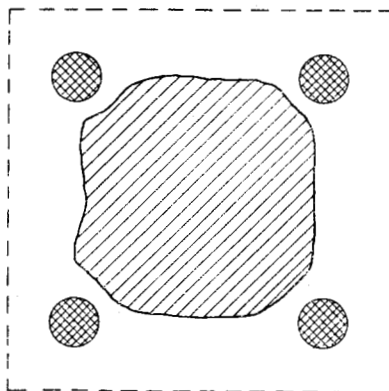
Fig. 18.

if the Author invariably exposed the whole bar before applying gunite. In the case of columns or struts the old material was cut away as shown in *Fig. 18*. That was usually done in two operations, guniting the first half before cutting the second. An exception to that practice occurred in the case of the Kahn reinforcement, which was in most cases only partially exposed. Such differences in method bore largely on the final remarks in Mr. Jackson's contribution in regard to the engineer's views on the methods to be adopted.
