# Failure mechanism of the Aznalcóllar Dam, Seville, Spain.

C. OLALLA and V. CUÉLLAR (2001). *Géotechnique* **51**, No. 5, 399–406

**Dr A. D. M. Penman**, *Chairman ICOLD Committee on Tailings Dams and Waste Lagoons*

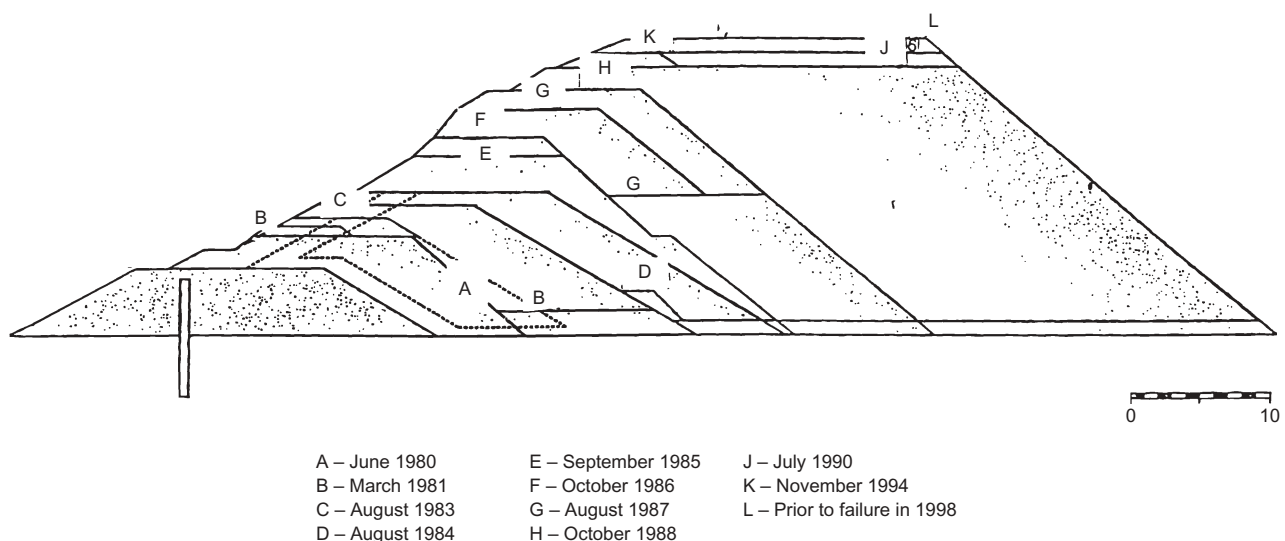
Fig. 18. Construction sequence of Aznalcóllar Dam

The starter dam and the bentonite-cement diaphragm cut-off wall were constructed at the beginning of the project, and the first part of the sloping impervious core with backup filters and compacted waste rockfill built during the following few years to correct upstream and downstream slopes. Later and up to nearly the end of 1988, construction became more irregular, and it is not clear that the integrity of the impervious core was maintained. A considerable amount of waste rockfill was placed between 1988 and 1990, greatly increasing the width of the dam. During the last eight years prior to failure, the rate of height increase was quite slow.
