Kawajiri S, Kawaguchi T, Ogasawara A, Minabe Y and Nakamura D (2025)
Geotechnical characteristics of levees subjected to sand boil due to high water levels.
Geotechnical Research **12(1)**: 29–42,
<https://doi.org/10.1680/jgere.24.00020>

Geotechnical characteristics of levees subjected to sand boil due to high water levels

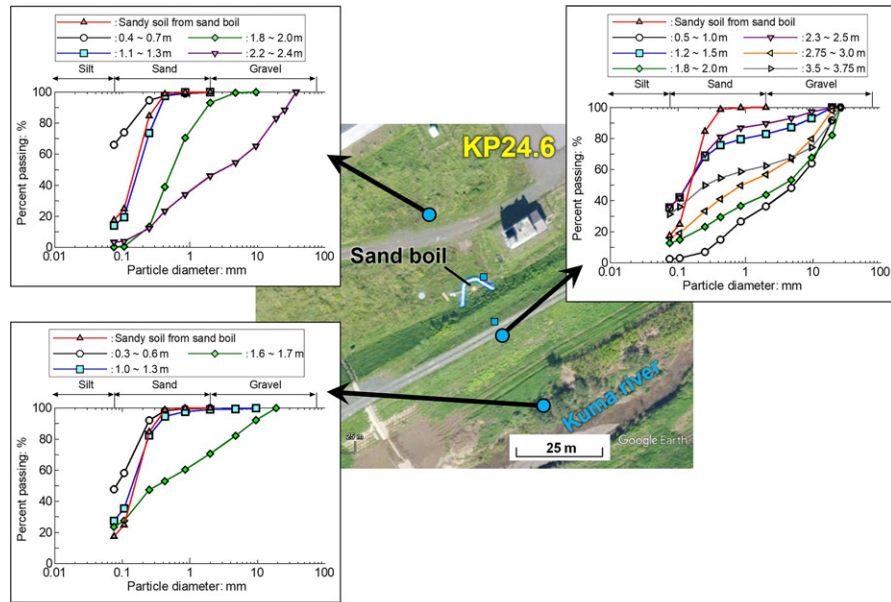
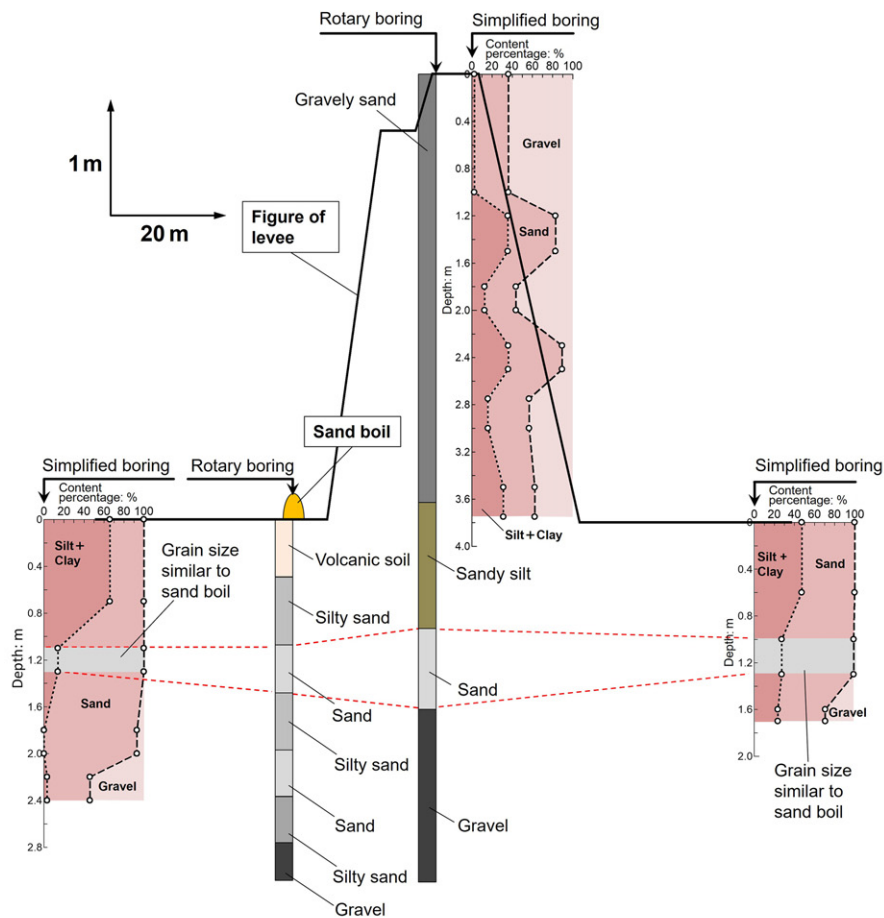
Figure 8. Grain size analysis results and estimated soil profile at KP24.6. (a) Grain size distribution at each location. (b) Soil profile estimated from borehole data (note: the aspect ratio of the figure is different)

distribution was unknown from the simplified boring at the crown of the levee. Figure 8(b) shows the grain size characteristics of the soil at each of the locations in Figure 8(a), compared with a cross-section of the levee. The surface layer on the landside and river-side is a fine-grained soil with a silt and clay content of 40%–60% to a depth of about 1.0 m. The subsoil is composed of sand, silt, and clay. Sandy soil with the same grain size characteristics as the sandy sediment is deposited in the subsoil.

According to the soil information obtained from the rotary boring at the top of the levee and around the sand boil, sandy soil with the same grain size characteristics as those of the sand boil is deposited with a thickness of about 1.0 m just below the levee and 0.4 to 0.6 m from the landside to the riverside. In other words, the sandy soil layer is presumed to be deposited in a lenticular manner. The sandy soil layer was continuously deposited from the landside to the riverside.

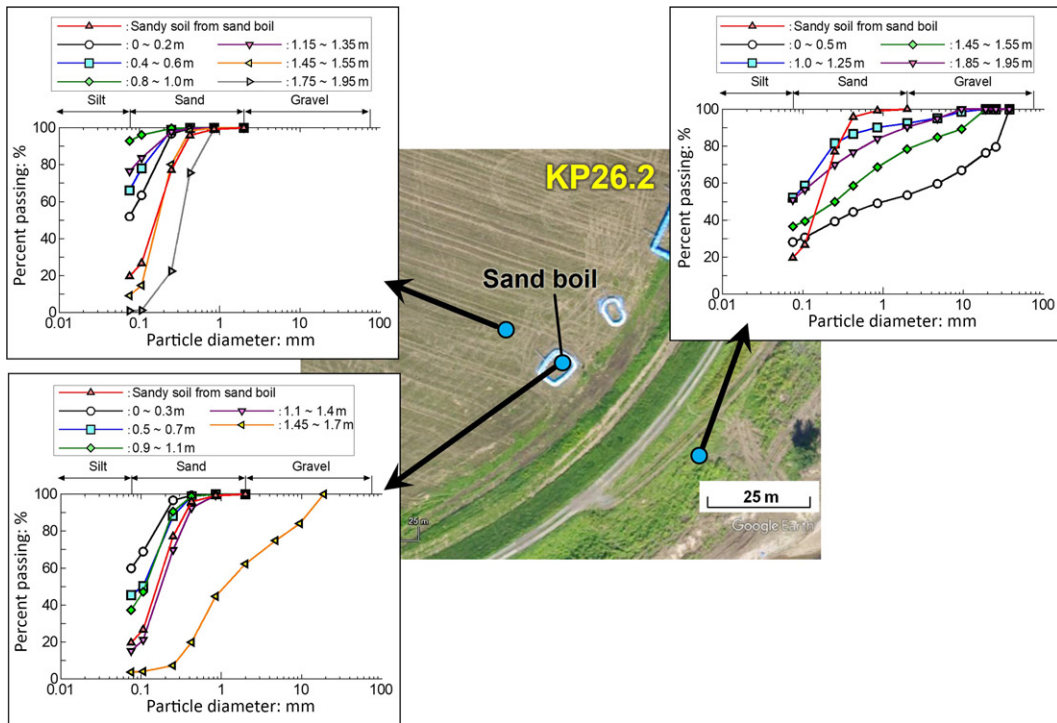
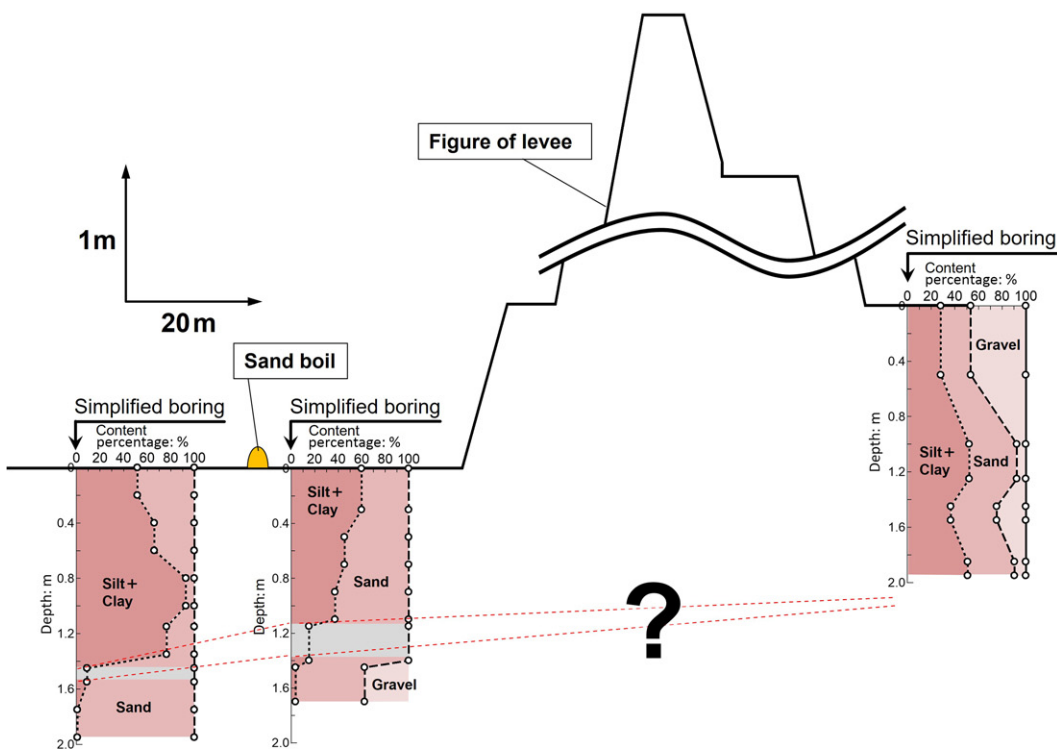
Figure 9. Grain size analysis results and estimated soil profile at KP26.2. (a) Grain size distribution at each location. (b) Soil profile estimated from borehole data (note: the aspect ratio of the figure is different)

Figures 9(a) and 9(b) show the grain size characteristics of soil samples procured at KP26.2 and their manifestation within the levee cross-section, respectively. The sandy soil, possessing similar grain size characteristics to those sampled from the surface of the sand boil, was found distributed both on the landside and in proximity to the sand boil, spanning depths from 1.45 to 1.55 m and 1.1 to 1.4 m, correspondingly. Moreover, a distribution of fine-grained soil was observed on the ground surface within the upper layer of the sandy soil layer, with a discernible elevation in the quantity of fine-grained soil at KP26.2 relative to KP24.6, attributable to the cultivated nature of the landside at KP26.2. Furthermore, an increment in the fine-grained composition of the cultivated soil was noted in the landside direction in contrast to the locus of the sand boil. Sandy soils with similar grain size characteristics to those of the sand boils were not found to be deposited in the riverside ground. However, it is important to note that information on the soil properties below a depth of 2 m in the riverside ground is currently lacking and needs to be included. This result differs from the soil composition observed in KP24.6. Figure 9(b) shows the difference in both depth and thickness of the sandy soil layer, reflecting identical grain size characteristics to the sand boil between the landside and riverside of the sand boil at the ground. The sandy soil layer on the riverside manifested a shallower depth and thicker layer compared with its counterpart on the landside.

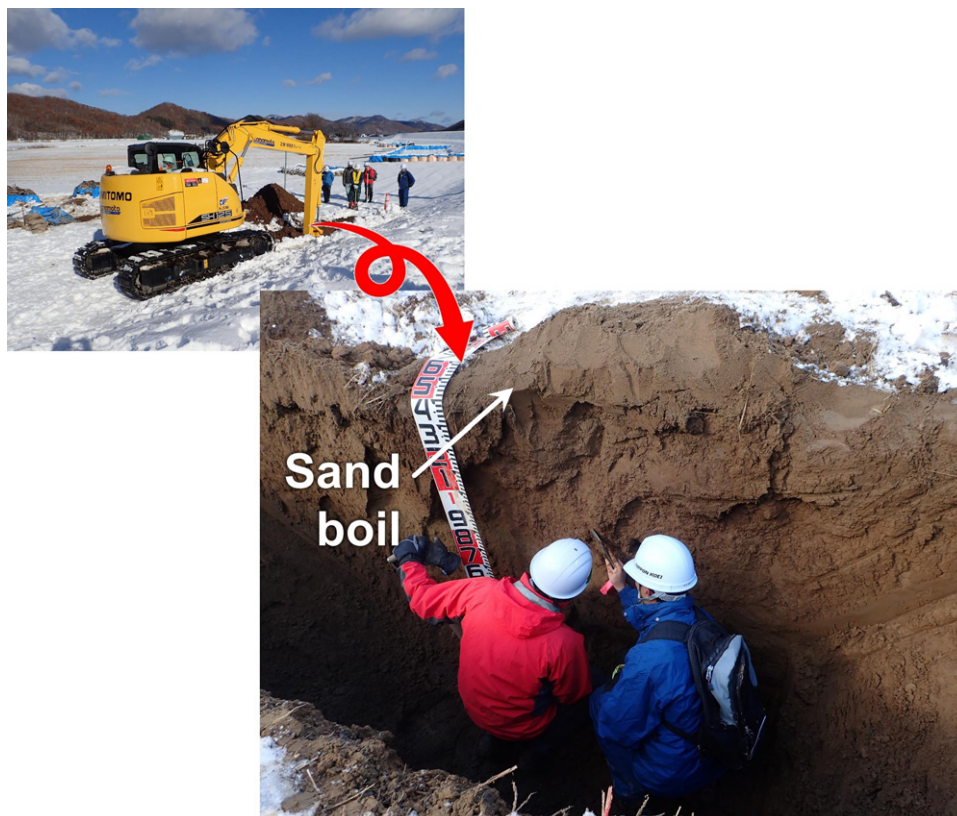
Figure 10. Progress in observation of soil profile on test trenching

Figure 10 shows the conditions of the test trench. The initial step in constructing this trench involved excavating the ground with a backhoe to obtain a preliminary observation section. Subsequently, this initial cross-section was meticulously refined through manual labour, utilising small shovels and sickles to enhance the visibility of the soil layers. Figures 11(a) and 11(b) show cross-sectional views of the test trenches on the riverside and the landside, respectively, delineated by a sand boil adjacent to the sand hill. In Figure 11(a), a layer of silty soil extends from the surface down to a depth of 1.0–1.3 m, beneath which lies sandy soil similar to that found in the sand boil. Below this silty layer, the deposition of sandy soil resembling that of the sand boil is observed, followed by gravelly soil interspersed with rounded gravel. These observations agree with the boring data shown in Figure 9. Conversely, the cross-section moving landward from the sand boil, as shown in Figure 11(b), reveals silty soil reaching depths of 1.5–1.8 m, below which sandy soil is encountered. As indicated above, the sand accumulation from the sand boil is a demarcation between the levee and the landward side, with distinct soil compositions on each side.

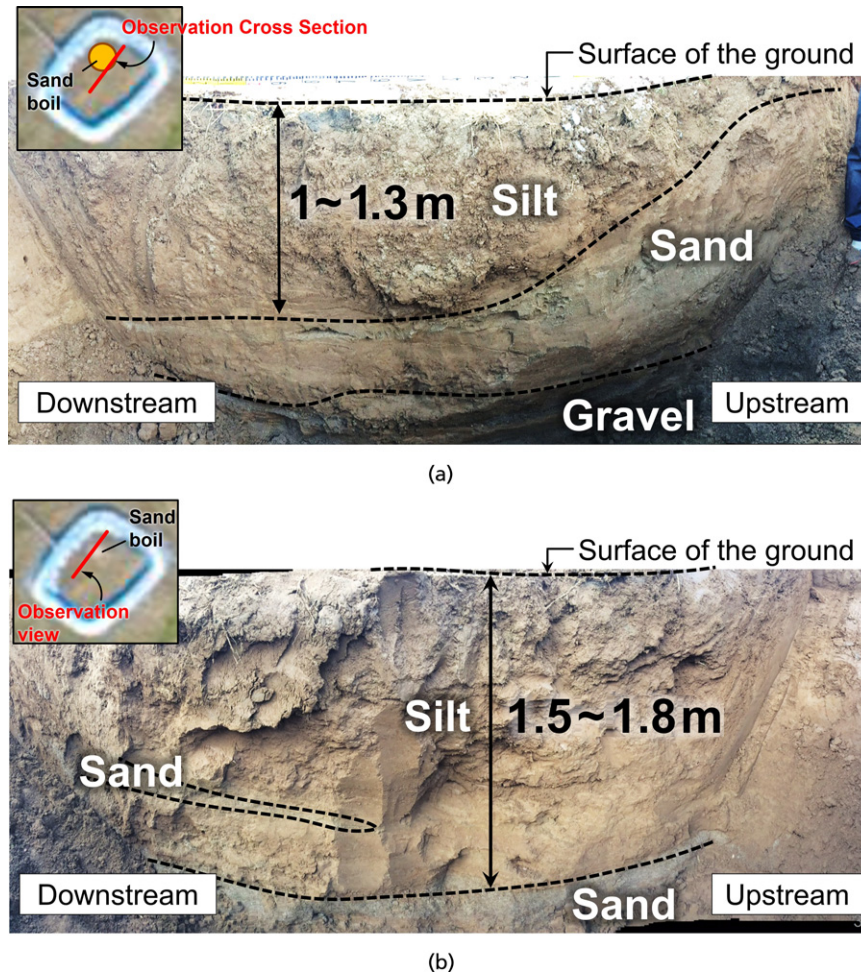
Figure 11. Observed surface of test trenching at KP26.2. (a) Levee side from the centre of the sand boil. (b) Landside side from the centre of the sand boil

The above suggests that the silty soil layer on the landside may have functioned as a barrier, preventing the horizontal transmission of seepage pressure from the river channel. This seepage pressure may have been directed upwards towards the surface in front of the silty layer, promoting the occurrence of sand boils.

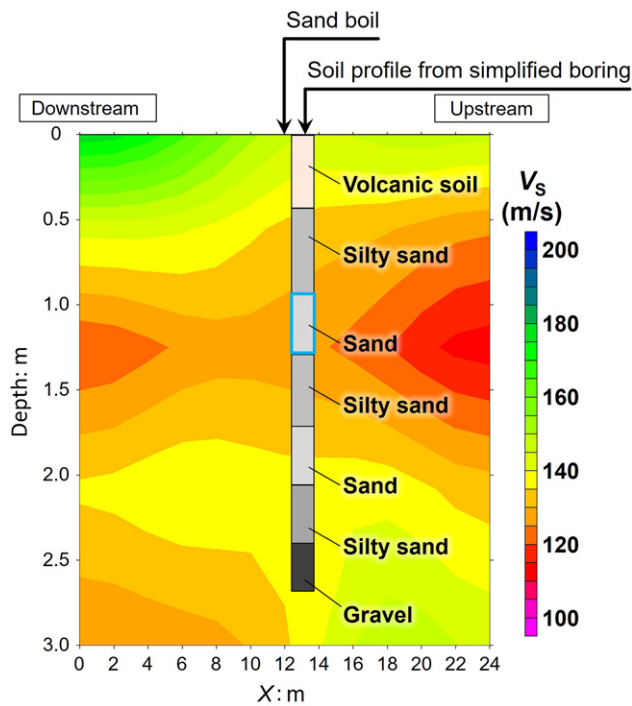
Figure 12. S-wave velocity profiles obtained from MASW near the sand boil occurrence at KP24.6 (survey array was placed in the longitudinal direction of the levee)

Figure 12 shows the two-dimensional distribution of V_S at KP24.6 obtained from the surface wave survey conducted at the survey line shown in Figure 4(a). The figure also shows the soil profile obtained from the rotary borehole near the location of the sand boil. Typically, V_S increases with depth. However, at $Y = 1.0$ – 1.5 m, where sandy soil with grain size characteristics similar to those of the sand boil is distributed, a low-velocity region of $V_S = 110$ – 130 m/s is distributed in the direction of the levee extension ($X = 0$ – 24 m), as indicated by the blue boxes in the figure. On the other hand, $V_S = 120$ – 130 m/s is relatively high near the point of sand boiling point ($X = 6$ – 14 m) within this low-velocity region. In other words, the V_S of the sandy soil layer, the source of sand boiling, is lower than that of the upper and lower layers, but the V_S at the sand boiling occurrence point is slightly higher within this region. This result suggests that the soil density in the foundation around the sand boil may have changed due to the soil disturbance caused by the soil piping.

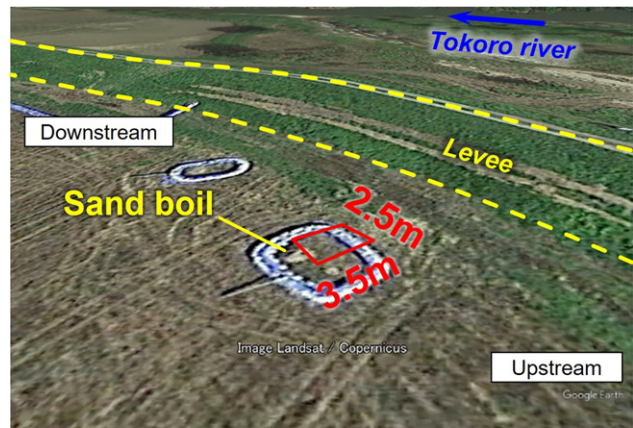
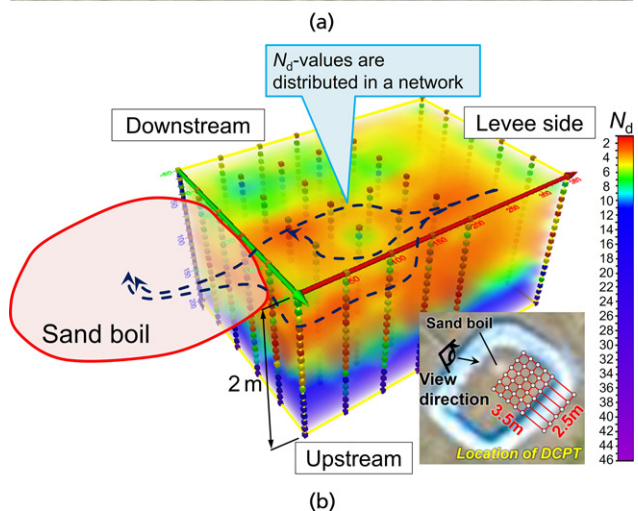
Figure 13. DCPT locations and N_d values obtained from DCPT at KP26.2. (a) Bird's-eye view of the area subjected to DCPT. (b) Three-dimensional distribution of N_d values around the sand boil

Figure 13 shows the three-dimensional distribution of DCPT N_d values near the sand boil occurrence at KP26.2. As a general observation, N_d values exceed 20 at depths beyond 1.5 m. This depth aligns with the distribution of gravelly soil within the soil profile, as determined from simplified boring and illustrated in Figure 9. Downstream of the soil profile, N_d values range from 5 to 8 to approximately a depth of 1.0 m. Beneath this, a layer is identified with N_d values as 3 or less, indicative of sandy soil and consistent with the soil profile analysis. Similarly, the upstream side exhibits surface areas where N_d values were 3 or less. This observation aligns with the findings from the test trench investigations presented in Figure 9. These results suggest that the sandy soil layer, exhibiting grain size characteristics similar to those associated with sand boils, presents as a loosely compacted zone with N_d values of 3 or less. The distribution of this sandy soil is not uniform towards the levee but appears in a network pattern. Visual identification of cavities or sand columns was not possible during the test trench survey. Consequently, it is inferred that the seepage pressure generated in and around the levee support ground propagated selectively, as indicated by the dashed lines in Figure 13(b).

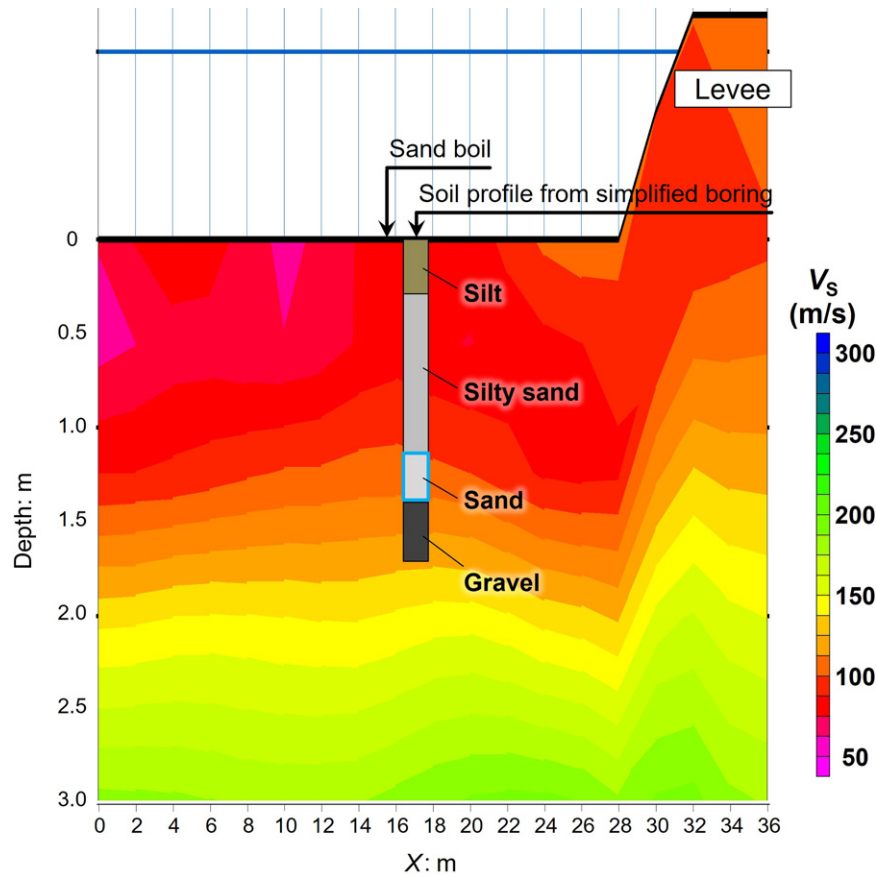
Figure 14. S-wave velocity distribution obtained at the MASW near the sand boil occurrence at KP26.2 (survey array is placed orthogonal to the longitudinal direction of the levee)

Figure 14 shows the two-dimensional distribution of V_S around KP26.2 (Kawajiri *et al.*, 2019). The soil layer classifications obtained from the boreholes near the sand boil (see Figure 9(a) and 9(b)) are also shown. The S-wave velocity of the sandy soil with similar grain size characteristics to the sand boil shown in the blue box is 100–110 m/s. This velocity range is distributed between 100 and 110 m/s toward the soil surface where the sand

boil occurred. This result can be interpreted as the sand boiling pushing the sandy soil layer towards the ground surface. Another interpretation is that the silty soil layer may have been locally thin even before the sand boiled, and the sand may have erupted through these areas. As shown above, the S-wave velocity distribution at the location of the sand boil was different depending on the occurrence of the sand boil. In the case of a large sand boil at the slope toe on the landside, an increase in S-wave velocity was suggested in the path of the backward erosion piping. On the other hand, the sand boil that occurred distant from the slope toe on the landside showed a reticulated area with low N_d values, suggesting that this area may have been the path of the backward erosion piping. At KP24.6, the movement of sandy soil with grain size characteristics similar to the sand boils due to seepage pressure and river water inflow is expected to have increased the density of the loosened area. On the other hand, KP26.2 has heterogeneous hydraulic conductivity and density, and this heterogeneity caused the development of a network of water channels when seepage pressure was applied. Sediment gradually moved through these water channels, and thus, it can be inferred that areas with low N_d values remained in the network after sand boiling occurred. Therefore, the profile of V_S and N_d values at the sand boil site is considered a characteristic distribution that contributes to the investigation of the mechanism of sand boil occurrence.
