S.S. "UMBRIA" THRUST-SHAFT.

The Discussion upon the Paper on "The Break-down of the R.M.S. 'Umbria'" occupied the evening.

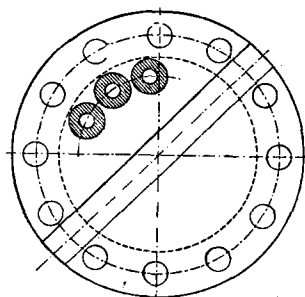
Mr. EDWARD REYNOLDS furnished particulars and copies of Mr. Reynolds. drawings of the tests made at the works of Messrs. Naylor, Vickers Sons and Company, Limited, under the direction of Mr. Bain, the Cunard Company's engineer, from pieces trepanned out of the

forward end of the broken shaft, and wedged backwards and forwards until they were broken out, Fig. 5. One piece, after being turned to the dimensions shown in Fig. 6, was tested for tensile strength; the other two were bent transversely as shown in Figs. 7.

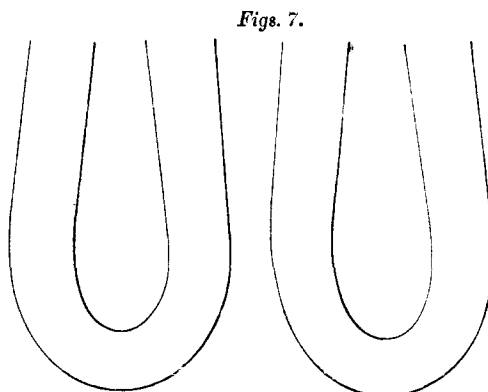
Mr. Reynolds. Results from pieces broken out in this way were possibly from 4 to 5 per cent. inferior to those which would have been obtained

if pieces had been cut out without being bent several times in the act of extraction. The end view showed the holes drilled in the

25·75 tons per square foot.

26·4 per cent. elongation.

47·1 „ contraction of area.

shaft at New York, and the key-way which was cut across the shaft to assist the bolts in driving.
