### Discussion

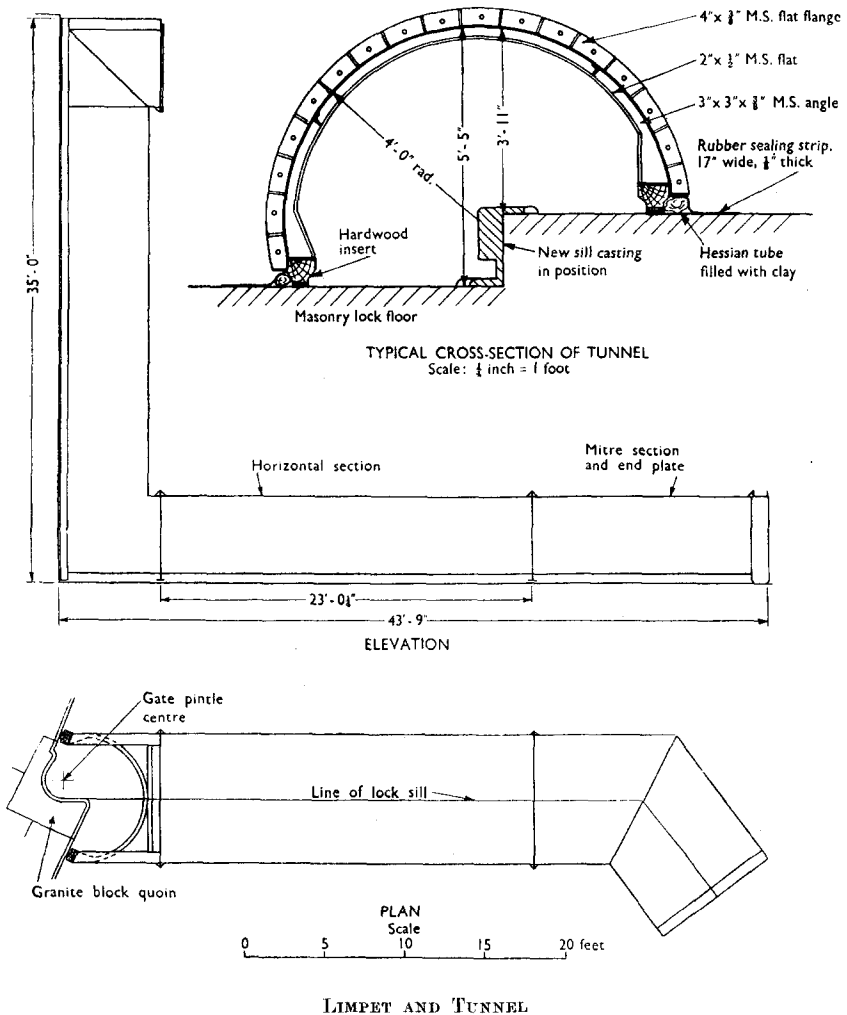
Figs 26

Essentially the limpet and tunnel consisted of five sections (*Figs 26*): (1) a vertical section which was the limpet proper, which had flanged connexions for attaching the tunnel at the top and bottom, so that it could be used on either side of the lock; (2) a removable diaphragm, incorporating an 8-inch sluice valve, to enable the limpet to be dewatered independently before the tunnel sections were attached; (3) a straight tunnel section; (4) a mitred tunnel section; and (5) an end cover plate shaped to fit the step of the sill.

The tunnel extended approximately 6 feet beyond the mitre so that a little more than one-half of the sill would be dewatered at a time, and then it was transferred to the other side. The limpet weighed 7 tons and was

35 feet deep ; the tunnel was of semicircular section, 8 feet in diameter and had a total length of 43 feet. In all, about 14 tons of steel were used. It was constructed of welded mild steel,  $\frac{1}{4}$  inch thick, suitably stiffened, and terminated with 8-inch-by-3-inch channels welded along the edges. Stiffened flanges were provided at the extremities for bolting the sections together.

All joints proved satisfactory except the rubber bonded to the timbers, which showed signs of failure after a fortnight's immersion. When the apparatus was transferred, the rubber was found to be quite loose. Softwood strips were substituted with satisfactory results.

Dewatering was effected by means of a 7-inch submersible pump, and subsequent seepage was dealt with by a small hydraulic ejector. At the first attempt to dewater the limpet, it had been found that the upstream leg of the limpet was sliding inwards along the wall of the lock, the maximum movement being at the bottom, diminishing to zero at the top. There had been no movement of the downstream leg.

The limpet had been withdrawn and found to be distorted. It was restored to shape by jacking, and additional stiffening was welded on.

The behaviour of the model had induced undue reliance to be placed on the friction between the limpet and the wall. To remedy the defect, stiffened channels were bolted to the lower half of the lock wall by divers, so that the limpet could be lowered over those channels with  $\frac{1}{2}$ -inch clearance to the inside of the limpet channels. No difficulty was then experienced and the dewatering was accomplished.

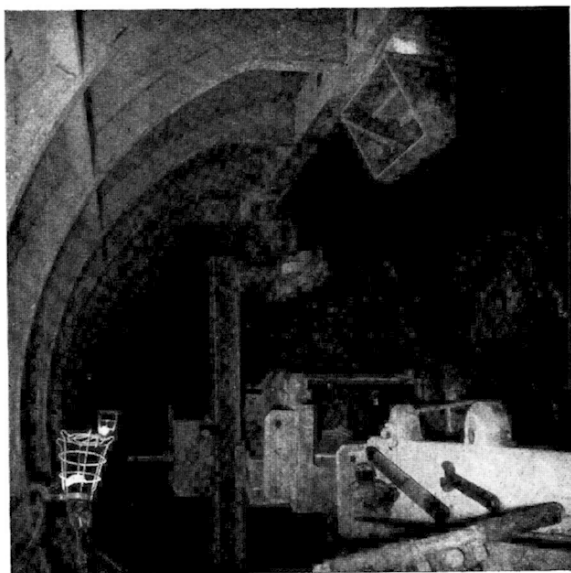
*Fig. 27*

Inside the tunnel a small travelling cradle with three-dimensional motion was used to handle the sill castings. (*Fig. 27.*)

INTERIOR OF TUNNEL SHOWING TRAVELLING CRADLE

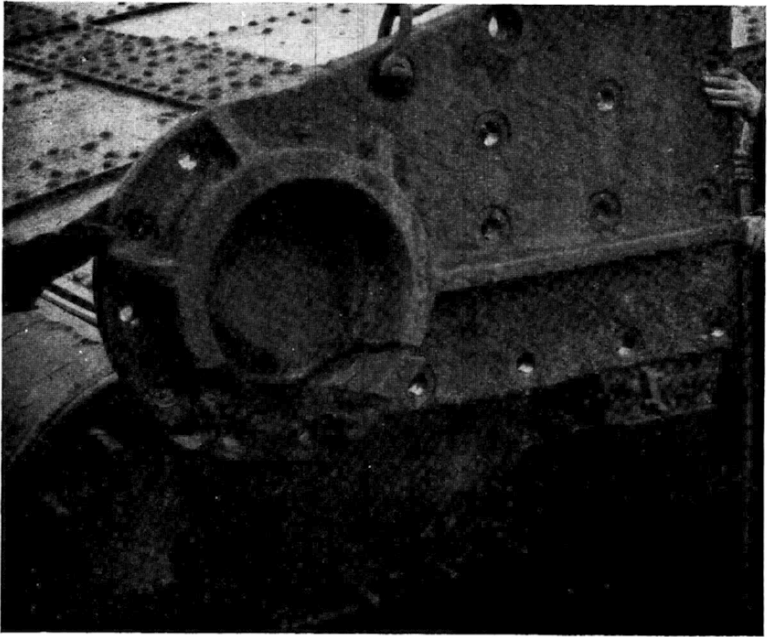
*Fig. 29*

FRACTURED HEEL-SOCKET CASTING

Mr Easton then displayed a series of lantern slides illustrating the points he had raised. Two of his slides, reproduced as *Figs 29* and *30* respectively, showed a heel-socket casting which had fractured under heavy service conditions; and a way of obviating the joggling difficulty, using machined tapered packings which enabled a "lazy joggle" to be employed.

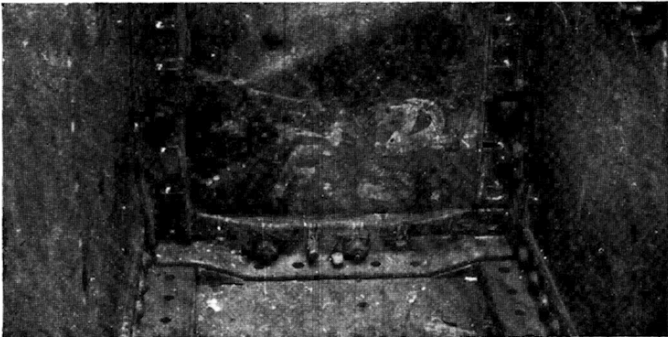
*Fig. 30*

USE OF MACHINED TAPERED PACKINGS TO AVOID JOGGLING DIFFICULTY

at the heel end, and considerable racking and loosening of rivets had been found. The supersession of riveted by welded design would obviate the considerable difficulties which might otherwise be expected through the increasing scarcity of competent angle-smiths who could produce those single and double joggles, and similar work.
