Colliford Dam sand waste embankment and asphaltic concrete membrane

T. A. Johnston and J. D. Evans

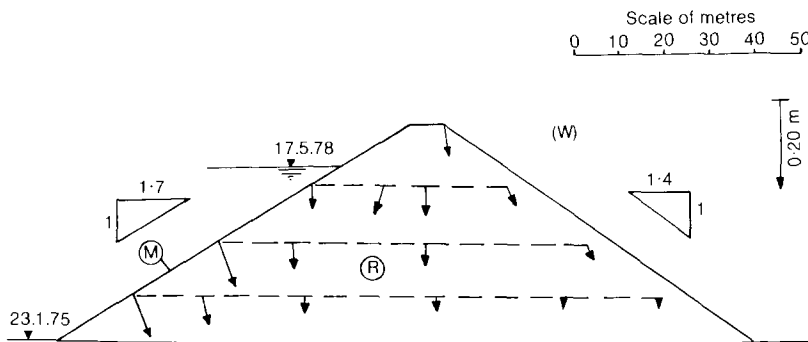
Fig. 13. Deflexion measurements during impounding at Windscar

84. Windscar was one of the first of these dams. The deformation of the membrane when the reservoir was filled could be measured by horizontal plate gauges which were fitted through the dam at three positions. The deflexion measurements made during impounding are given by the vectors shown on Fig. 13. This instrumentation does not reveal the differential movement that can take place at the plinth. Measurements were made on Marchlyn Dam which was one of the other few British dams to use an upstream asphaltic membrane. For this exercise a trolley was devised which would run on a railway line that was fitted on the face of the asphalt. It ran underwater so that the deflexion that occurred on filling the reservoir could be measured. A description of the measuring trolley has been given by Penman and Hussain.¹⁴

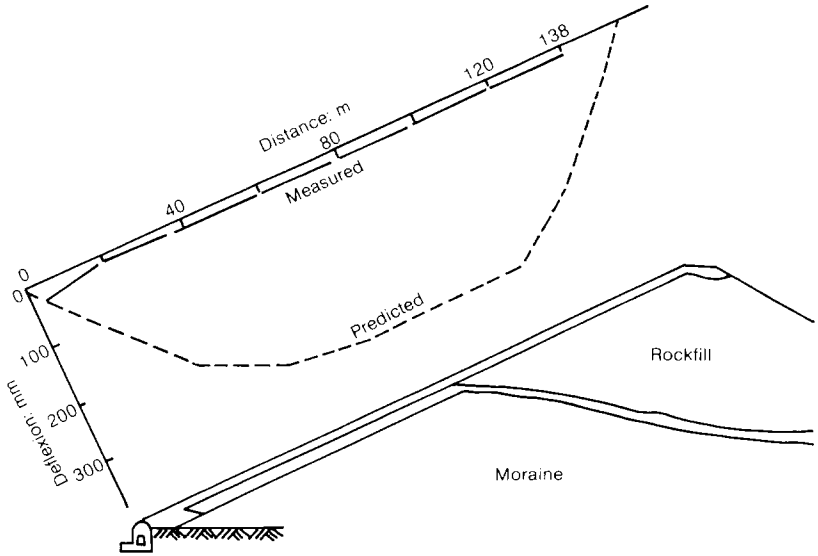
Fig. 14. Membrane deflexion at Marchlyn Dam

85. The designers of the dam had made various assumptions and predicted a total deformation of the upstream slope during and subsequent to construction with a maximum of about 250 mm near the middle. The measured movements of the membrane were much less than this, as shown by Fig. 14 the maximum being only about 20 mm in the central part of the membrane. Near the toe, adjacent to the concrete cut-off structure, there was a differential movement of 25 mm, shown by Fig. 15. The beauty of the trolley mechanism was that it shows the movement that can occur between the rigid concrete structure, which is both founded in bedrock and standing on top of the grout curtain, and the asphaltic membrane, which is supported by the fill. As in the case of bridge abutments, the fill is very difficult to compact tight up to a concrete structure with a vertical wall, so in this zone it may be slightly less dense or well compacted than the rest, and this leads to some differential settlement. Special arrangements had been made to allow for more movement at this point, so 25 mm did no harm. However, it shows that there can be larger movements immediately adjacent to the concrete structure. At the bottom of Colliford Dam (Fig. 8 of the Paper) the Authors have wisely made a sloping back to their concrete cut-off to simplify the completion of the sand fill. Could they explain more about that? They have also provided for extra reinforcement of the membrane to allow for differential movement that might occur.

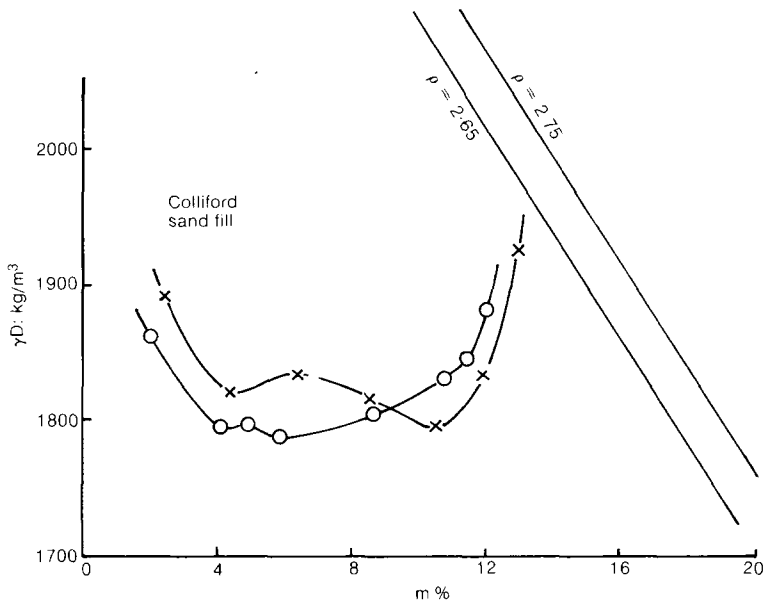
Fig. 16. Colliford—compaction curves and saturation lines

87. Concerning the problems of compaction of the sand, the Authors showed the upside down sort of compaction curve that develops with sand, but omitted the saturation lines. I have put on saturation lines for specific gravities of the sand of 2.75 and 2.65 in Fig. 16. It is very difficult to imagine such a curve turning over in time to meet the 2.65 line. Perhaps the figures here are wrong. Could the Authors explain this problem?

113. *Dr Penman and Mr Smith* have drawn similar graphs, Figs. 16 and 17. The specific gravity of the sand fill is 2.66 and no doubt if the fill had been well graded and included particles of clay and silt size the saturation lines on the graphs would have been useful in assessing compaction. However, the concept of a saturation line is not really helpful with uniform materials such as at Colliford. The size and shape of the particles in the fill dictate the matrix of the fill. Point-to-point contact of the fill material, and hence the same dry density, can be achieved over a reasonable wide range of moisture contents.

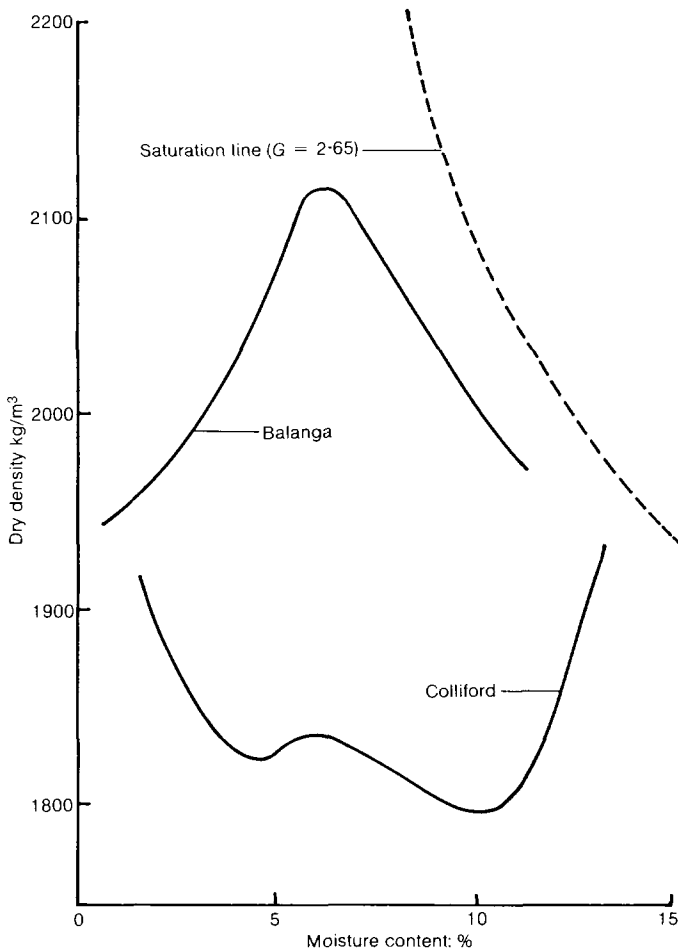
Fig. 17. Compaction curves for embankment sand—Balanga and Colliford

The fill, as the Authors point out, is rather unusual with an inverted W or U density curve (as in Fig. 17) but it is perhaps not so unusual to people used to working in desert climates. Desert sands and desert fills frequently have this sort of curve which seems typical for the more or less uniform graded material that occurs. The uniformity of that grading probably also leads to the fairly low densities of these sands. The influence of adding a little silt to the material drastically changes that behaviour.

91. There is a great difference in both the density and the shape of the curve. This is probably caused only by the silt content. A further point is that the curve for Colliford sand is close to and tending to cross the 100% saturation line at high moisture content. The 100% saturation line has been plotted assuming a specific gravity of 2.65. Could the Authors comment on these points in the light of any other investigations that they made on other materials? At Balanga the fines made the material very easy to handle. Although very similar compaction plant was used, that is a large smooth-drum vibrating roller of about the same weight as at Colliford, only about four passes were needed to get the maximum density, provided the considerable volume of water needed was added.

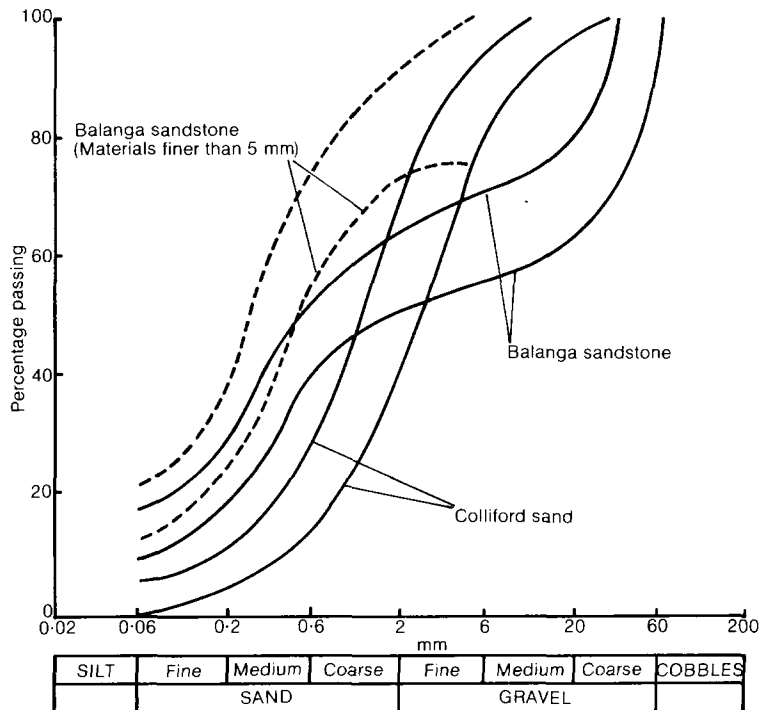
Fig. 18. Sand particle size distribution—Balanga and Colliford

90. The Authors alluded to this in their talk and discussion. They found that other sands elsewhere in Devon showed very different properties. At the dam that my company has built at Balanga in Nigeria the sand used shows a wavy grading curve (Fig. 18). It was produced from a weak sandstone which broke down extensively on placing. It is quite gap graded as shown by the waviness in the curve. The flatter curve in the middle of the grading indicates larger particles mixed with smaller ones with a lack of intermediate sizes. Also plotted in the figure is the Colliford sand which is of a more uniform material. If on the gap grading the coarser material of the Balanga sands is cut out, the resulting grading looks similar to the sand at Colliford (see dotted curve, Fig. 18). However, appearances perhaps can be deceptive because the density curves are very different, as seen in Fig. 17.

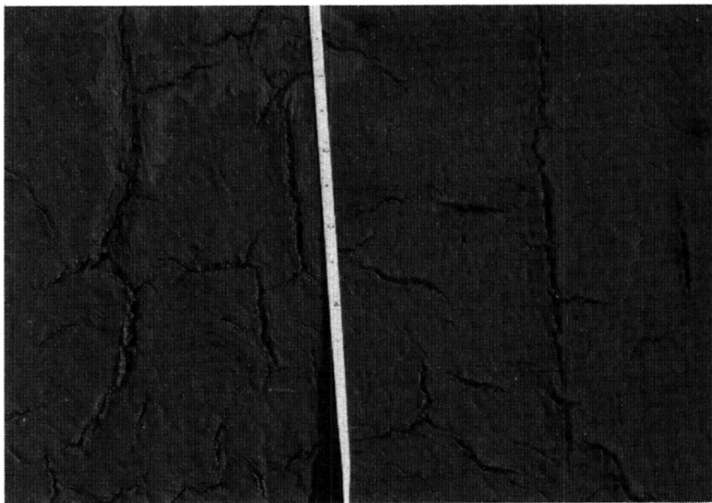
Fig. 21. Kindaruma Dam membrane cracks

layers and over the plinth there is a protective cap of asphaltic material. Drainage water is collected from the central layer and carried away through the dam to a measuring station. Fig. 21 shows cracking within the membrane in the area that is alternatively wetted and dried as the reservoir level varies. Fig. 22 shows essentially vertical cracking both within and above the normal operating range of the reservoir.

97. Membrane cracking has been identified at both dams quite early in their lives. Despite the appearance of the cracks, the relatively constant seepage suggests that both dams are working well. Nevertheless we are continuing to measure seepage daily and the need for maintenance is reviewed continuously. Several suggestions have been made during recent inspections as to the causes of the cracks. These include

- (a) strong ultra violet light
- (b) loss of volatile components of the asphalt leading to a reduction in ductility
- (c) downhill creep may be responsible for horizontal cracks
- (d) relatively poor compaction under the edges of vertical strips may be responsible for vertical cracks
- (e) the mix may have been locally too rich in bitumen.

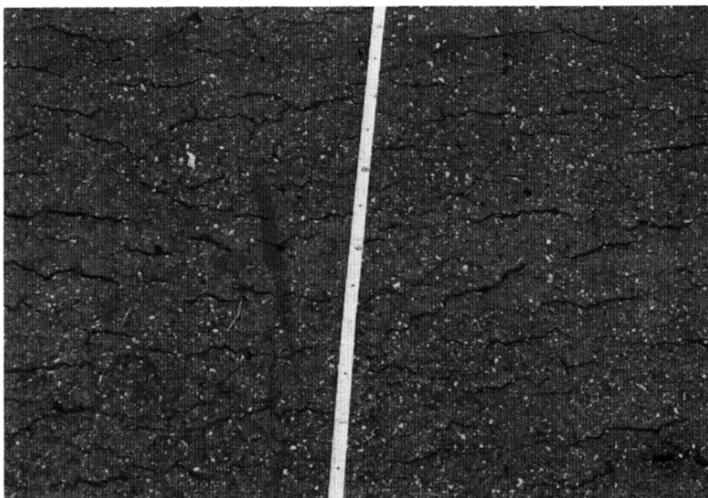
Fig. 25. Kamburu Dam membrane cracks

95. Kamburu Dam is shown on Fig. 23. It was completed in 1973 and is 50 m high and 900 m long. It is at 1000 m above sea level. Fig. 24 shows the construction detail of the asphalt face. In this design there is no internal drainage layer. The design of the connection of the membrane to the plinth is similar to that used at Colliford: there is a levelling and binder course and two layers of dense asphaltic concrete covered by a protective layer. Fig. 25 shows surface crazing within the operating range. The crack width here is 2 mm to 3 mm. Fig. 26 shows a more pronounced crack about 5 mm wide.
