Collapse of Ynys-y-Gwas Bridge, West Glamorgan

R. J. Woodward and F. W. Williams*

DISCUSSION

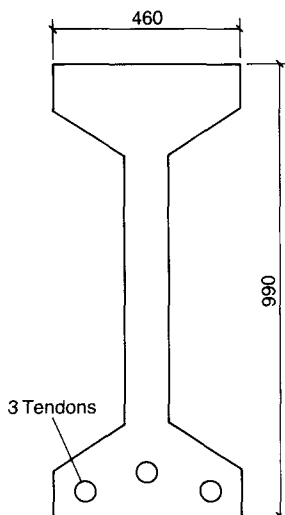
In 1974 a post-tensioned, precast concrete roof beam 18.6 m long collapsed due to corrosion of the tendons. The typical section of the beam is shown in Fig. 24 and the elevation in Fig. 25. The beam had been constructed of three precast concrete units assembled in line and stressed together with dry packed mortar joints.

119. At the time of collapse the beam was 14 years old. It was visually exposed in the roof of a warehouse and no signs of distress had been noticed. Failure occurred at one of the joints. Examination showed that the tendons were severely corroded in a manner very similar to that illustrated in Fig. 11. The exterior of the beam showed no indication of the condition of the tendons.

Fig. 24. Cross-section of a beam of a post-tensioned precast concrete roof which collapsed due to corrosion of the tendons

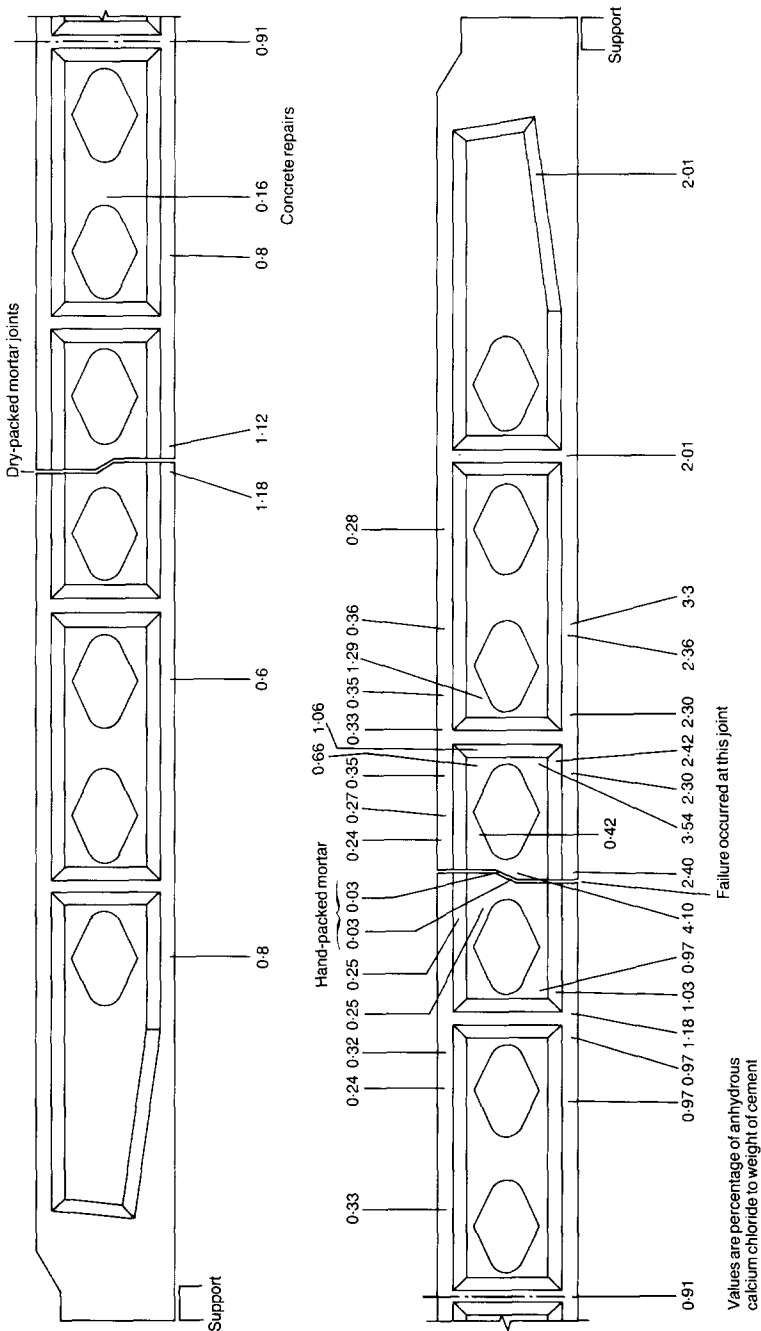
120. A programme of testing was undertaken which included the determination of chloride content in the concrete at various points along the beam. The values obtained are shown in Fig. 25. The values in the bottom of the beam unit immediately to the right of the point of failure are high compared with those immediately to the left of the point of failure and with other locations in the beam.

Examination of the tendons and ducts shows that the tendons and ducts immediately to the left of the joint had virtually no corrosion and that the severe corrosion of the tendons and ducts occurred immediately to the right of the joint. It might be concluded that the significant change in chloride content across the joint had been a factor in causing the severe corrosion at the joint.

Fig. 25. Elevation of roof giving percentage of anhydrous calcium chloride to weight of cement
