Assessment of a fire-damaged concrete overpass: the Verona bus crash case study

Verona bus
crash and fire

Roberto Felicetti

Civil and Environmental Engineering, Politecnico di Milano, Milan, Italy

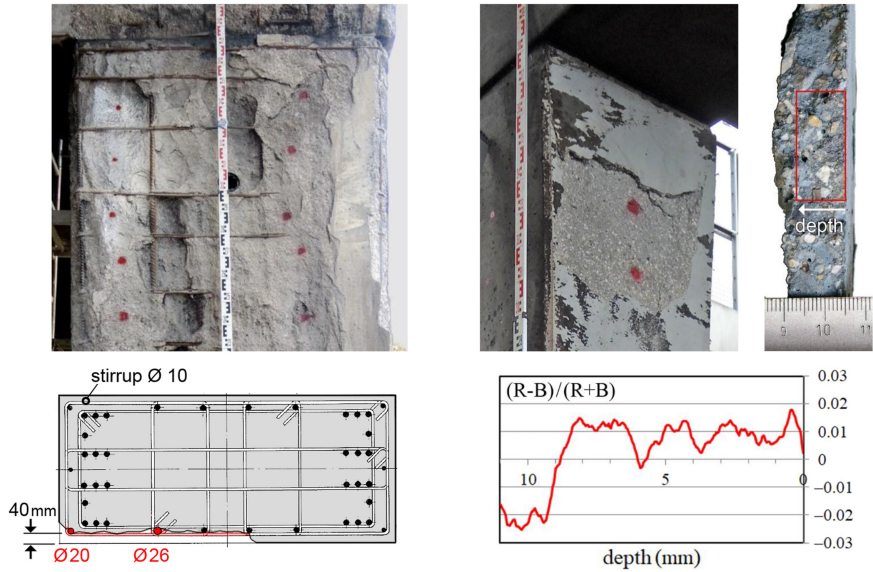
As concerns fire, the visible signs of damage include spalling on one side of the impacted pillar (with direct exposure of some rebars) and diffuse surface cracking and cover delamination of the above transverse beam.

The visible damages observed during preliminary inspection (Figure 2) include spalling on the upper half of Pillar 1, with direct exposure of two longitudinal rebars and some stirrups (then, a small share of the member reinforcement). A stable delamination of large plates (10–15 mm thick) was recognized at the top of Pillar 2. Here the fractured debris could be easily removed and inspected for discolouration. Extensive incipient delamination was detected by hammer tapping also at the intrados of the transverse beam, together with regularly spaced vertical cracks with the same pitch as the stirrups. In summary, no lack of rebar protection affected these latter two elements.

Figure 2. Observed damage patterns: spalling at the top of Pillar 1; stable delamination at the top of Pillar 2 and discolouration of a detached plate; equally spaced cracks and incipient delamination at the bottom chord of the transverse beam

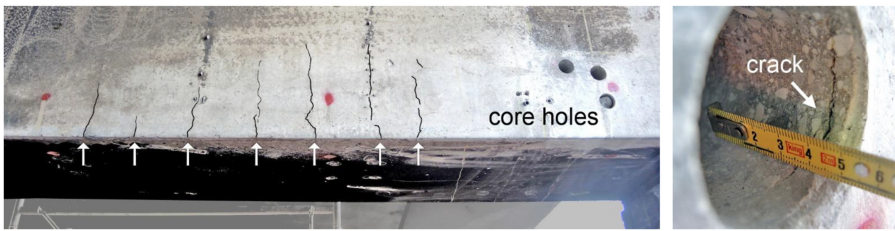
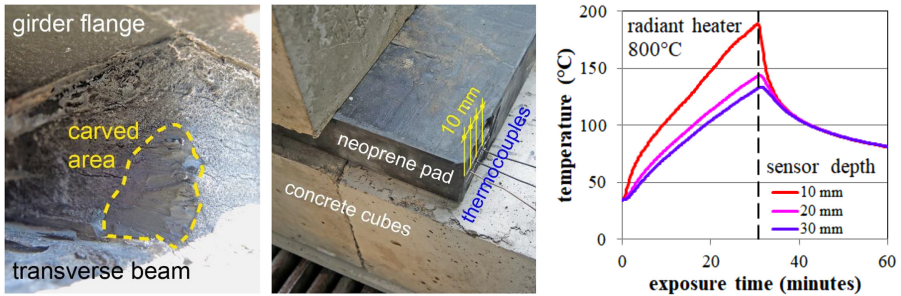
A last aspect deserving attention was the possible damage undergone by the elastomeric bearing pads laid between the transverse beam and the box girders. Visual inspection showed a charred surface on the most exposed sides (Figure 3). However, carving a thin slice was sufficient to expose an intact material with a rubbery consistency. In a laboratory test, a identical pad was stacked between concrete cubes and exposed to 30-min intense radiant heating (about 50 kW/m²). The specimen showed limited charring depth (4 mm) and decreasing heating rate, due to the protective effect of the charred layer and the high conductivity of the reinforcing metal shims. The maximum temperature at 10-mm depth was below the onset of decomposition as indicated by thermogravimetric analysis (Caballero *et al.*, 2005), confirming the good fire endurance of this component.

Figure 3. Charred skin removal from a neoprene bearing pad and heating curves resulting from the radiant heater test

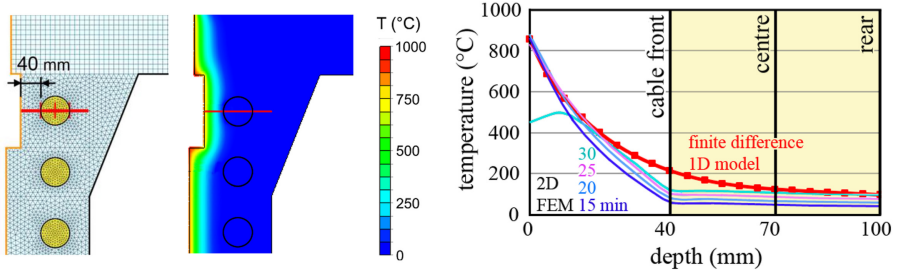
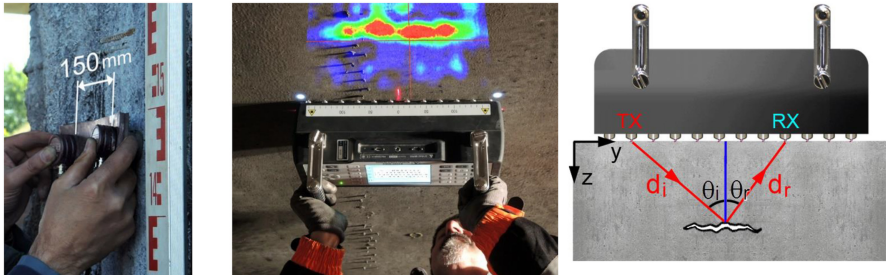
Figure 7. Setup for fast UPV mapping via the indirect method and the A1040 MIRA tomograph; their respective pulse velocity maps detected at the intrados of the five box girders composing the deck (abscissa measured from the portal edge)

Besides the different magnitude (shear waves are 40% slower than compression waves), the resulting map (Figure 7) is very similar to the one obtained by means of the traditional UPV method. However, merging 66 waveforms in one measurement allows offsetting the local disturbance due to cracks, rebars and other defects, producing a smoother output. To be mentioned is that both mapping techniques were implemented at the pace of 25 test points per hour, minimizing the traffic disruption in this strategic highway.

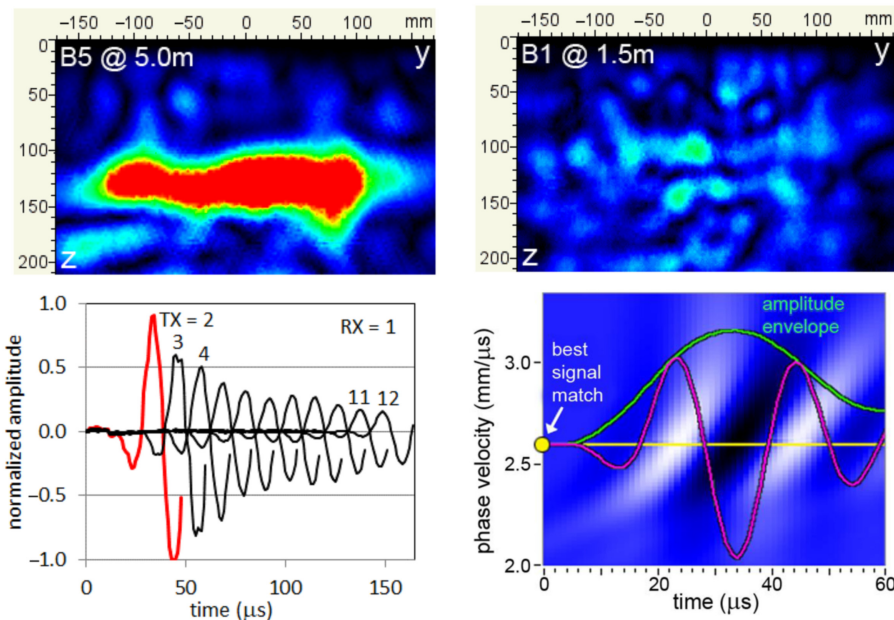
In the application at issue, the steep gradients of pulse velocity tend to invalidate the SAFT algorithm and the strong bottom-echo produced by the inner cavity of the girders progressively vanishes as fire damage increases (Figure 8). Nonetheless, the slower surface layer tends to

Figure 8. Different strength of the bottom-echo in case of pristine and damaged concrete flanges, regular increase of arrival time at the increasing transmitter–receiver distance, assessment of surface wave velocity by optimization of the pulse alignment

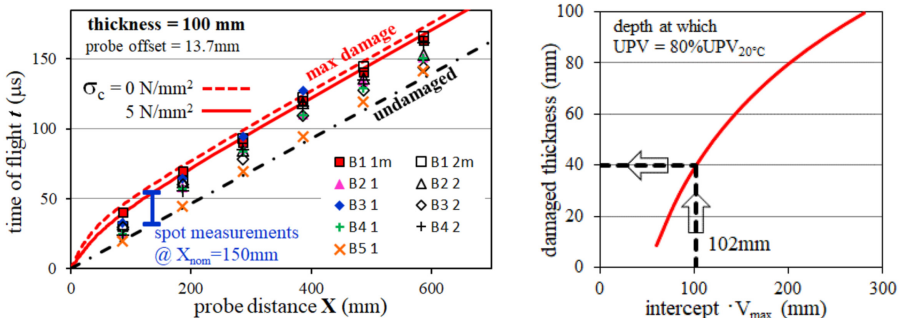
In situ measurements were taken along the central axis of each box girder, at a 1 and 2 m distance from the edge of the supporting transverse beam. The comparison against the theoretical trends (Figure 11) shows that all results lie between the plots pertaining to undamaged concrete (a straight line of slope $1/V_{20^\circ\text{C}}$) and to the maximum expected damage above the localized fire source. A good correspondence is observed between damage depth and the location in the general velocity maps of Figure 7, with smoothly decreasing effects in Beams 4 and 5. The effectiveness of spot measurements at $X = 150$ mm nominal probe distance in discriminating damage levels in this range is also highlighted in the diagram.

Figure 11. Comparison between measured pulse propagation times and the theoretical $X-t$ curve descending from the assumed fire scenario; quick assessment of damage depth according to the semi-empirical correlation proposed in Felicetti (2013)

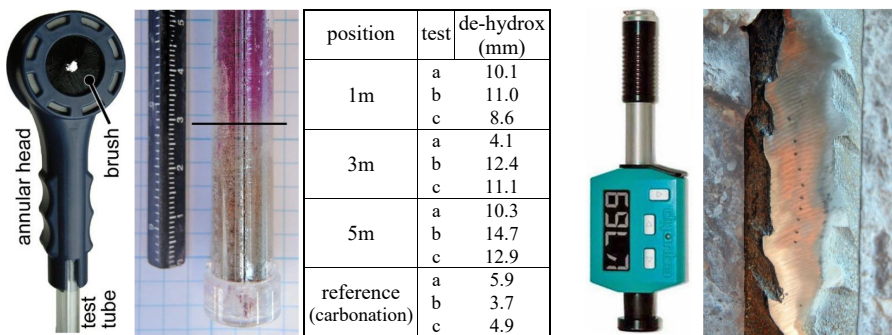
De-hydroxylation depth. Calcium hydroxide is the main source of alkalinity in concrete pores. It is decomposed by heating above 450 °C, leading to the formation of calcium oxide, which is a highly hygroscopic product. For this reason, the reaction is reversible and can be recognized only if no water is used while sampling, as is made possible by collecting drilling powder via the Carbondest[®] kit (Felicetti, 2013). Tests performed on the portal confirmed the lower impact of fire, as anticipated by colour analysis (max de-hydroxylation depth = 10.5 mm). Checks on the exposed web of the first girder (Figure 12) gave slightly lower values than expected (<15 mm vs 16.8 mm in Figure 9), confirming the assumed fire scenario as a cautious description of the event.

Dynamic hardness tests on rebars. Steel rebars may recover a significant share of their initial strength during cooling, though this strongly depends on their metallurgical features (alloying elements, thermal and mechanical working process – Felicetti *et al.*, 2009). The dynamic hardness test (Leeb method) is a viable tool to assess their residual performance regardless of original quality (Felicetti, 2014). Tests were performed on one rebar exposed by spalling in Pillar 1 and a reference piece uncovered by chiselling on the opposite side. The results (mean rebound index/std deviation = 515/6 and 536/8, respectively) showed a marginal decay of the rebar response (−4%), which corresponds to an almost double loss of yield strength. Given also the minor contribution to the sectional capacity of rebars laid bare by spalling (Figure 2), this confirms the little impact of fire on this element. For Tempcore bars, a permanent loss of strength of about 10% can be ascribed to heating in the range between 600 and 700 °C (Felicetti *et al.*, 2009), which seems coherent with the other observations.

Figure 12. The Carbondest[®] kit, a de-hydroxylated powder sample (scale factor 2.25) and results collected on the exposed web of the first girder; Leeb dynamic hardness tester and resulting indentations on the smoothed face of an exposed rebar of Pillar 1

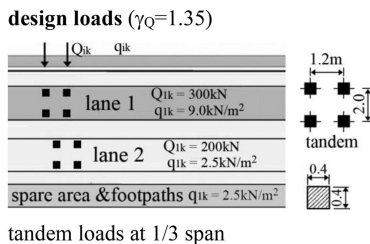
Concerning the ultimate capacity of the critical section, the performed investigations led to the conclusion that the post-tensioning cables underwent a non-significant heating (<120 °C, Figure 6), whereas temperature exceeded 300 °C in the first 30 mm of the most exposed cover (temperature profile of Figure 9). Though concrete is expected to retain most of its strength at this reference temperature, stability in the presence of possible fractures and durability in case of increased porosity were also of concern. Then, a check on the residual capacity was performed by neglecting any contribution from this layer. The results showed that the original extra capacity in the hogging bending moment region dropped from +30% to +10% relative to the design bending moment as per the current design regulations (Figure 13). Even though the safety check was passed, the sizeable loss of resisting area caused a rise of the neutral axis at the Ultimate Limit State from 20% to 35% of the cross-section depth, significantly affecting the rotation capacity of the weakest cross-section in this redundant scheme. Some strengthening works were then recommended to the highway management to reinstate the original sectional ductility as well as cover stability.

Figure 13. Design loads and diagrams of the design and resistant bending moments for the most fire-damaged girders
