NATIONAL-SCALE INSPECTION OF FLOOD DEFENCE INFRASTRUCTURE WITH REMOTELY SENSED DATA

Environment Agency, Bristol, England.

ABSTRACT

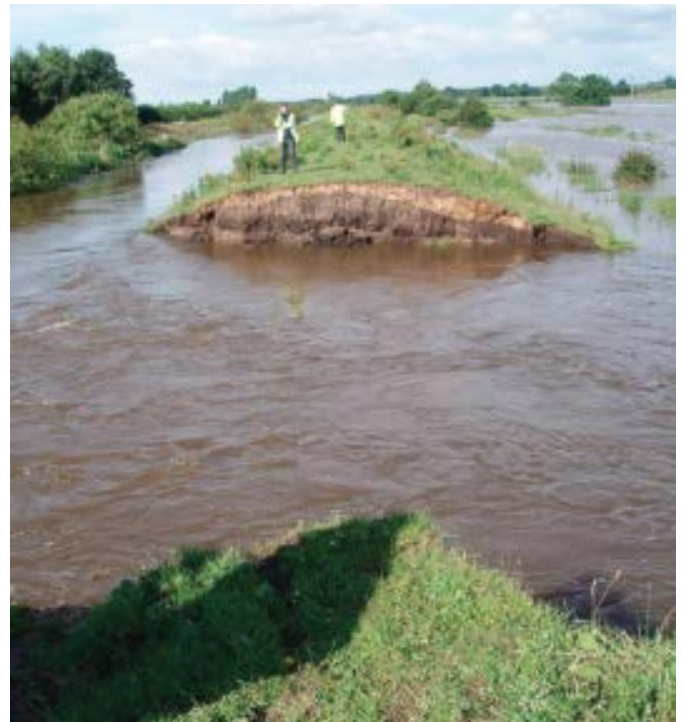
Figure 2 Learning lessons from a breach defence at the River Torne during the Summer 2007 floods (from Flikweert and Simm, 2008)

These reviews are based on a collation of engineering data gathered from surveys with anecdotal information in order to re-create a 'story' of what might have actually happened in each event. The reviews process develops knowledge from highly situated and localised data sources. Data is generated and analysed to determine loading, strength and failure modes during the event and then compared with existing models of defence performance. This analysis helps to identify the processes and contributing factors leading to failure from which conclusions can be drawn and recommendations developed – see Figure 2.

An important finding reported by Flikweert and Simm (2008) was that three of the four breaches occurred when the water-level was well below the top of the defence. This meant that the breaches were caused by geotechnical failure modes governed by processes active inside the defences. The authors discuss their suspicion, that failure in these three examples, was initiated by 'local irregularities' in the defences. Stating, that the breaches were not caused by overall poor quality of design or condition. In some of the cases these irregularities may have been visible (such as the presence of rabbit holes) and hence captured in the condition grade. It is more likely however, that they were invisible to the inspectors and were related to the embankment fill material or to the subsoil.

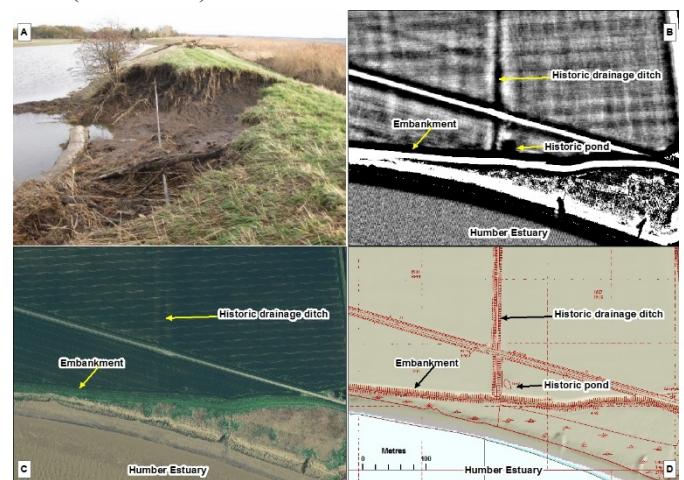
Figure 3: Humber Estuary - a) Flood defence failure at Blacktoft; b) Detrended LIDAR data; c) Digital aerial photography (true colour); d) Historic (1969) County Series 1:2500 scale Ordnance Survey (OS) mapping data (Red detail)

For example significant weaknesses can be introduced in defences by buried infrastructure such as pipes crossing the embankment. A partial breach occurred in the defence along the Humber Estuary during an east coast storm surge (5 December 2013). Failure occurred at the point of intersection between an old (now in-filled) drainage channel that ran perpendicular to the flood embankment. The drain wasn’t known, and the recent visual inspection had graded the defence as ‘good’. See Figure 3.

From Figure 3a concrete head wall which was previously buried within the defence is clearly visible. Figure 3b highlights the expression of the drainage channel and historic pond in the micro-topography. A crop mark can be seen depicting the line of the drainage channel in panel (Figure 3c). Historic mapping (Figure 3d) confirms the presence of the drainage channel. This figure serves to highlight the power of integrating several sources of remotely sensed data and mapped information to build up a comprehensive picture of the changing context of the flood defence asset.

Analysis of these sources of remotely sensed data and the historic mapping would have alerted flood risk managers to this weakness and work to address it programmed.

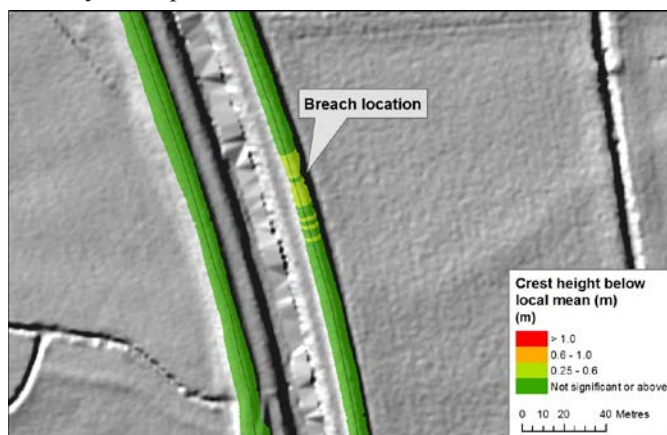
Figure 4 Show example of relative height analysis to identify low spots

Maximum height values were extracted from the LIDAR elevation data at transects stationed every 2 meters perpendicular to the defence centre line. Each defence line is split into segments of no more than 400 metres and/or at river confluences. The average maximum transect height is calculated along each of these sections. Relative crest heights for each transect were calculated by subtracting each individual maxima from the average. This process accounts for the downstream trends in elevation change of the defence crests and enables the analysis to be run over very large areas with a uniform colour palette. Thus, standardising the visual display of the data – See Figure 4.

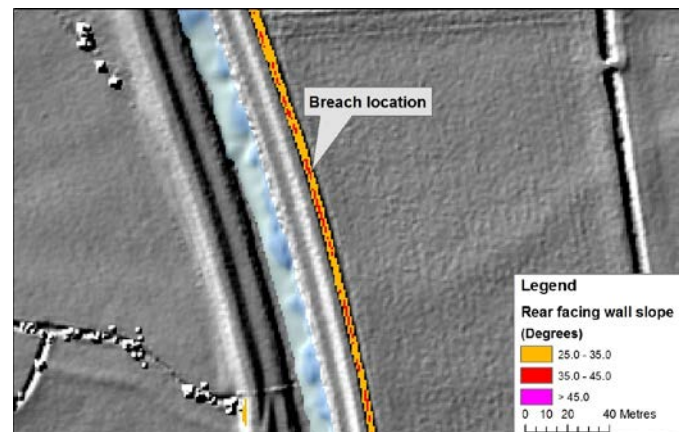
Figure 5 Analysis of the rear face slope conducted with the 1m resolution LIDAR highlights in red areas where the embankment slope is greater than 35°.

LIDAR data can be used to rapidly extract cross-sectional information from defences to help inform reliability analysis. However, the suitability of these data for measuring slope angles is again, directly a function of the horizontal resolution and therefore caution has to be exercised not to use data at a resolution not appropriate to the length of the slope being measured. See Figure 5.

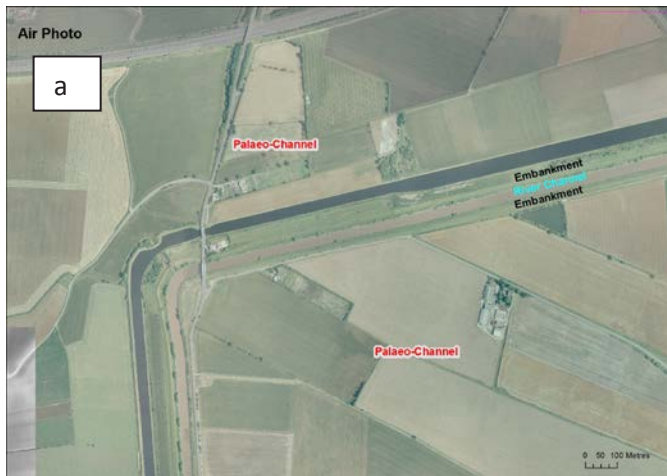
Figure 6 a) Aerial photo showing the area where a palaeo-channel crosses a river channels; b) LIDAR data with relative flood defence crest heights analysed

It can be seen from Figure 6a, the palaeo-channel is not visible in the air photo data, nor is it visible on the ground. However the palaeo-channel is clearly visible in the detrended LIDAR data shown in Figure 6b. Similarly, the effect of consolidation of the weaker soils that infill the palaeo-channel can be seen on the height of the embankment crest level.
