# EVALUATION OF A RAILWAY BRIDGE USING DISTRIBUTED AND DISCRETE STRAIN SENSORS

C. Barker<sup>1</sup>, N.A. Hoult<sup>1\*</sup>, H. Le<sup>2</sup> and V. Tolikonda<sup>3</sup>

<sup>1</sup>Department of Civil Engineering, Queen's University, Kingston, Canada

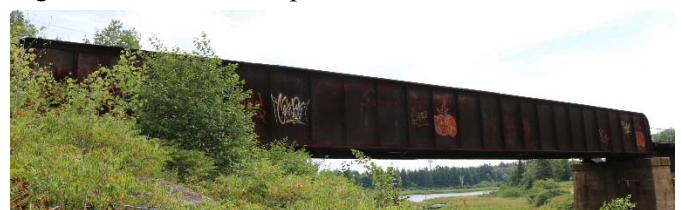
Figure 1 Instrumented span

The Newmarket Bridge is a four span, single-track, open deck steel plate girder bridge located near North Bay, Canada (46°16'6.66"N 79°23'33.70" W). The bridge was constructed in 1912 and is comprised of three deck plate girder spans crossing the Lavase River, and a single through plate girder (TPG) span, passing over a Canadian Pacific Railway track. Each deck plate girder span measures roughly 23 meters in length, approximately 2.75 meters in depth and is simply supported with an expansion joint at its north end and a fixed joint at its south end, all resting upon a series of reinforced concrete piers.

For this study, the single 37 meter TPG span at the north end of the bridge was the subject of monitoring, as seen in Figure 1. There is a lateral force bracing system under the TPG that is divided into 8 bays, 7 of which being evenly spaced at 5.53 meters on centre, and the remaining bay on the south end being skewed in order to conform to the orientation of the pier it rests upon, as seen in Figure 2. Each bay consists of two built-up floor beams connected at their webs by two W610×120 and two W610×171 stringers running parallel to the track and on which 14 evenly spaced wooden ties are connected via steel hook bolts. The stringers are braced laterally to one another at the midspan of each bay by a series of built-up I-beams. Lastly, each bay contains a pair of L152×89×13 cross braces, which are connected at the bay corners to the plate girders and floor beams by gusset plates. The plate girders of this span measure approximately 3 meters in depth with stiffener plates spaced every 1.5 to 2 meters. The 115 lbs RE continuously welded rail is centrally located over the bridge and has a gauge (rail to rail) spacing of 0.823 meters. In similar fashion to the three other spans, the support conditions of the through plate girder span include an expansion joint at its north end and a fixed joint at its south end. The monitoring described in this paper represents the first, of two, rounds of planned tests. The second will follow the installation of traction bracing at the north end of this span in order to investigate the effects of such reinforcement.

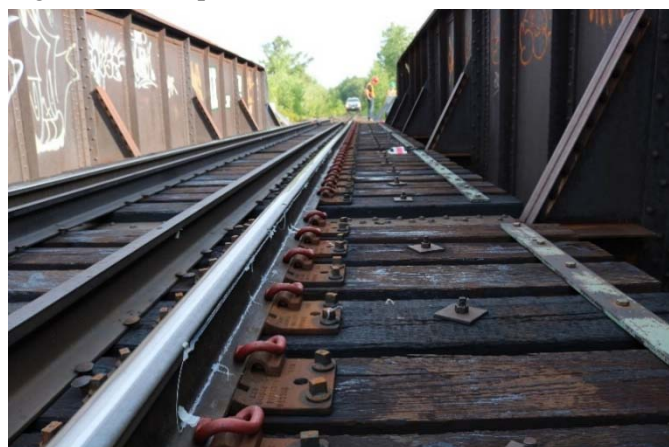
The rail was instrumented with both fibre optic sensors and strain gauges at midspan to evaluate the correlation between measured results, see Figure 3. A nylon-coated fibre with an  $8.2\ \mu\text{m}$  diameter core was bonded using a cyanoacrylate adhesive (Loctite 4861) to the head and foot of the rail, at a height of 25 mm and 140 mm above the rail's base. Prior to bonding, the rail surface was cleaned using water and a degreasing agent. Finally, the fibre was coated in silicone to protect it for long-term use, as seen in Figure 3.

Figure 3 Fibre optic sensors on rail

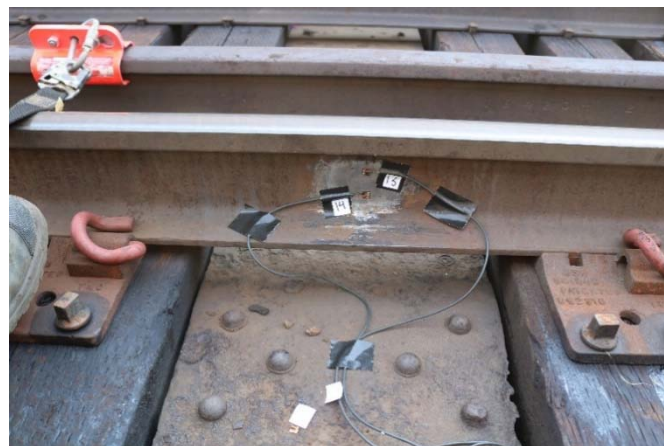
Strain gauges were bonded to the rail at three locations on the bridge and one location at 2.13 m off the bridge in order to determine a distribution of longitudinal rail force and to detect the extent to which this force was being transferred between the bridge and the connecting track. In a similar orientation to the fibre optic layout, see Figure 3, the strain gauges were bonded above and below the neutral axis of the rail, at heights of 57 mm and 95 mm above the rail base, as shown in Figure

4. This allows for the calculation of curvature and subsequently the derivation of axial stress at each sensor location. The strain gauges were installed by first grinding the rust off the steel and then applying the gauge to the chemically cleaned surface with a bonding adhesive, before soldering the lead wires to the terminal pads of the gauge.

Figure 4 Strain gauges on the rail over top of floor beam

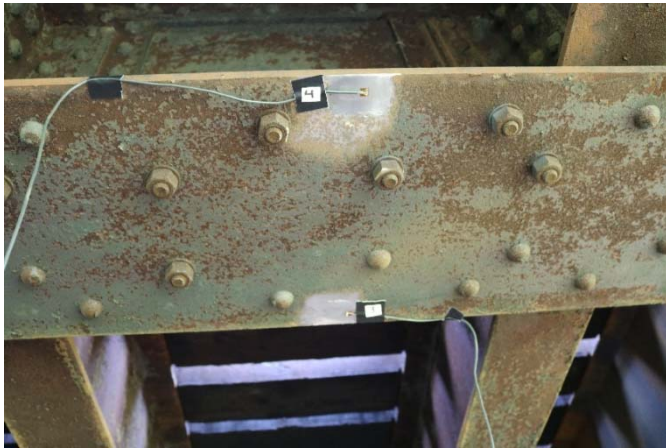
In order to study the complex longitudinal force transfer mechanism between the rail and underlying bridge members, a series of strain gauges were bonded to the floor beam and cross braces located directly under the rail instrumented with gauges at the north end of the bridge, as indicated in Figure 2. Four gauges were bonded towards the extreme edges of the top and bottom flange at the midspan of the floor beam, in order to capture in-plane and out-of-plane bending strains, as shown in Figure 5.

Figure 5 Strain gauges on the floor beam's bottom flange
