# FIELD DEPLOYMENT OF AN AMBIENT VIBRATION-BASED SCOUR MONITORING SYSTEM AT BAILDON BRIDGE, UK

*KKGKD Kariyawasam\**, *PRA Fidler*, *JP Talbot* and *CR Middleton*

*Department of Engineering, University of Cambridge, United Kingdom*

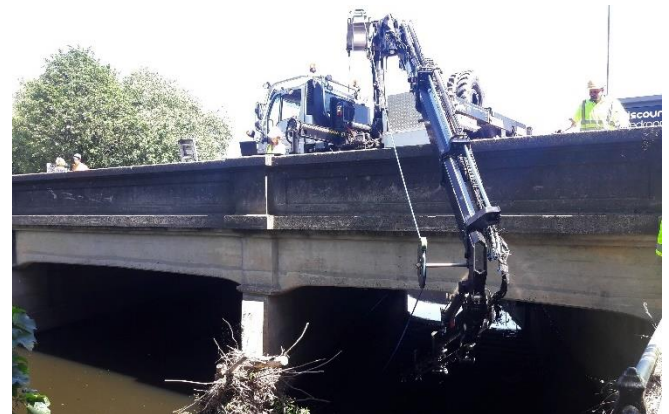
The river bed profile was scanned with sonar using the BridgeCat mobile bridge inspection system before the scour repair works started. The BridgeCat system consists of a Unimog all-terrain vehicle fitted with a crane capable of extending 14.8m below the level of the crane base (Roberts, 2017). With the vehicle parked on the pedestrian pavement near the parapets, the crane was able to reach all locations of interest under the bridge. Once the crane was extended to a desired location underwater, a sonar scanning head at the end

of the crane captured 2D sonar images. See Figure 3. BridgeCat scanning of the full bridge was carried out over 6 hours during off-peak daytime traffic after 09:00.

Figure 3: BridgeCat vehicle taking sonar scans before repair

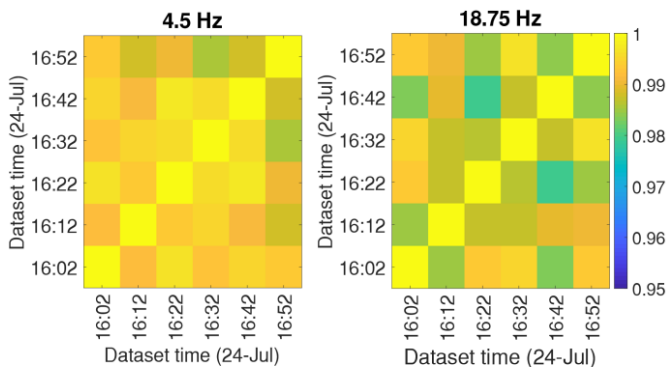
The singular value plots of the six adjacent datasets are shown in Figure 8. The peak frequencies at  $4.5 \pm 0.6$  Hz and  $18.75 \pm 0.8$  Hz were found to be consistent across all datasets. In addition, the mode shapes found at these frequencies showed high modal assurance (over 98%) when compared with different datasets, as shown in Figure 9.

Figure 9 Modal assurance criteria for the dataset combinations at 18.75 Hz and 4.5 Hz showing high consistency (above 98% modal assurance) of mode shapes at both peaks

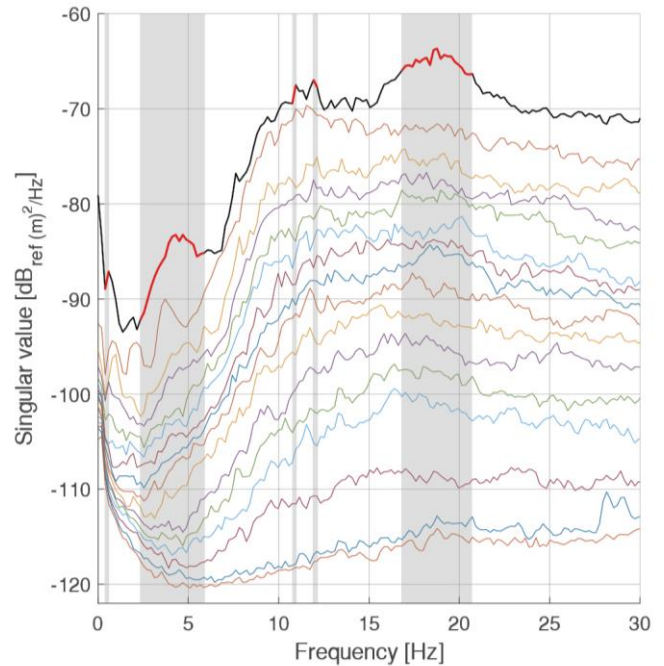
Figure 10 shows all singular values for one dataset. The first singular value shows five peaks. The range of frequencies that have mode shapes with more than 90% modal assurance criteria to the modes at the adjacent peaks are shaded. The peaks at 0.58 Hz, 10.95 Hz and 11.95 Hz were found to be harmonics since the same peak is present in higher singular values (Jacobsen et al., 2017).

Figure 10 Singular values of the dataset at time 16:22. The 90% MAC region to the mode shape at each first singular value peak is shaded.
