STRUCTURAL ASSESSMENT FOR AN OLD STEEL RAILWAY BRIDGE UNDER STATIC AND DYNAMIC LOADS USING FIBRE OPTIC SENSORS

ABSTRACT This article presents the structural assessment of an existing old steel railway bridge in Malaysia using fibre optic sensors. The steel bridge was built more than a century ago and the bridge structural drawings and other documentations were lost over the years. Keretapi Tanah Melayu Berhad (KTM), the Malaysian rail operator was upgrading the railway line to cater for heavier and faster locomotives. The bridge is subjected to a potential risk of structural health deterioration or fatigue due to corrosion and long service period in such a high humidity country. Full scale static and dynamic tests using locomotives were carried out to assess the structural integrity of the steel bridge. Two types of optical sensors were used. Discrete and distributed fibre optic sensors were mounted on critical steel panels to monitor the change in strain of these members under dynamic and static loads. The discrete sensor, Fibre Bragg Grating (FBG) strain sensors were able to measure the change in strain at 1000 Hz frequency, and were used during the dynamic test where a locomoti

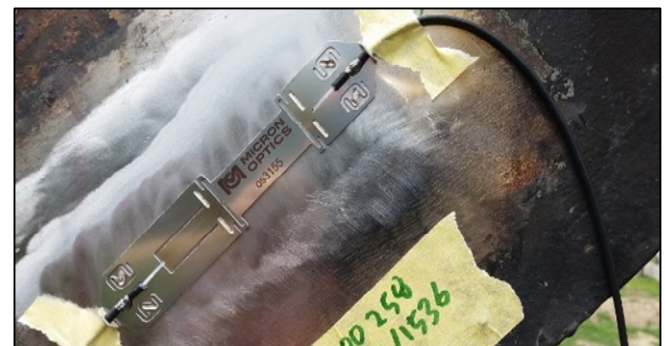
Figure 3 Optical Strain Gauge (os3155) installed on the neutral axis of steel bridge components

There were ten FBG sensors, i.e. the optical strain gauge (os3155) with a gauge length of 50 mm, installed on the smooth surface of the uniform steel components (Figure 3). A loop of DFOS sensor was instrumented on the bottom chord of the steel bridge with a total length of 31.4 m on both strain and temperature sensing cables. The DFOS readings were set to 5 ns spatial resolution (that is equivalent to 0.5m), 65,000

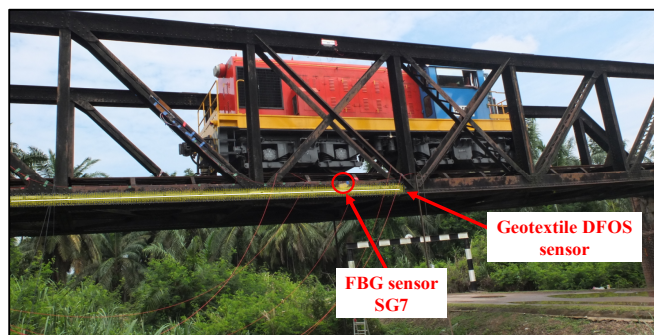
Figure 4 DFOS sensor mounted at the bottom chord of the old steel bridge and the FBG sensor SG7 is mounted very close to it at 14m from Abutment A, in order to

compare the strain results obtained from different type of sensors.

Table 3 summarized the maximum strain obtained during the static load test using FBG sensors (SG7) and DFOS. The SG7 was placed very close to the DFOS geotextile sensor, assuming the two sensors should be able to capture similar data. It can be observed that the maximum strain obtained during the static load test is not more than $250 \mu\epsilon$ which is far from the failure limit of steel. On average, the percentage difference between the results obtain using FBG and DFOS is only 4.5%.

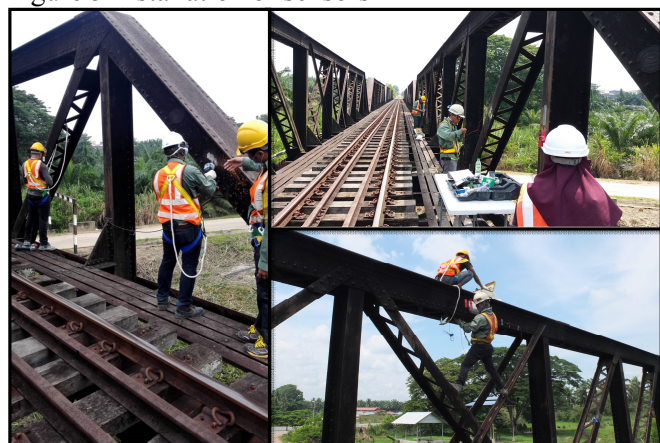
Figure 5 Installation of sensors

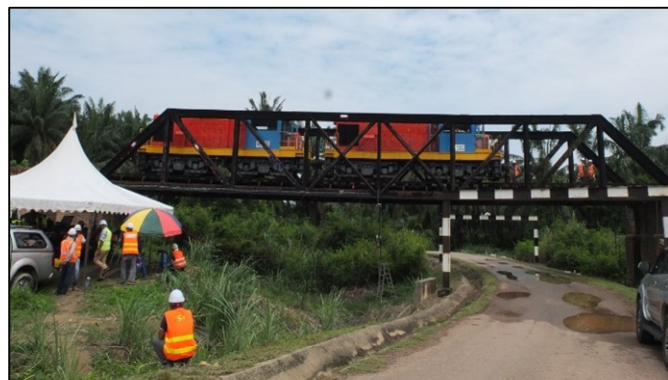
Figure 6 Example of Load Test Arrangement: Case 13 - Double Locomotive Static Test 25 m from Abutment A

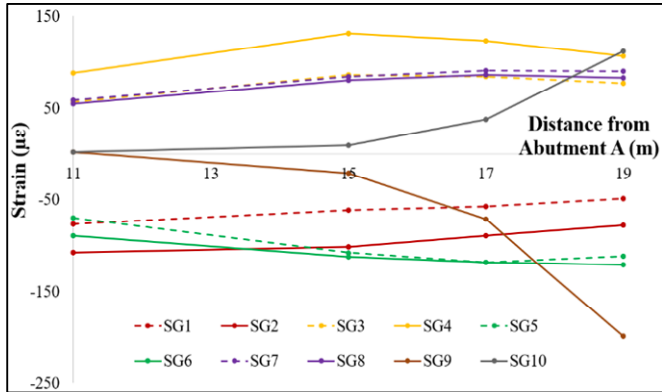
Figure 7 Strain measurements (static test single locomotive)

Figures 7-9 show the measurements of strain using FBG sensors when the locomotives were placed at different distance from Abutment A.

As the strain gauges were placed at different sides of the steel members, the strain values are not the same but of very close magnitude. Generally, the inner components of the steel bridge (SG2, SG4, SG6 and SG8) experienced higher strain as compared to the outer members (SG 1, SG3, SG5, SG7). This may be due to the slightly uneven load distribution which may

be caused by the difference in joint and connection system at both sides of the steel components (Figure 10). For single locomotive static load test, the maximum strain recorded was $132\mu\epsilon$ at SG4 (Case 2).

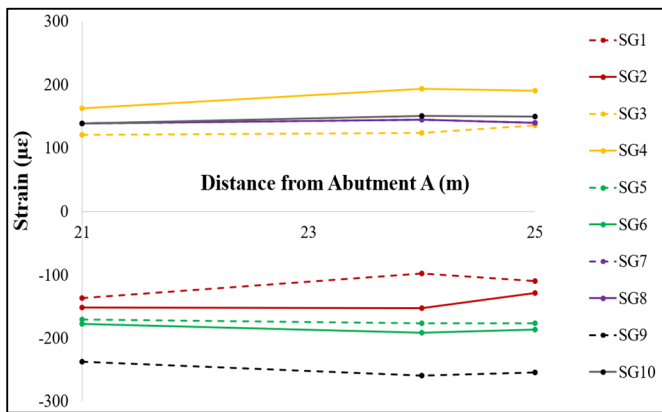
Figure 8 Strain measurements (static test double locomotive)

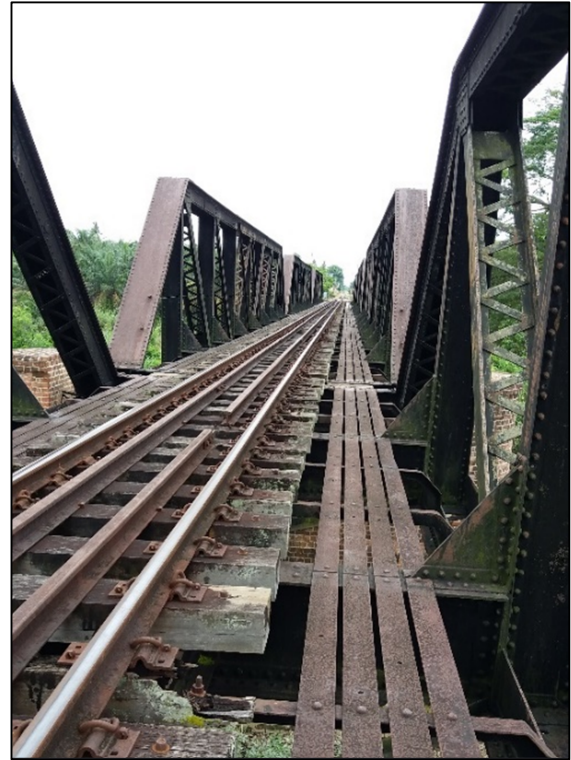
Figure 10 The connection and jointing system at the inner truss is more complicated than outer truss

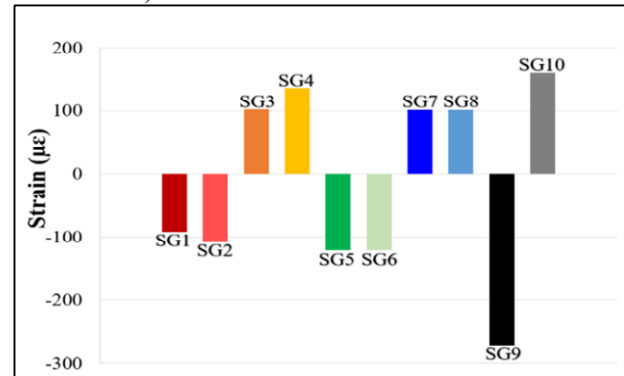
Figure 11 Strain measurements (static test single locomotive)

For single locomotive, the locomotive moved at a speed of 40km/hr across the old steel bridge. As shown in Figure 11, the

FBG sensors which placed on the same steel components but different sides showed similar readings. SG3 and SG4 showed a relatively higher difference in strain measurement of approximately 33%. SG4 produced the highest strain of $192 \mu\epsilon$ amongst the vertical truss member. While, the horizontal FBG sensors SG9 and SG10 showed similar trend as Figure 7 due to their placement at top and bottom of horizontal chord.

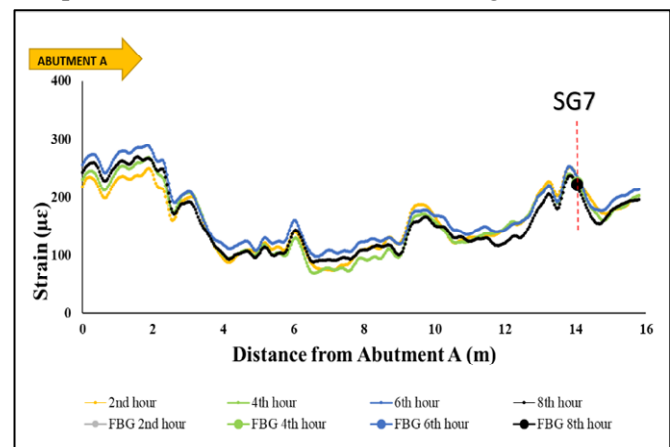
Figure 13 Strain measurement using DFOS and comparison to strain value obtained using FBG sensor

Figure 13 shows the result obtained from DFOS for Case 13. The double locomotive was placed at 25 m from Abutment A for eight hours. Strain was measured once the locomotive parked at the exact location, and readings were taken at an interval of two hours. From Figure 13, it is noticeable that while time passed, there is no significant change in strain pattern or trend. However, the magnitude of strain slightly increased. This is due to the creep effect experienced by the old steel bridge over the 8 hours. Table 3 shows the maximum strain collected during the static load tests of different load applied. Measurement were taken at an interval of two hours, i.e. 2nd, 4th, 6th and 8th hour. The DFOS captured a maximum strain reading of $237\mu\epsilon$, which was mainly due to the creep effect.

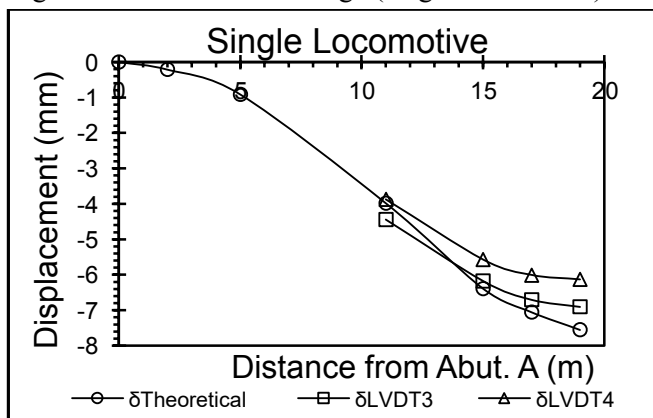
Figure 14 Deflection of bridge (single locomotive)

Vertical deflections of bridge were measured during all static load tests. Figures 14 and 15 showed the maximum deflection measured when the bridge was loaded by single and double locomotives. Maximum displacement occurred at the middle of span (LVDT3 and LVDT4).

From Figure 14, maximum measured vertical displacement is 6.52mm or 13.7% less than theoretical computed deflection, when the single locomotive stopped at 19.5m from Abutment A. While, Figure 15 illustrates the maximum deflection occurred when double locomotive is 24.0m away from Abutment A, with a measured average displacement of 11.0mm or 3% more conservative as compared to theoretical value.

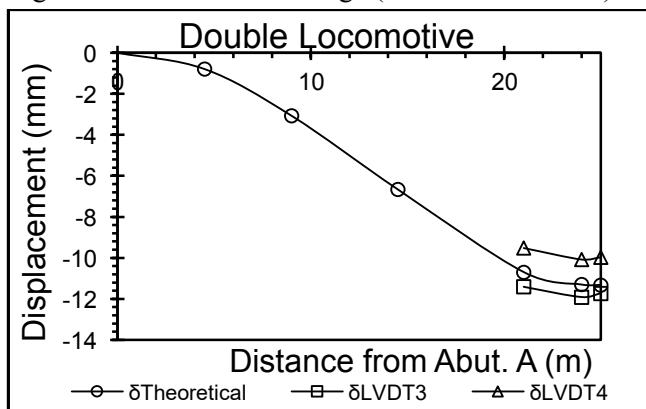
Figure 15 Deflection of bridge (double locomotive)
