EVALUATION OF A RAILWAY BRIDGE USING DISTRIBUTED AND DISCRETE STRAIN SENSORS

C. Barker¹, N.A. Hoult^{1*}, H. Le² and V. Tolikonda³

¹Department of Civil Engineering, Queen's University, Kingston, Canada

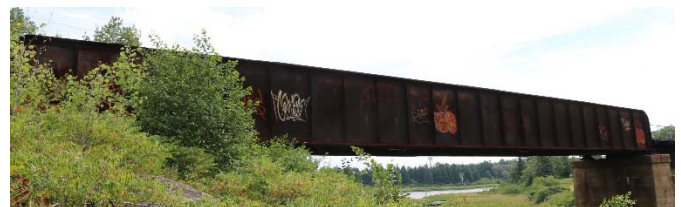
Figure 1 Instrumented span

For this study, the single 37 meter TPG span at the north end of the bridge was the subject of monitoring, as seen in Figure 1. There is a lateral force bracing system under the TPG that is divided into 8 bays, 7 of which being evenly spaced at 5.53 meters on centre, and the remaining bay on the south end being skewed in order to conform to the orientation of the pier it rests upon, as seen in Figure 2. Each bay consists of two built-up floor beams connected at their webs by two W610×120 and two W610×171 stringers running parallel to the track and on which 14 evenly spaced wooden ties are connected via steel hook bolts. The stringers are braced laterally to one another at the midspan of each bay by a series of built-up I-beams. Lastly, each bay contains a pair of L152×89×13 cross braces, which are connected at the bay corners to the plate girders and floor beams by gusset plates. The plate girders of this span measure approximately 3 meters in depth with stiffener plates spaced every 1.5 to 2 meters. The 115 lbs RE continuously welded rail is centrally located over the bridge and has a gauge (rail to rail) spacing of 0.823 meters. In similar fashion to the three other spans, the support conditions of the through plate girder span include an expansion joint at its north end and a fixed joint at its south end. The monitoring described in this paper represents the first, of two, rounds of planned tests. The second will follow the installation of traction bracing at the north end of this span in order to investigate the effects of such reinforcement.

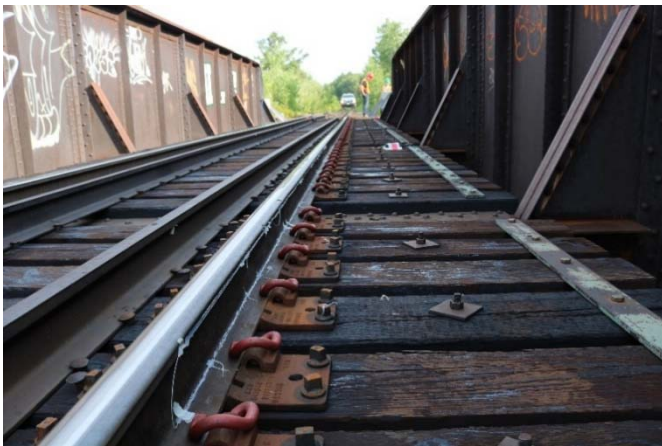
Figure 3 Fibre optic sensors on rail

The rail was instrumented with both fibre optic sensors and strain gauges at midspan to evaluate the correlation between measured results, see Figure 3. A nylon-coated fibre with an $8.2\ \mu\text{m}$ diameter core was bonded using a cyanoacrylate adhesive (Loctite 4861) to the head and foot of the rail, at a height of 25 mm and 140 mm above the rail's base. Prior to bonding, the rail surface was cleaned using water and a degreasing agent. Finally, the fibre was coated in silicone to protect it for long-term use, as seen in Figure 3.

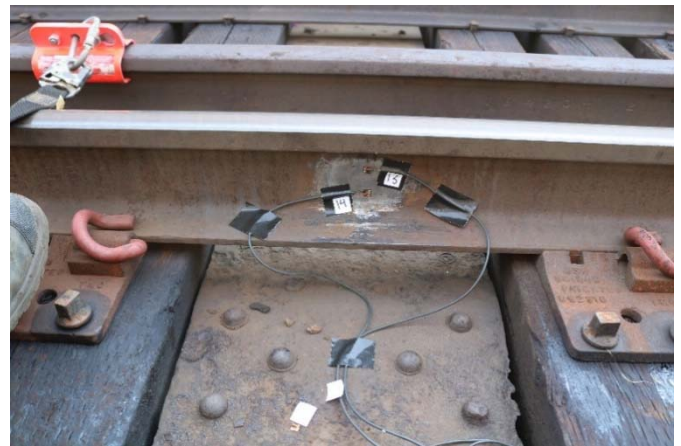
Figure 4 Strain gauges on the rail over top of floor beam

Strain gauges were bonded to the rail at three locations on the bridge and one location at 2.13 m off the bridge in order to determine a distribution of longitudinal rail force and to detect the extent to which this force was being transferred between the bridge and the connecting track. In a similar orientation to the fibre optic layout, see Figure 3, the strain gauges were bonded above and below the neutral axis of the rail, at heights of 57 mm and 95 mm above the rail base, as shown in Figure

4. This allows for the calculation of curvature and subsequently the derivation of axial stress at each sensor location. The strain gauges were installed by first grinding the rust off the steel and then applying the gauge to the chemically cleaned surface with a bonding adhesive, before soldering the lead wires to the terminal pads of the gauge.

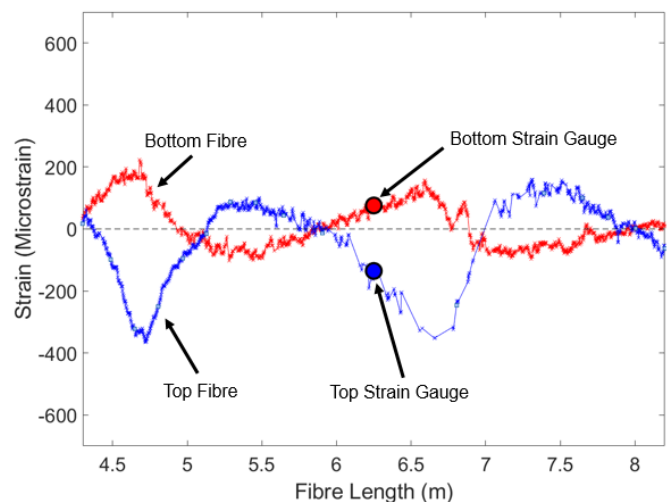
Figure 6 Strain gauge and DFOS strain measurements

Figure 6 shows the strain measured by both the fibre optic sensor and the strain gauges as two axles accelerated past the midspan of the TPG, heading northbound. The data from the fibre bonded above the neutral axis of the rail (top fibre) and below the neutral axis of the rail (bottom fibre) are presented with respect to their location on the rail, in which 8 total meters of fibre was bonded above and below the neutral axis of a 4 meter segment of rail. In order to improve the visual appearance of the fibre optic data, a cut-off filter was used to remove noise due to vibrational effects followed by a linear interpolation between remaining data points. It is important to note that the strain gauges, whose data is presented in Figure 6, were bonded to the rail next to the one with the fibre but at the midspan of the bonded fibre length. Additionally, the strain gauges were not bonded at the same height along the rail that the optical fibres were, so the measurements have been extrapolated to what they would be at the fibre optic height, assuming plane sections remain plane, in order to visually assess their correlation. While Figure 6 depicts a single point in time where two axles of a locomotive bogie were directly over the fibre, dynamic strain was recorded for the entire event. In this case, the direction of the wheel's motion would be from left to right when looking at Figure 6.

As expected, axle loads cause positive bending directly at wheel locations, and negative bending between wheels. This indicates that rail behavior under the passage of a train is primarily dominated by bending, rather than axial forces. Figure 6 also demonstrates the significant advantage that distributed strain sensors have over traditional strain gauges. The fibre optic sensors provide a more comprehensive understanding of structural behaviour over discrete sensor technologies while offering similar accuracy to strain gauges, as demonstrated here by the good visual agreement of the data. It is, however, important to note that the top strain gauge measurements deviated from the fibre optic measurements when the wheels were directly above the strain gauges, possibly to the effect of localized stress concentrations at the wheel-rail interface.

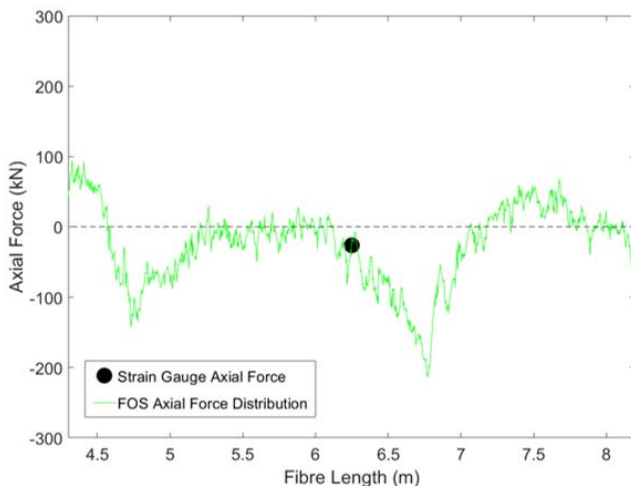
Figure 7 Axial rail force from strain gauges and DFOS

Figure 7 shows the distribution of axial force generated in the rail at the same moment in time as depicted in Figure 6. Since strain was measured at two points along the height of the rail at each sensor location, curvature could be calculated and used, through interpolation, to determine the strain at the neutral axis of the rail, which was established from the geometric and material properties of the section. Multiplying this axial strain by the rail's cross-sectional area (7236.8 mm²) and elastic modulus (assumed to be 207,000 MPa) results in the axial force distribution shown in Figure 7.

Figure 7 again demonstrates the good visual agreement between fibre optic and strain gauge data while showing the advantage that distributed sensors have over traditional, discrete sensors in aiding with the understanding of overall structural behaviour. It is clear from Figure 7 that the axial force distribution from locomotive loading is not constant, but rather has local maximums of compression at wheel locations that then transition to zero force between wheels and a tensile force between adjacent bogies. This may be indicative of a high connection stiffness between the rail and the girder, according to models put forth by Srinivas *et al.* (2011) that propose a similar axial force distribution in rails whereby this force is quickly dissipated from the rail into the bridge superstructure.

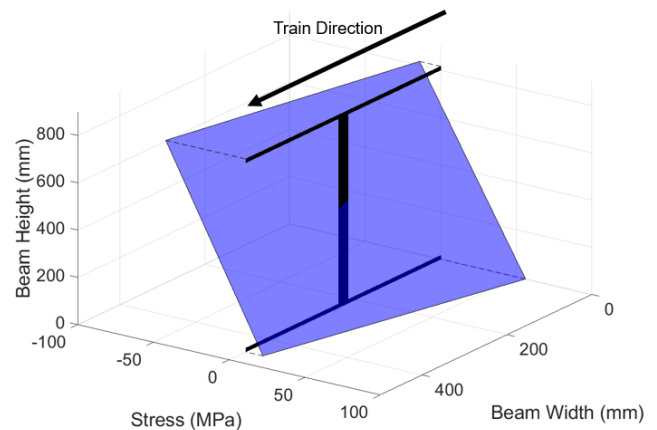
Figure 8 Biaxial bending in floor beam

Since the intermediate floor beam was instrumented with four strain gauges bonded on the outer surface and at the extreme edges, 4 points of strain could be measured at a single cross-section of the beam, allowing a plane of stress at the midspan of the beam to be determined. Figure 8 was created using this data in order to visualize the bending stresses experienced by the floor beam under the passage of a train. The I-beam section in the figure represents the nominal dimensions of the actual floor beam's cross section. Each value of stress (calculated using the measured strain multiplied by the modulus of elasticity) was then plotted at the exact location on this cross-section where the strain gauges were bonded. A two dimensional plane connecting each point of calculated stress

and extending to the extreme edges of the cross-section was then produced to aid in the visualization of the floor beam's complex stress state.

Figure 8 specifically depicts a plane of stress corresponding to a single point in time during an acceleration test in which a locomotive axle was positioned directly over the floor beam. It is important to note that the floor beams are perpendicular to the rails and that, for this specific test, the train was moving in the direction indicated in Figure 8.

As evident by the skewed orientation of the stress plane, the floor beam experiences a state of bi-axial bending at the point in time presented. In this instance, the bending in the out-of-plane direction is opposite to the direction of the train motion. That is, the beam is going into compression on the left side of the cross-section in Figure 8 and tension on the right side of the cross-section. The weight of the train is causing the beam to bend downwards, as expected, causing compression in the top of the beam and tension in the bottom. As a result, the maximum compressive stress (approximately 60 MPa), due to both in-plane and out-of-plane bending, occurs in the top left corner of the cross-section in Figure 8 while the maximum tensile stress (again approximately 60 MPa) occurs in the lower right corner.
