DAMAGE ASSESSMENT OF A RAILWAY BRIDGE USING FIBRE OPTIC SENSING AND LIDAR DATA

1.1 Bridge CFM-5

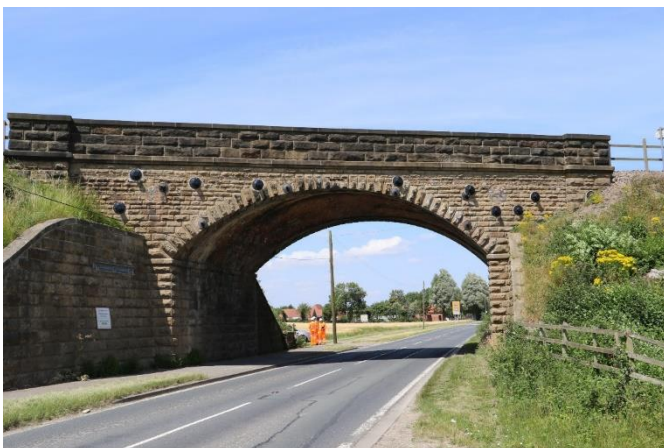
Figure 1 Bridge CFM-5, as viewed from the south

Figure 1 shows bridge CFM-5, while Figure 2 highlights the major cracks. Figure 3 shows signs of the recent intervention at the southern spandrel wall, in particular the grout marking where the separation crack has been stitched through each stone on the spandrel wall.

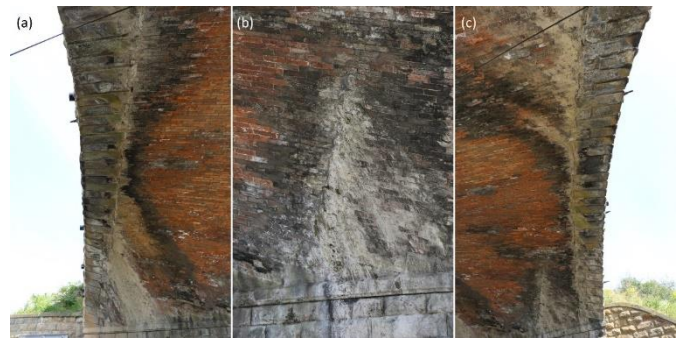
The bridge has suffered historic damage during its operational life. Both sides of the arch barrel exhibit separation cracks with the spandrel walls, and there is an additional longitudinal crack in the south-eastern corner of the arch barrel. Furthermore, the spandrels and the north-eastern and south-western wing walls show signs of bulging.

Figure 2 Key cracks at bridge CFM-5: (a) the northern spandrel separation crack, (b) the south-eastern longitudinal crack to the arch soffit, and (c) the southern spandrel separation crack

These sources of damage were addressed through intervention work in 2016. Ten tie rods were fitted through the bridge, to restrain transverse movement of the spandrel walls, and the three notable cracks were comprehensively stitched and grouted. Soil anchors were installed on the wing walls which had been observed to have bulged. Although this work was recently carried out, the length of time over which the intervention will remain effective is uncertain. This provides additional motivation for the monitoring project.

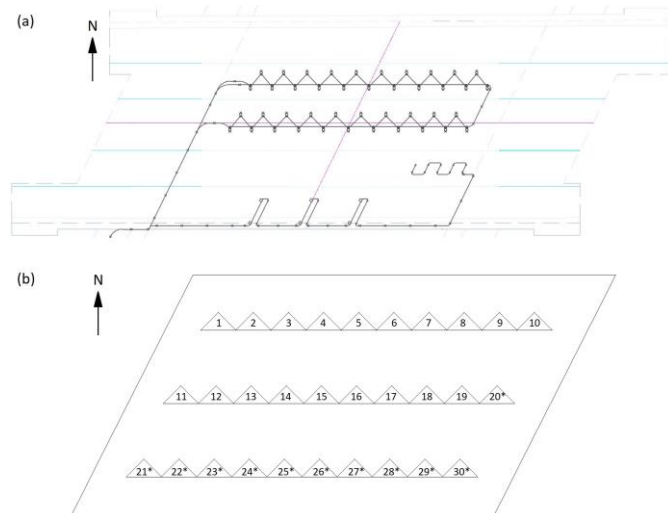
in future work. However, of principal interest in this paper are the FBGs that were arranged in triangular rosette formation across the northern half of the bridge (top half of Figure 4(a)). In Figures 4(a) and 4(b), the skewed span is horizontal.

Two lines of these rosettes were positioned on the arch soffit, under the centreline of the northern track (rosettes 1 to 10 in Figure 4(b)) and the centreline of the overall bridge (rosettes 11 to 20* in Figure 4(b)). Because the bridge is relatively undamaged in these regions, it was hoped that the measured response could be taken to be reasonably indicative of the response of skewed masonry arch bridges in general.

Figure 4 Plan views of CFM-5 showing (a) the installed FBG sensors and (b) the full arrangement of FBG rosettes, which consists of both installed rosettes and “imaginary” rosettes (marked “*”) for which results are inferred from the installed rosettes using symmetry

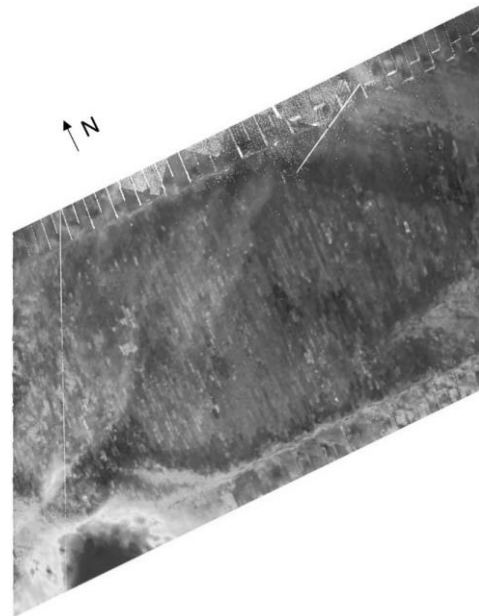
Detailed point cloud data for bridge CFM-5 was captured using a FARO Focus 3D laser scanner. This LiDAR technology allowed for accurate assessment of the “as-is” geometry of the bridge. After segmentation of the point cloud to leave only the arch barrel, as shown in plan view in Figure 5, the point cloud could be compared against a “best-fit” cylinder to produce an error map of deformations from this assumed “as-built” geometry, by plotting the discrepancies between the real arch and the “best-fit” cylinder. It can be shown that the arch barrel is a cylindrical shell, where the axis of the cylinder is parallel with the bridge abutments.

Figure 5 Plan view of the arch barrel point cloud

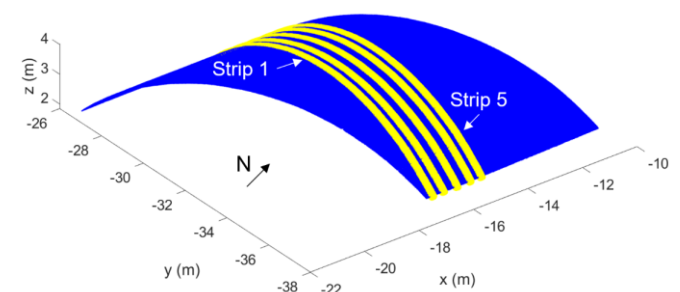
Individual “2D” slices of the point cloud, as shown in Figure 6, were also analysed, against theoretical circular (or elliptical) segments which describe the assumed reference geometry. Because the axis of the “best-fit” cylinder is parallel with the bridge abutments, slices in the skewed span direction will be elliptical whereas slices in the square span direction will be circular. Originally, slices were taken in both the square and skewed span directions for further investigation. However, it

Figure 6 Slices analysed in the square span direction

Next, the analysis of individual slices from the point cloud is considered. As previously mentioned, only slices aligned with the square span direction were found to give sensible results, which were sufficiently consistent between strips. This is in keeping with the error map of Figure 9(b) in which deformation bands are aligned with the transverse of this direction. Five slices were analysed, the locations of which were shown in Figure 6.

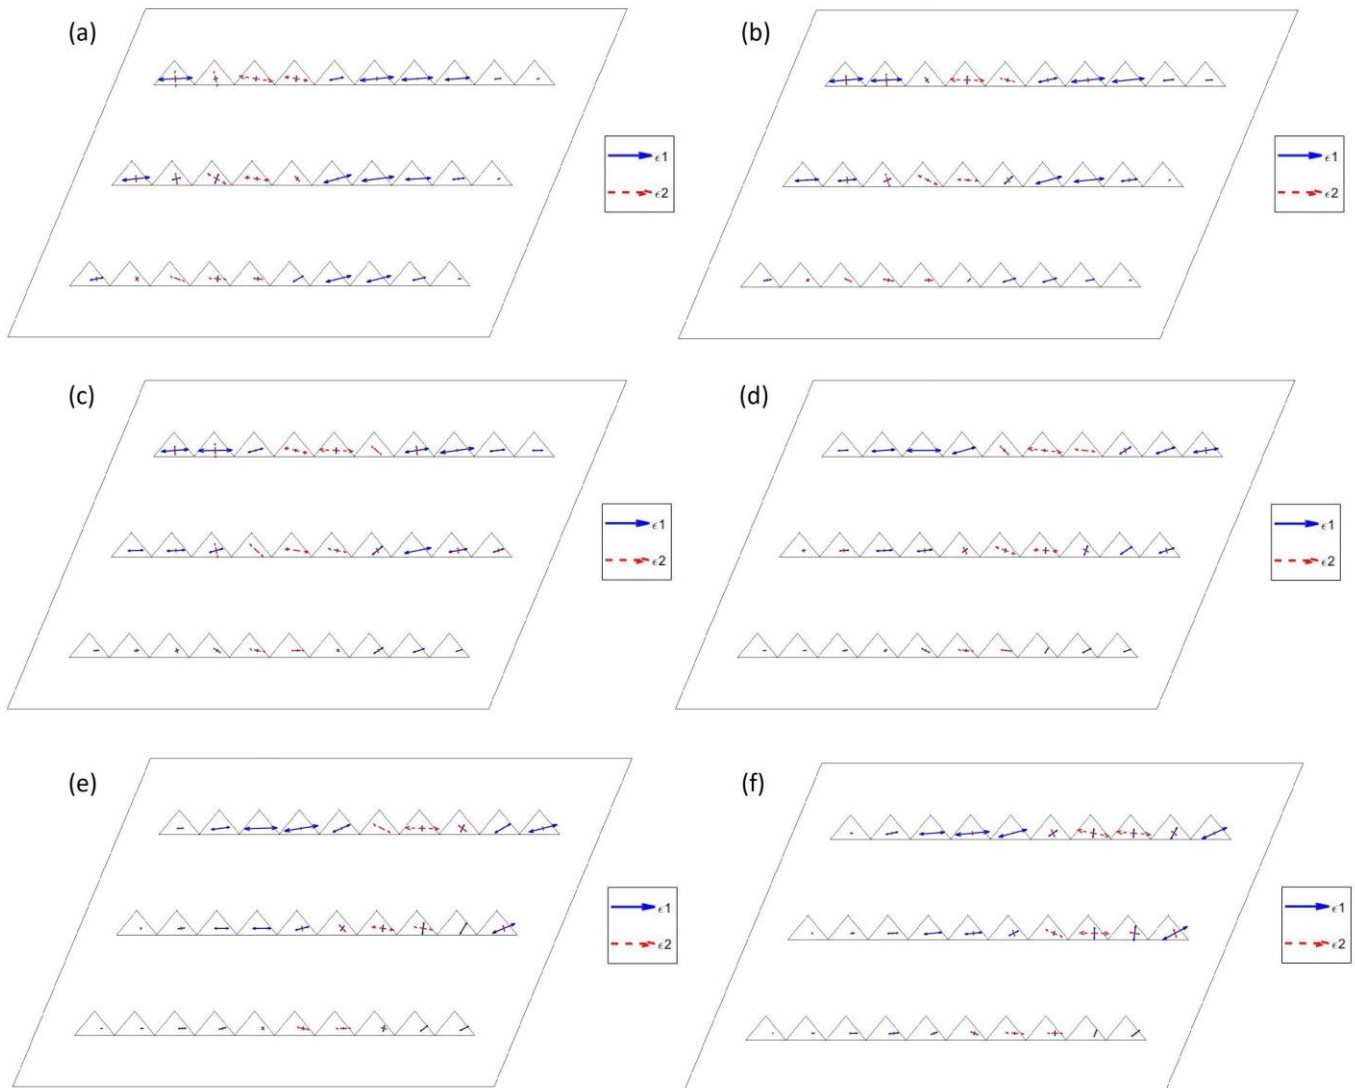
While the rosettes are typically characterised by a single dominant principal strain, approximately aligned with the skewed span direction, there are some exceptions to this. In Figures 8(d) to 8(f), points on the eastern side of the bridge, such as rosettes 9, 10, 19 and 20, exhibit compressive principal strains that appear to be inclined from the skewed span direction, oriented instead towards the north-eastern corner. One potential explanation for this could be that, since the brickwork barrel is laid helicoidally starting from north-eastern and south-western corners, this construction method has imbued these corners with additional stiffness and that these corners therefore present a preferable load path.

Another exception is seen in Figures 8(a) to 8(c), in which rosettes 1, 2, 11, 12, and 13, in the north-western corner of the bridge, show noteworthy secondary principal strains. These strains are tensile and perpendicular to the skewed span direction. The presence of tensile strains in the transverse direction of the bridge provides an indication that the bridge is responding to applied loads through transverse bending of the arch barrel. If this is the case, then the arch is transferring loads into the stiffer spandrel walls rather than carrying them directly to the abutments.

Figure 8 Principal strains mapped across the arch barrel of bridge CFM-5 for a typical 2-carriage train travelling on the northern (top) track, for cases where the axle loads are applied directly above (a) rosette 3, (b) rosette 4, (c) rosette 5, (d) rosette 6, (e) rosette 7, and (f) rosette 8; ϵ_1 is compressive and ϵ_2 is tensile

One exception to this is the possibility of transverse bending in the north-western corner, which would give rise to the transverse tensile strains seen in this region in Figure 8. This mode of response relies on sufficient connectivity between the arch and spandrels, which is likely to have been significantly improved following the recent intervention work.

From Figure 8, it can be observed that the principal strains sometimes deviate from the skewed span direction. It is important to remember that the strains measured at bridge CFM-5 are small, of the order of tens of microstrain. The reliability of the principal strain calculation, given that it is an average of the strain state over the 0.25 m² area of the rosette, is reduced when the measured strains are very small. Therefore, when the magnitudes of principal strains are small, less significance should be attached to the calculated principal strain direction.

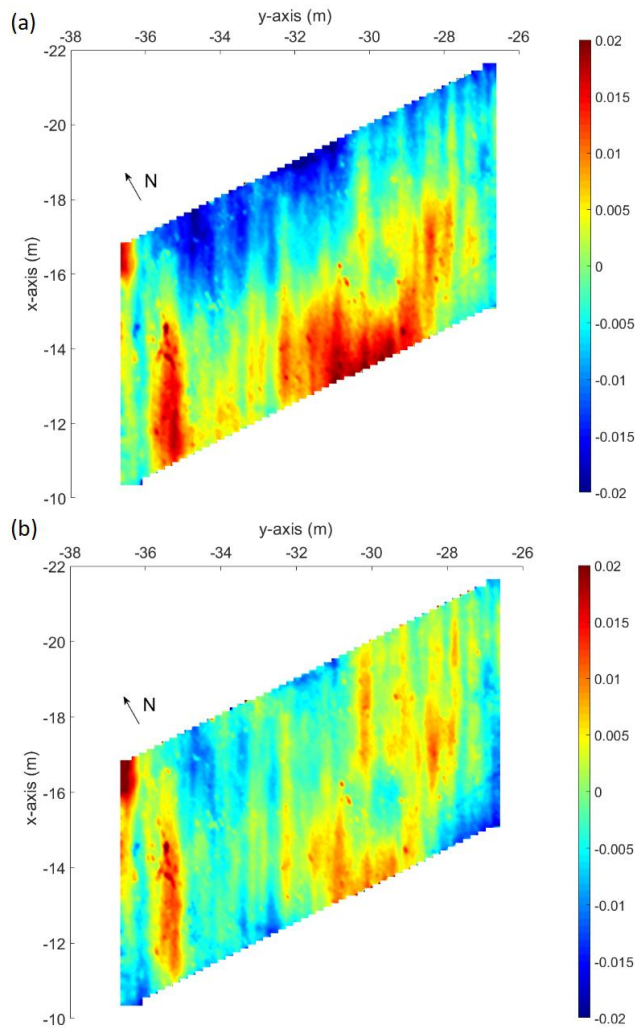
It can be seen in Figure 9(a) that the error map is dominated by rotation of the barrel. In Figure 9(b), after the rotation has been accounted for, deformation bands can be more easily identified and are consistently oriented with the square transverse direction. The axis of the “best-fit” cylinder for Figure 9(b) is inclined by 0.02° from the horizontal, corresponding to a variation in elevation of approximately 23 mm across the width of the bridge.

Figure 9 “Best-fit” cylinders for the CFM-5 arch barrel, for (a) a cylinder that is constrained to have its axis in a horizontal plane, and (b) a cylinder with no constraints applied (colour bar values in m: positive values (red) signify upwards movement, negative values (blue) signify downwards movement)

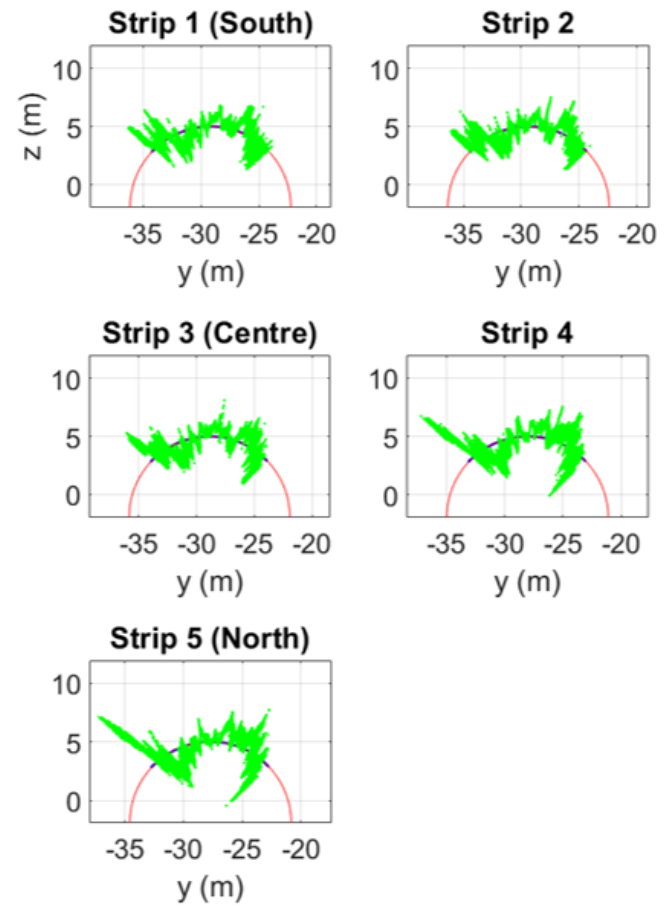
The error maps in Figure 10 correspond to viewing the arch from the south and perpendicular with the square span direction. These suggest a partial asymmetric mechanism with movements occurring at the western abutment. Two possibilities exist which could produce error maps of this type. As indicated previously in Table 1, these correspond to either span opening resulting from outwards horizontal movement of the western skewback, or to vertical settlement of this skewback. In practice, the true deformations could also be the result of a combination of both mechanisms.

It can also be seen from Figure 10 that the error maps show a larger response towards the north of the bridge, indicating larger arch deformations and associated support movements towards the north end. Fitting the two potential mechanisms to Strips 3 and 5 produces Figure 11, in which the first column corresponds to results for arch spreading and the second column to results for differential settlement.

Figure 10 2D error maps of the point cloud slices

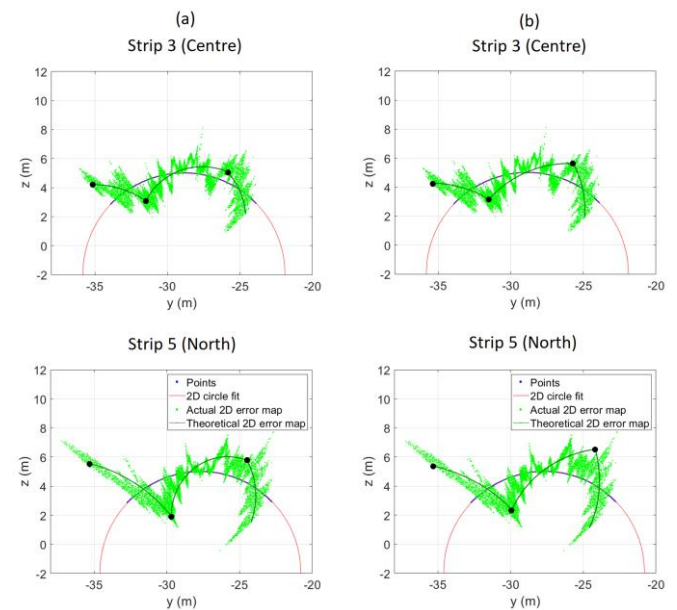
The likely support movements that give the theoretical error maps in Figure 11 are presented in Table 2. The data indicates that the current geometry of the bridge could be caused by differential movement of the western skewback (between Strips 3 and 5) of either 1 cm, if only horizontal abutment movement occurred, or 3 cm, if only vertical abutment settlements occurred. These predictions assume that each mechanism acts alone and so provide upper limits on the potential differential movements in each direction.

Figure 11 Fitted theoretical mechanisms for (a) arch spreading and (b) relative vertical settlement of the western skewback
