Natural hazards affecting cultural heritage: assessment of flood and landslide risk for the 28 existing Norwegian stave churches

Chiara Bertolin and Elena Sesana

*Department of Mechanical and Industrial Engineering,
Norwegian University of Science and Technology, Trondheim, Norway*

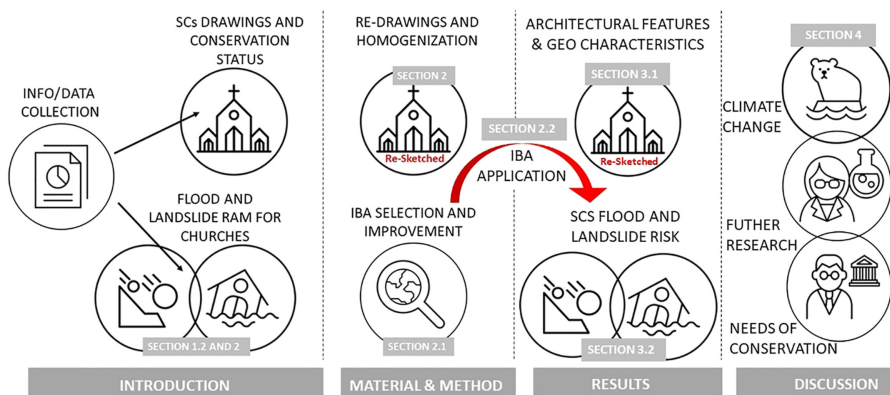
Figure 1. Visual overview of the structure of the paper, with the methodological approach subdivided among the search for data and information related to stave churches and risk assessment method

Note(s): This introductive research has brought to the identification of the IBA as most suitable assessment method in the case of the 28 stave churches

During the process of data collection and literature review, plans and 3D images for the 28 churches were searched. Plan schemes were found for only 21 out of 28 churches in existing publications and/or database (<https://kulturminnebilder.ra.no/fotoweb/archives/5002-Tegninger/>). The latter, is a repository developed by the Norwegian Directorate which make publicly available information, documents and images about Norwegian Heritage. For this specific search, the keyword "Stavkirker" was used to identify 850 images contained in the repository of which only 25 served as reference for the plan images reproduced in this contribution; the full references and images credits references are reported in [Appendix 1](#). Starting from these diversified schemes, new plans were homogeneously reproduced with the use of the Autocad® Software; they do not correspond to the geometrical surveys of the churches in their current form as the images of reference correspond to different time periods (1800–1900, see [Appendix 1](#)). The 3D schemes were also digitally hand-drawn with a graphic tablet, the references for the church images derived from the pictures available in the literature (e.g. [Bakken et al., 2016](#)) and on the Google Images website. Once the geographical conditions and architectural features of the 28 "Stavkirke" as well as their conservation status (e.g. refurbished, rebuilt and relocated) were defined, the risk of natural hazards, i.e. flooding and landslides events, for the locations where the churches are placed was investigated. The whole structure of the paper with the methodological approach adopted is illustrated in [Figure 1](#).

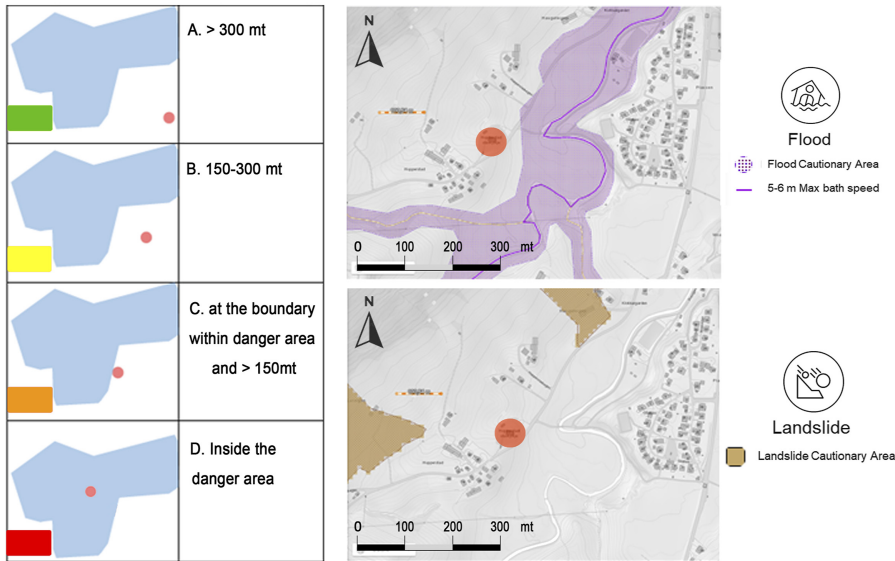
Figure 3. Legend depicting the four classes of risk with their traffic light colour codes from green to red (left) and example of danger zone maps for flood (top) and landslide (bottom)

Note(s): The location of the SC is highlighted with an orange circle over the danger grid map (0.6 × 0.6 km)

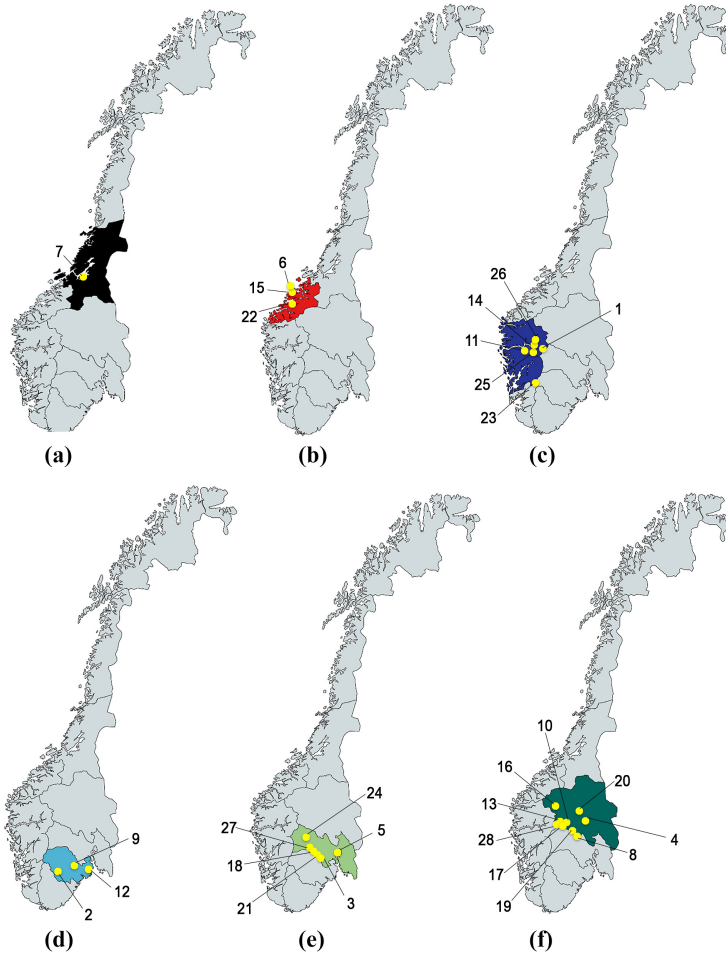
Figure 4.
Location of the SCs in
the six Norwegian
regions: (a) Trøndelag
(b) Møre-Romsdal
(c) Vestland (d)
Vestfold-Telemark
(e) Viken (f) Innlandet

Note(s): The numbers are the SC ID as reported in Table 2

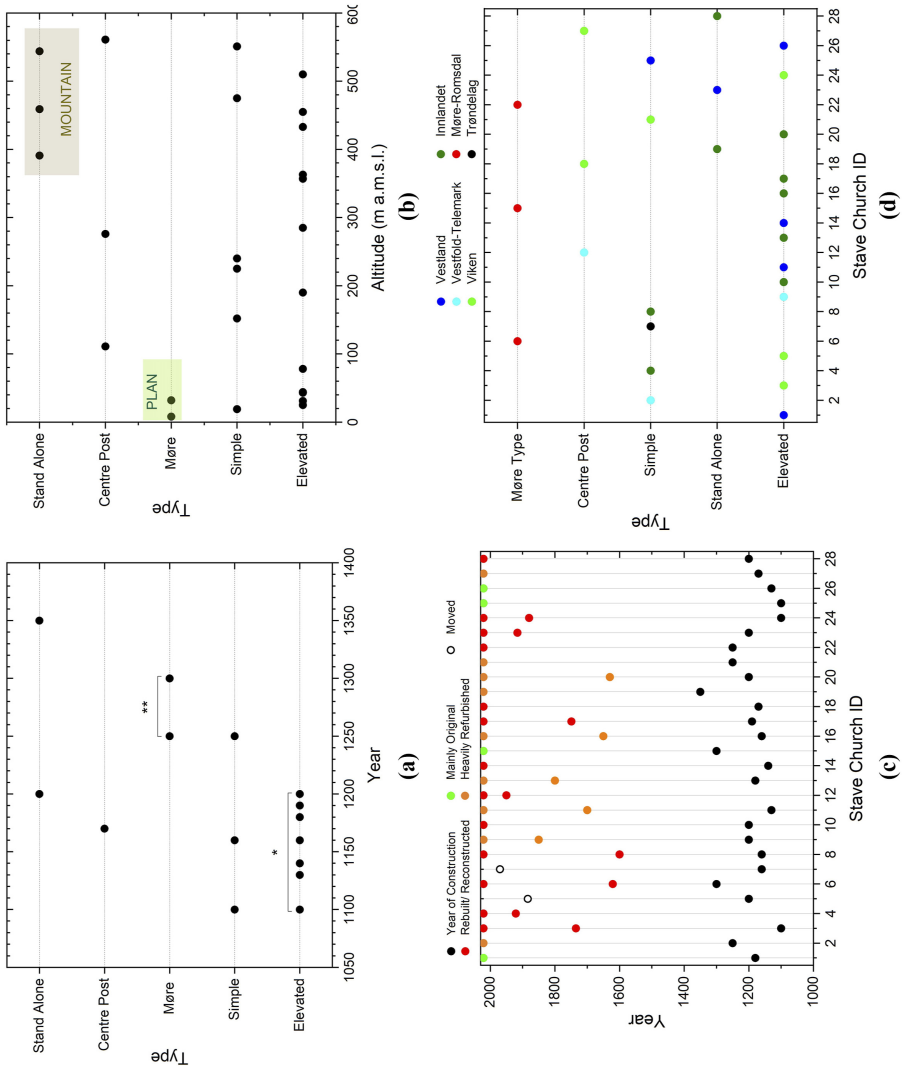
Figure 5.
 (a) SC architectural type compared to the year of construction.
 (b) SC architectural type analyzed by altitude (meter a.m.s.l.).
 (c) Year of construction and subsequent refurbishment according to the IDs of the SCs as reported in Table 2.
 (d) SCs' type according to IDs and grouped as per Norwegian regions

by a rectangular nave, but the “møre type” introduced intermediate posts. The Møre type is peculiar of the Norwegian coastal region of Møre. The center post churches have a large center post connecting the foundations and the roof, while the “elevated section” SCs have a more complex construction with raised nave churches. The “standalone” churches do not fit in any of these categories, and, from our overview, they are located at higher altitude (Figure 5b). Most of the churches belong to the “elevated section” category that is also represented by churches with ancient original elements (Figure 5a).

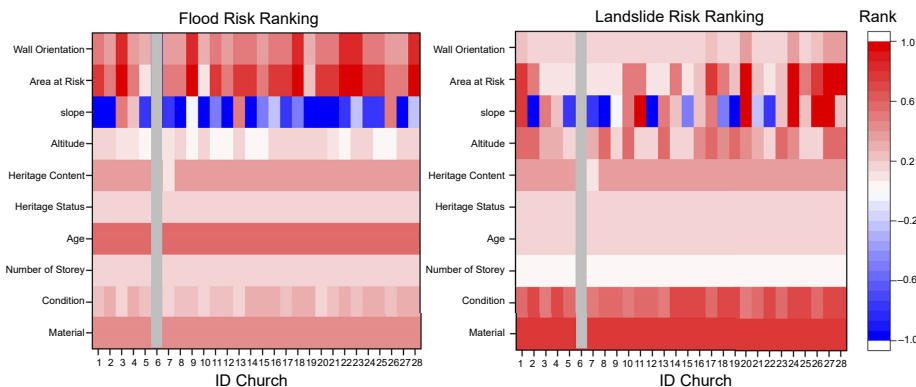
Figure 6. Matrices of flood (left) and landslide (right) risk component

Note(s): Lines report indicators as shown in Figure 2; Columns report SC IDs as in Table 2. Coloured elements are the weighted indicators with dark red (high risk rank) and dark blue (low risk rank)

The matrices of risk components for floods and landslides events are reported in Figure 6 left and right respectively. In the matrices, lines (i-index in equations (1) to (3)) report the indicators in Figure 2; columns (j-index in equations (1) to (3)) report the 28 SCs ID codes. The colored (i; j) elements are constituted by weighted indicators (i.e. indicators multiplied by their weights reported per each church). The color code shows the main risk factors (i.e. dark red color) or the single resilient factors (i.e. the unfavorable slope that cannot make possible downslope movement of water, soil and rocks toward the SC and highlighted in dark blue color) which may prevent the triggering of the hazard event. Concerning the flood risk ranking, main causal factors are the HA and the wall orientation linked to the exposure and hazard, while age is the most sensitive factor. Interestingly the factor that prevents the hazards is the slope as the majority of the SCs were built at the higher altitude than water bodies. Concerning the landslides risk ranking, principal causal factors are HA at high

altitude and appropriate slopes and curvature to trigger the phenomena, while main sensitive factors are the material mechanical properties. Circa 40% of the SCs (white and blue shadows colors) were built on the top or far from embankments formed by earthy material moved by past landslides.

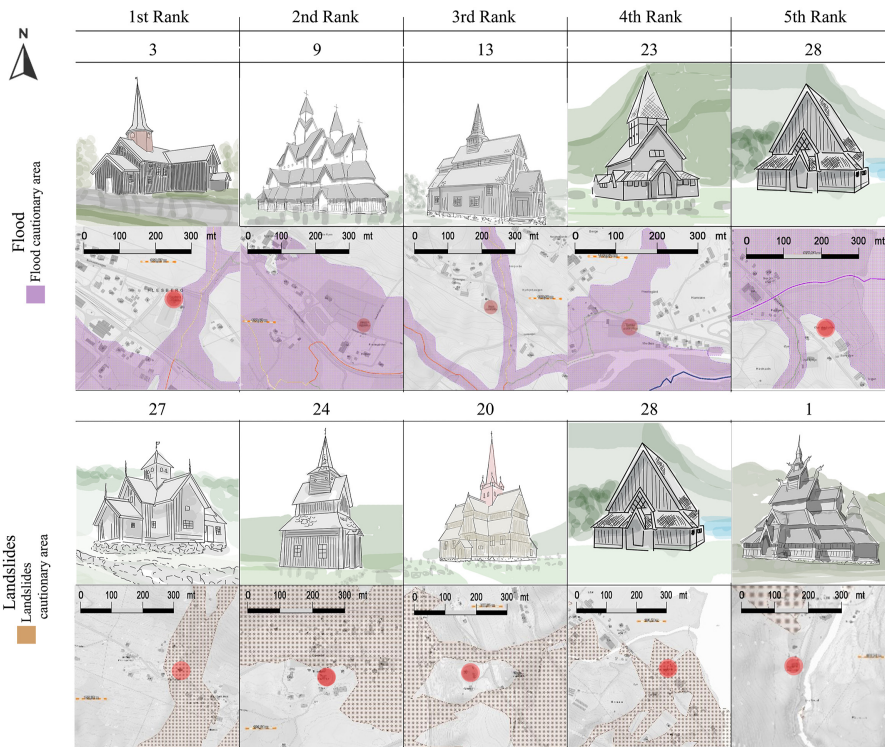
Figure 8. Flood (top, violet color) and landslides' (bottom, brown color) danger maps outcome for the five SCs at higher risk

Note(s): The rank number is reported on the top header

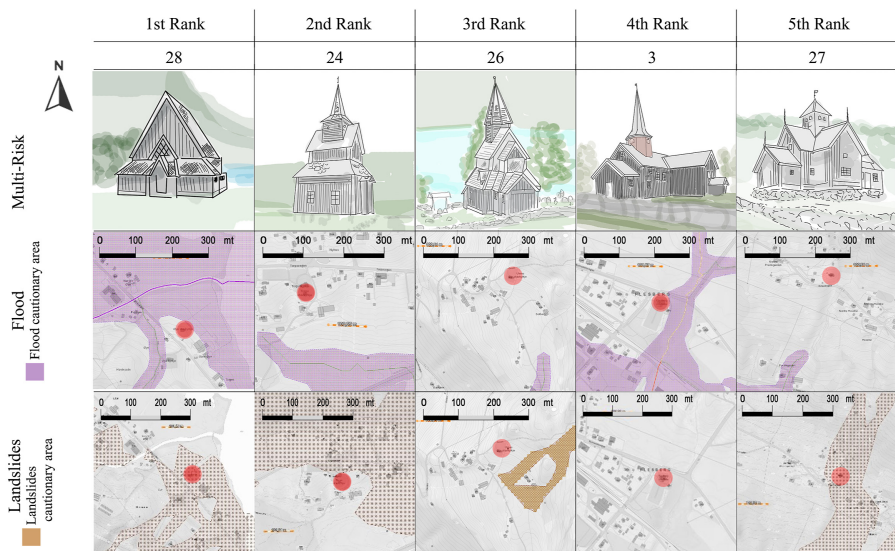
Figure 9. Flood (center, violet color) and landslides' (bottom, brown color) multi-hazard danger maps outcome for the five SCs at higher risk

Note(s): The rank number is reported on the top header
