Wear of different material pairings for the cylinder liner – piston ring contact

Purpose – This paper aims to investigate the wear behaviour of different materials for cylinder liners and piston rings in a linear reciprocating tribometer with special focus on the wear of the cylinder liner in the boundary lubrication regime.

Paper type Research paper

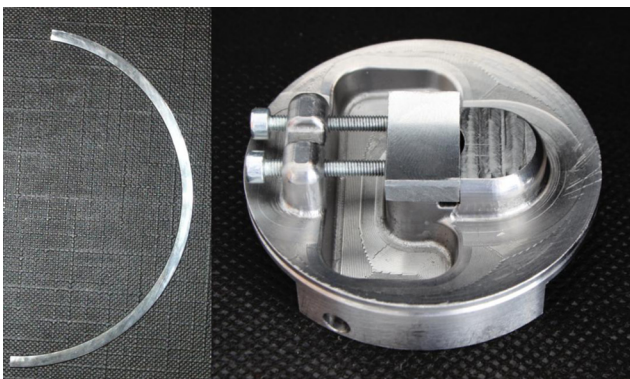
Figure 1 Piston ring sample (left) and cylinder liner sample mounted in the bottom part of the tribometer sample holder (right)

the tribological contact zone between the ring and the liner. The sample holder includes a soft plastic enclosure that prevents oil loss during the tests. The test setup of the tribometer with the mounted samples, the oil circuit and the detector unit is shown in Figure 2.

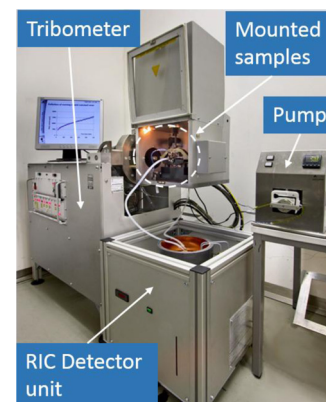
Figure 2 Test setup showing the tribometer with the mounted samples, the RIC detector unit and the pump for the oil circuit

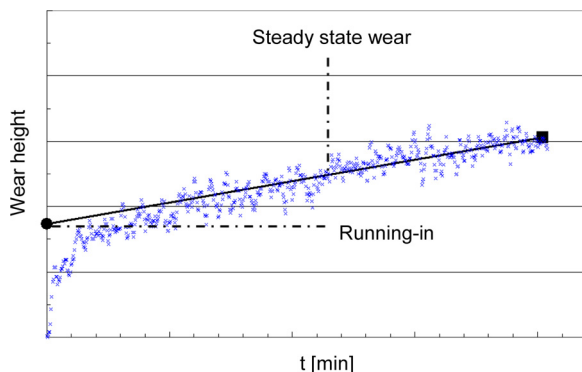
Figure 3 Characterisation of running-in and steady-state wear

Separation of running-in and steady-state wear is important, especially when the long-term behaviour of a tribosystem (lifetime) is estimated on the basis of short-term tribotests. Figure 3 shows the definitions for running-in and steady-state wear for a typical wear curve obtained with the RIC method.

The steady-state wear rate is defined here as the slope of the linear fit in the steady-state wear region, whereas the running-in wear is defined as the y-abscissa of the linear fit (i.e. the wear depth extrapolated to the start of the test).

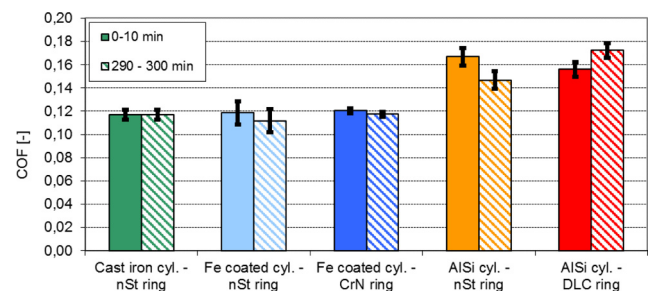
Figure 4 Coefficient of friction for different material pairings

Note: Mean values for the first and last 10 min of the tribometer test

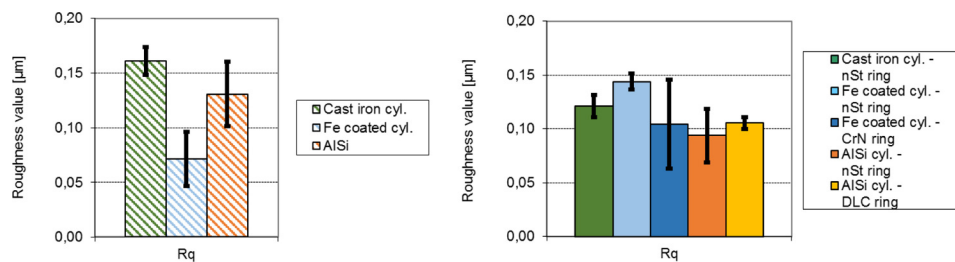
Figure 5 Rq of the cylinder samples before (left) and after the test (right)

Before the wear test (Figure 5, left), the Fe-coated cylinder samples have the lowest initial Rq, which is a result of the different honing process. The initial Rq values of the cast iron cylinders are slightly higher than the AlSi cylinder Rq values.

After the wear test (Figure 5, right), the Rq values of the cast iron and AlSi cylinders are lower than those before the test, whereas the Rq values of the Fe-coated samples are higher than those before the tribotest. Using nitride steel rings as counterparts to the Fe-coated liners leads to a higher increase of the Rq of the cylinder compared to the CrN rings. In the case of AlSi cylinders, the Rq reduction of the cylinder was similar for the nitrided steel rings and DLC rings.

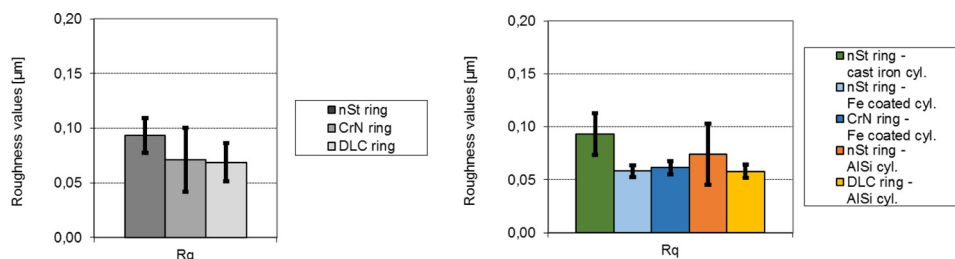
Figure 6 Rq of the piston ring samples before (left) and after the test (right)

The Rq values of the piston rings before and after the wear process are presented in Figure 6. The initial values of the CrN and DLC rings are similar and the Rq value for the nitrided steel rings is slightly higher. The tribometer tests resulted in no significant change of the Rq values for most piston rings, with the exception of the nSt-rings tested against the Fe-coated liners, which showed a slight decrease in the Rq value.

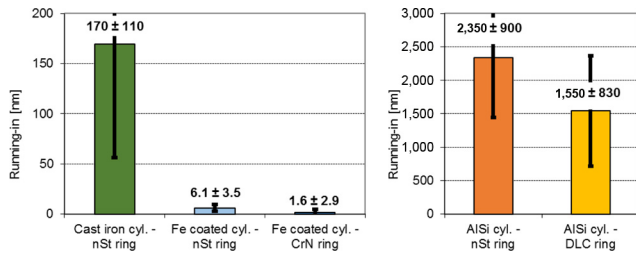
Figure 7 Cylinder liner running-in for different material pairings (measured with RIC)

The running-in wear and the steady-state wear rate of the cylinder liners were quantified with the RIC method. Figures 7 and 8 show the running-in and steady-state wear of the cylinder samples for the different material pairings. The illustrated values are obtained by averaging the results of all tests for each material combination, with the standard deviation determining the measurement uncertainties.

The AlSi cylinder material shows much higher wear in the tribometer tests than the cast iron and especially Fe-coated cylinders for both running-in and steady-state. Results for AlSi are therefore shown on a different scale in both Figures 7 and 8. The lowest cylinder liner wear rates were recorded for both material pairings with Fe-coated samples, with CrN piston

rings leading to slightly lower cylinder wear of Fe-coated liners than nSt piston rings. Similarly, both running-in wear and steady-state wear rates for AlSi were reduced by using DLC piston rings as counter bodies instead of the nitrided steel rings.

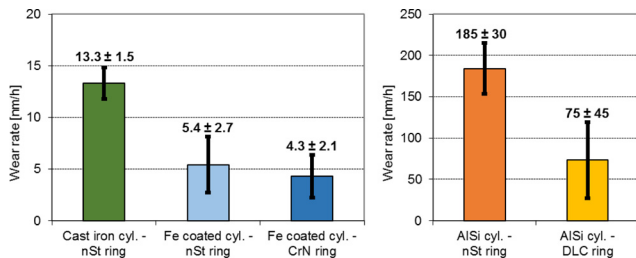
Figure 8 Cylinder liner steady-state wear rate for different material pairings (measured with RIC)

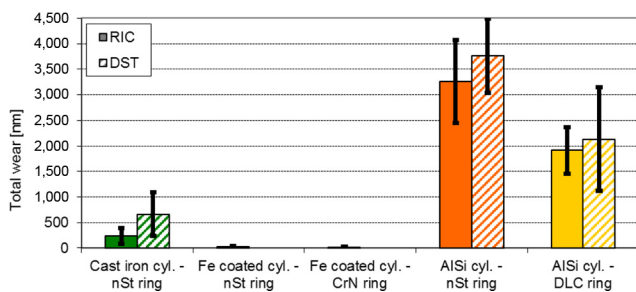
Figure 9 Comparison of the total wear of the cylinder samples at the end of the test measured with the RIC and DST methods

To get an idea regarding the comparability of these continuously measured wear results with literature values obtained with the more frequently used post-test methods (such as optical methods), the total amount of wear measured with the RIC method at the end of the tribological process is compared to the wear depths obtained with the DST method (Figure 9).

For the low amounts of wear of the Fe-coated cylinder liners, the DST method did not prove to be suitable. The uncertainties of these measurements significantly exceeded the determined average values and therefore the amount of wear was below the detection limit of the DST method and no DST results are shown for Fe-coated cylinders in Figure 9. For the cast iron and AlSi cylinders, the values for the total wear depth obtained with DST are higher than the values obtained with the RIC method, but are within the uncertainty ranges. Taking into consideration that wear is determined in a fundamentally different manner by these methods, which are affected differently by parameters such as roughness, the wear results obtained with both methods are comparable and therefore reliable. However, for low amounts of total wear, the DST method reaches its detection limits (due to the roughness of the surface), whereas the nanometre resolution of the RIC method is still sufficient.

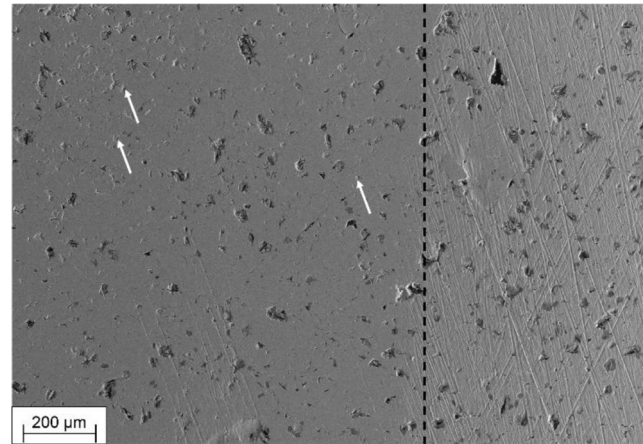
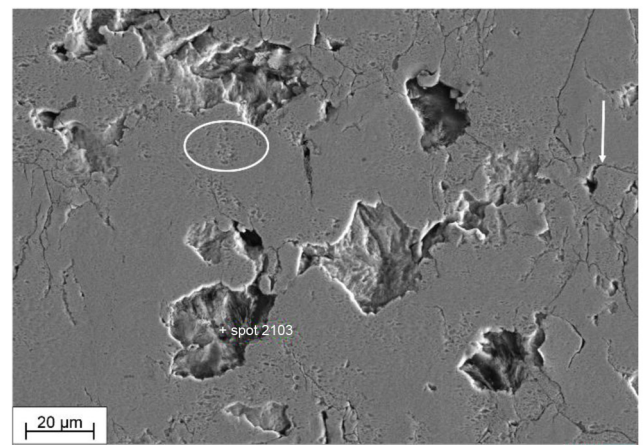
Figure 10 (a) SEM image of the cast iron cylinder liner surface with a dashed line dividing the wear track (left) and the unworn surface (right) (white arrows indicate shallow pits) and (b) detail of some orange-peel-like roughening (encircled region), pits and cracks (white arrow) in the worn surface

The cast iron microstructure (Figure 10) consists of vermicular graphite with fine lamellar pearlite and randomly distributed graphite flakes without any spheroidal graphite. The surfaces of the cast iron samples show the highest

density of large break-outs of material of all the surfaces investigated here. The dashed line in [Figure 10\(a\)](#) divides the wear zone (left of the line) and the unworn surface (right). As break-outs already existed in the initial condition (i.e. after honing), they are not a result of the tribological testing. Only the density of cracks was observed to increase in the tribologically stressed part of the surface. [Figure 10\(b\)](#) shows typical pits in the worn surface of the cast iron with a diameter of about 25 µm and a depth of approximately 1 µm. Lateral distances between these break-outs in the tribosurface range from 30 to 100 µm. In between the pits, the worn surface appears to be smooth but is pervaded by long branched cracks, which mainly propagate along the cementite structures and eventually lead to the observed shallow break-outs of material.

The pre-existing deeper pits get slightly wider due to wear of their edges in the tribocontact, but such deep pits are not included in the determination of the Rq values. Only shallow pits and cracks contribute to the surface roughness measured with 3D microscopy [shallow pits are indicated by white

arrows in [Figure 10\(a\)](#)]. The scanning electron microscopy (SEM) pictures show that a smoothening of the pearlitic matrix phase takes place, as the honing marks are completely abraded. This abrasion of the pearlitic matrix constitutes the wear volume measured with the RIC method. A minor orange-peel-like roughening [encircled region in [Figure 10\(b\)](#)] can be observed in the neighbourhood of the cracks, which are most likely caused by sets of cementite plates oriented perpendicular to the tribosurface [see white arrow in [Figure 10\(b\)](#)]. A formation of grooves or flakes cannot be observed and only shallow pits with a depth of less than 5 µm evolve in the tribocontact region where fragments of pearlite grains are abraded.

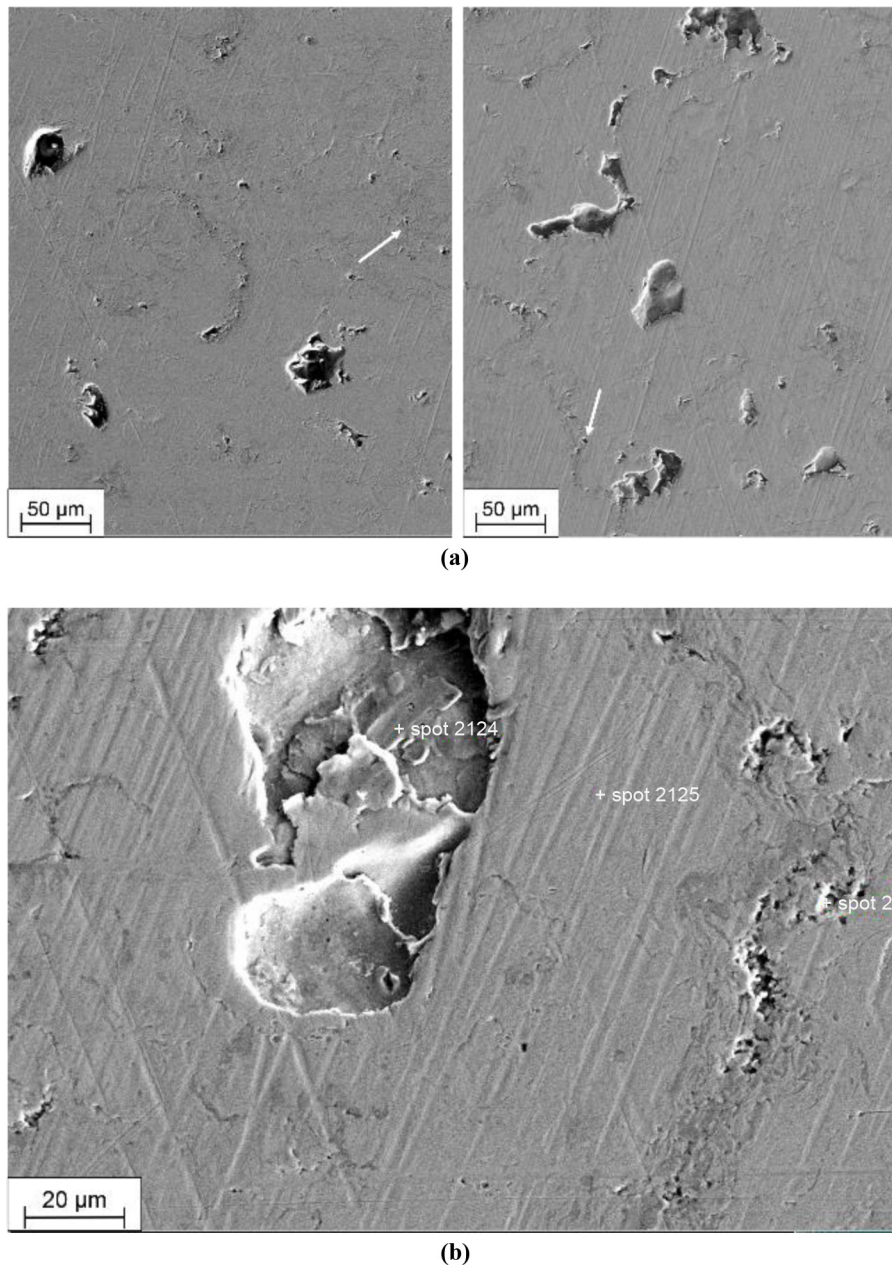
Figure 11 (a) SEM image of the wear track (left) and an unworn surface region (right) of the PTWA-coated cylinder liner surface (the white arrows indicate pre-existing pores in both areas) and (b) detail of the tribosurface showing a pre-existing pit and some micropores

The plasma sprayed Fe-coating shows a structure which is characteristic for thermal sprayed coatings consisting of solidified splats ([Figure 11](#)), including pores and intersplat thin oxide layers ([Rabiei et al., 1999](#)). The unworn surface in

Figure 11(b) shows that some splats were delaminated by the honing process, but no splat fractures or fragmentations were observed on the originally honed surface or within the worn surface [Figure 11(a)]. The lateral dimensions of the delamination pits of 20–40 μm are comparable to those in cast iron, but the average distances between them are smaller. The splats observed in the tribocontact shown in Figure 11(a) exhibit similar lateral dimensions as in the unworn surface. Therefore, the SEM pictures give no evidence that splats are formed or abraded during the wear process. The micropores, which can be seen in Figure 11(a) (white arrows), do not seem to initiate cracks and no crack network encircles the larger pits [Figure 11(b)] like in the cast iron tribosurface. Figure 11(a)

shows that the honing structure – the one with lowest Rq values of all samples – was still partly observable after the tribometer test. In fact, the wear depth is so low compared to the depth of the honing marks that the edges of the tribocontact are not clearly discernible. This indicates a clearly higher wear resistance of the Fe-matrix compared to the cast iron matrix (Hahn *et al.*, 2009) and is in good agreement with the low amount of wear measured with the RIC. Despite the observed smoothing of the honing structure, the Rq values increase due to the tribological process and reach equal or even slightly higher values than the cast iron tribosurface. This can be attributed to more pores of the Fe-based coating being exposed during the wear process (Figure 11).

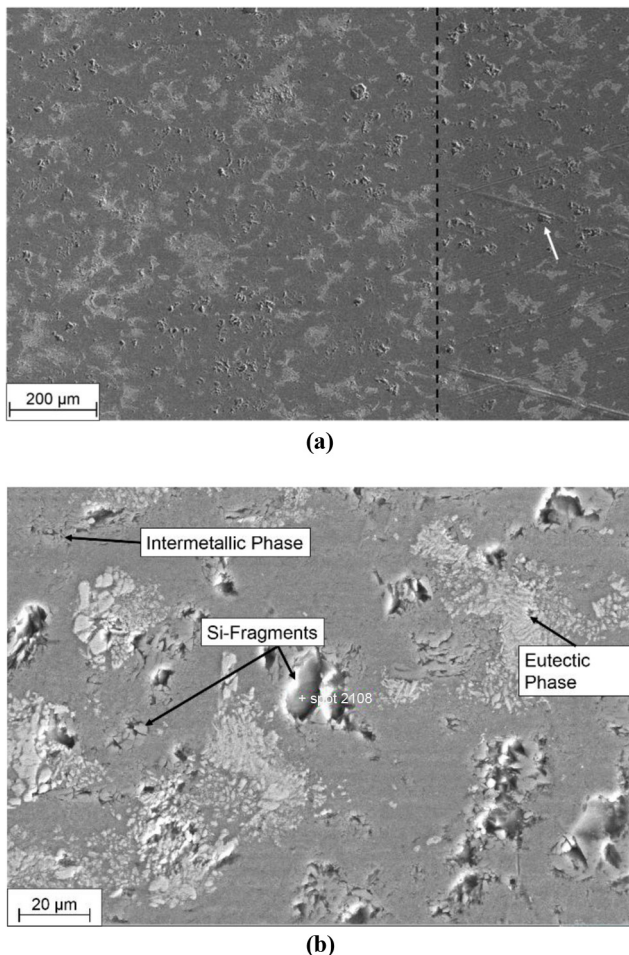
Figure 12 (a) SEM image of the AlSi cylinder liner surface with a dashed line dividing the wear track (left) and the unworn surface (right) (white arrow points out a typical break-out with lateral dimensions up to $30\ \mu\text{m}$) and (b) detail of the worn surface showing intermetallic phases, Si fragments and eutectic phases

The dashed line in [Figure 12\(a\)](#) divides the wear zone (left of the line) and the unworn surface (right). On the initial honed surface, break-outs with lateral dimensions up to $30\ \mu\text{m}$ can be observed [white arrow in [Figure 12\(a\)](#)]. On the worn surface of the AlSi cylinders [[Figure 12\(a\)](#), left], numerous small additional break-outs were produced. The break-outs lead to a seemingly rough appearance of the AlSi worn surfaces in the SEM pictures. However, the honing structure was completely worn in the Al-matrix leading to lower Rq values of AlSi after the experiments compared to the initial surface. An image of the wear zone with higher magnification [[Figure 12\(b\)](#)] shows that microstructural phases can be clearly distinguished by their morphology and brightness with SEM. The size of the pits is similar to the lateral size of the hard phases and the pits can therefore be regarded as break-outs of the Si particles and fragments of the intermetallic phase. In between these break-outs, the worn surface of the Al-matrix appears to be much smoother compared to cast iron ([Figure 10](#)), because the latter is pervaded by a crack network accompanied by some orange-

peel-like roughening. Some Si particles have only partly detached from the surface, but are cracked and show the status right before being removed from the surface [[Figure 12\(b\)](#)]. The more ductile eutectic phase (white in the SEM image) shows hardly any cracks, presumably because some small cracked debris have already detached from the surface. The depths of these small pits are about $0.5\ \mu\text{m}$ and partly up to $2.5\ \mu\text{m}$ for Si particles and the intermetallic phase. Wear debris that might have formed from these fragments did not create any wear grooves in the tribocontact. [Figure 12\(a\)](#) shows that the Al-matrix is smoothly worn without indications of grooves caused by wear debris. We regard these results as an indication for a fine fragmentation of all hard phases pulled out during the sliding motion, followed by an effective transportation out of the contact zone by the lubricant ([Figure 12](#)).
