Beaver E and Mitoulis S-A (2026)
Evidence-based flood resilience models for bridges.
Proceedings of the Institution of Civil Engineers – Bridge Engineering 179(1): 63–77,
<https://doi.org/10.1680/jbren.24.00039>

Research Article

Evidence-based flood resilience models for bridges

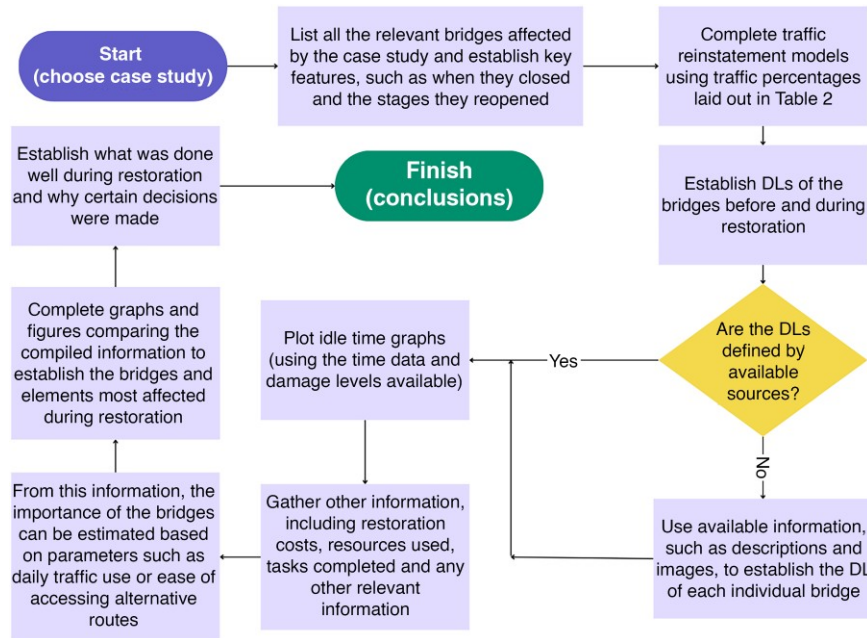
Figure 1. Flowchart of the proposed methodology for the generation of evidence-based restoration models for decision making

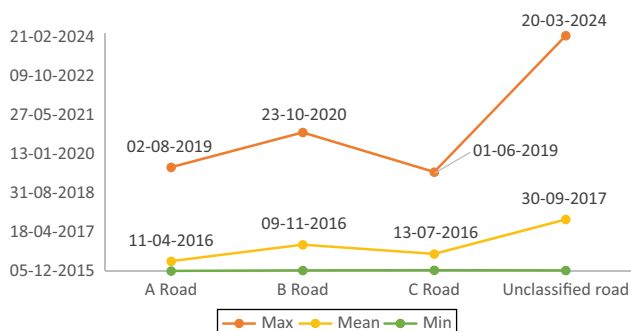
Figure 3. Plot of opening date against route/road type

From the 57 chosen bridges, 13 were on A roads, six on B roads, 20 on C roads and 18 on unclassified roads. Figure 3 shows an idle time graph of these grouped bridges and when they were opened. Figure 3 shows a correlation – the bridges that opened first being were primarily those on routes of higher importance and traffic demand, despite some outliers, such as C roads primarily having smaller and more easily repairable designs.

The major outlier of the unclassified roads is primarily due to Broad Head Bridge (U5291) not reopening at the time of writing. For B roads, the choice of using the fully reopened date of Pooley Bridge in 2020 instead of the 2016 opening date of the temporary bridge resulted in a higher mean than expected but, given the time to dismantle the temporary bridge and reconstruct the new

permanent bridge, which resulted in a period of over 1 year without any road traffic, choosing the earlier date would be inappropriate. Similarly, Middleton Hall Bridge (A683) had a period of over a month in 2019 without any traffic, making it inappropriate to use the 2016 date. If both Pooley and Middleton Hall's earlier dates were used, a much smoother mean line would be visible.

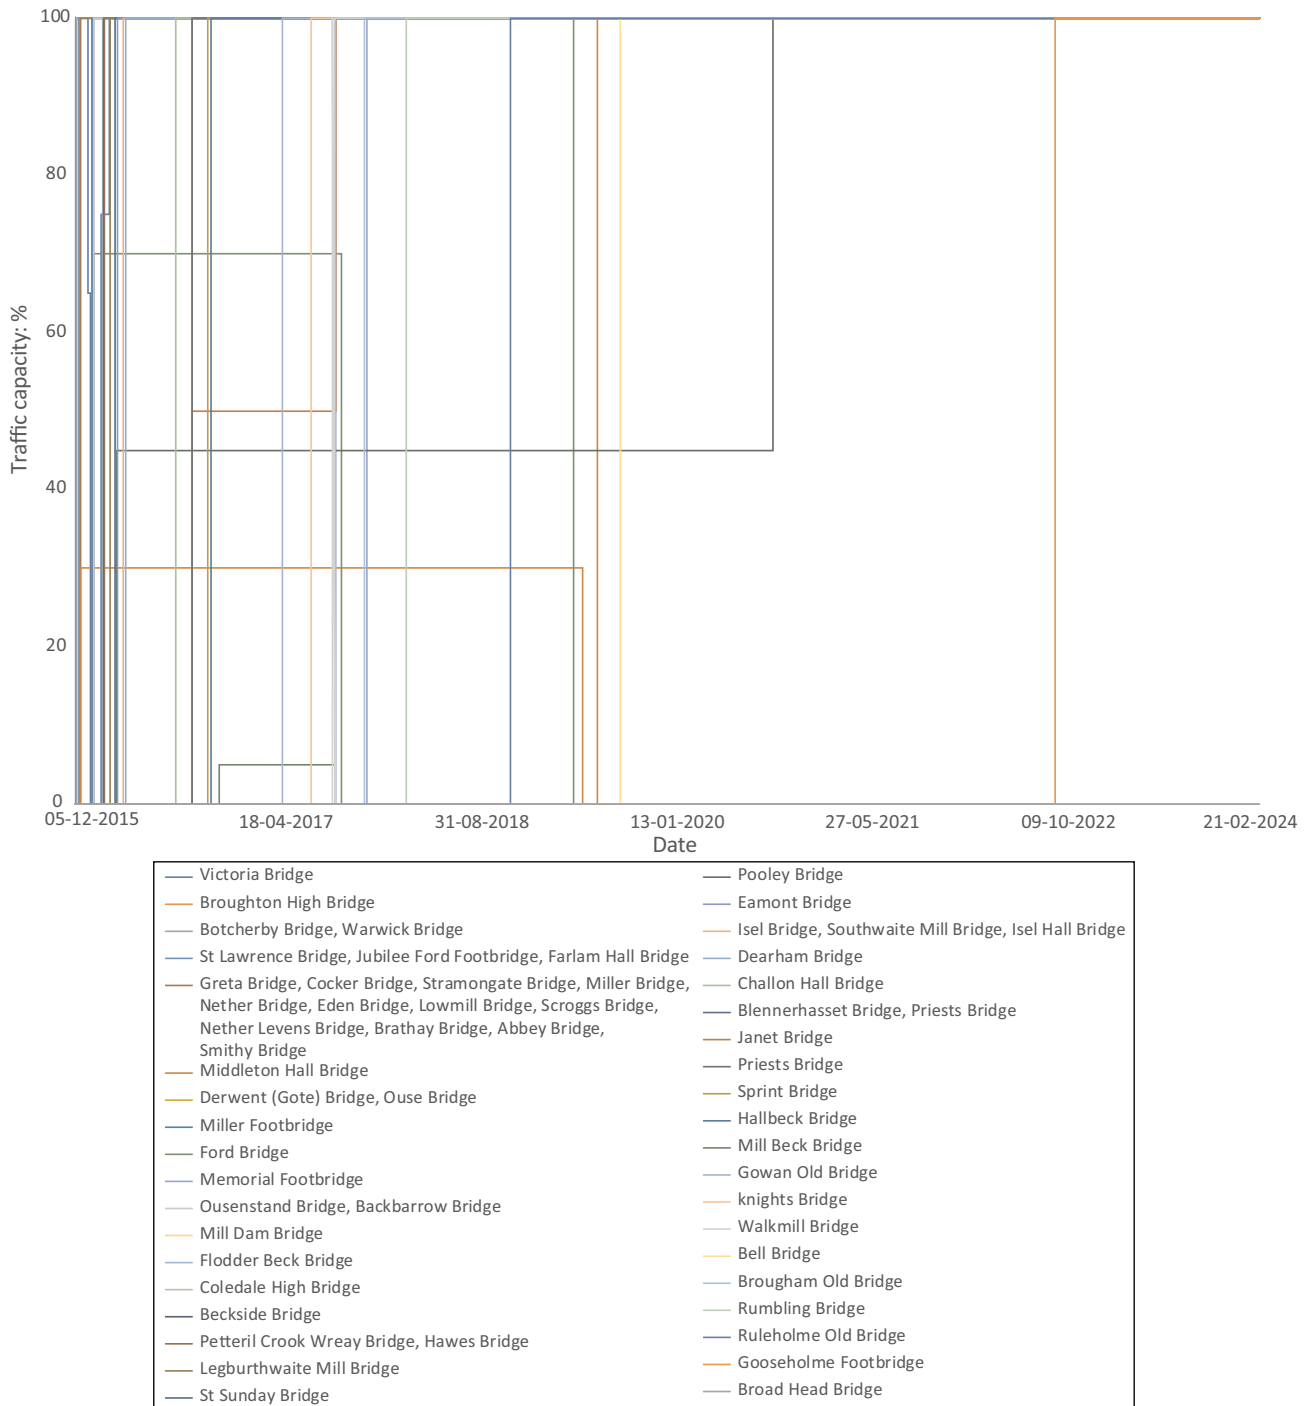
Figure 4. Traffic reinstatement model illustrating the post-flood gain of traffic capacity against time, for the most affected bridges in the 2015 Cumbria floods

As illustrated in Figures 4, 5 and 6, for most of the analysed bridges, traffic reinstatement occurred in the first few months, with half of them being fully reopened by 17 February 2016 (Figure 7). From the data gathering, various reasons for the varied capacity shown in Figure 4 were found. For example, in the case of Broughton High Bridge and Ford Bridge, they were reopened after the floods before being forced to close again to undergo further assessment and repairs/reconstruction (Cumbria Crack, 2019a; Times & Star, 2016). Pooley Bridge, however, fully collapsed in 2015, with two temporary bridges opening on and alongside the remains in March 2016 and September 2019, and eventually the new permanent bridge reopening in 2020 (ICE, 2020; Lytollis, 2019).

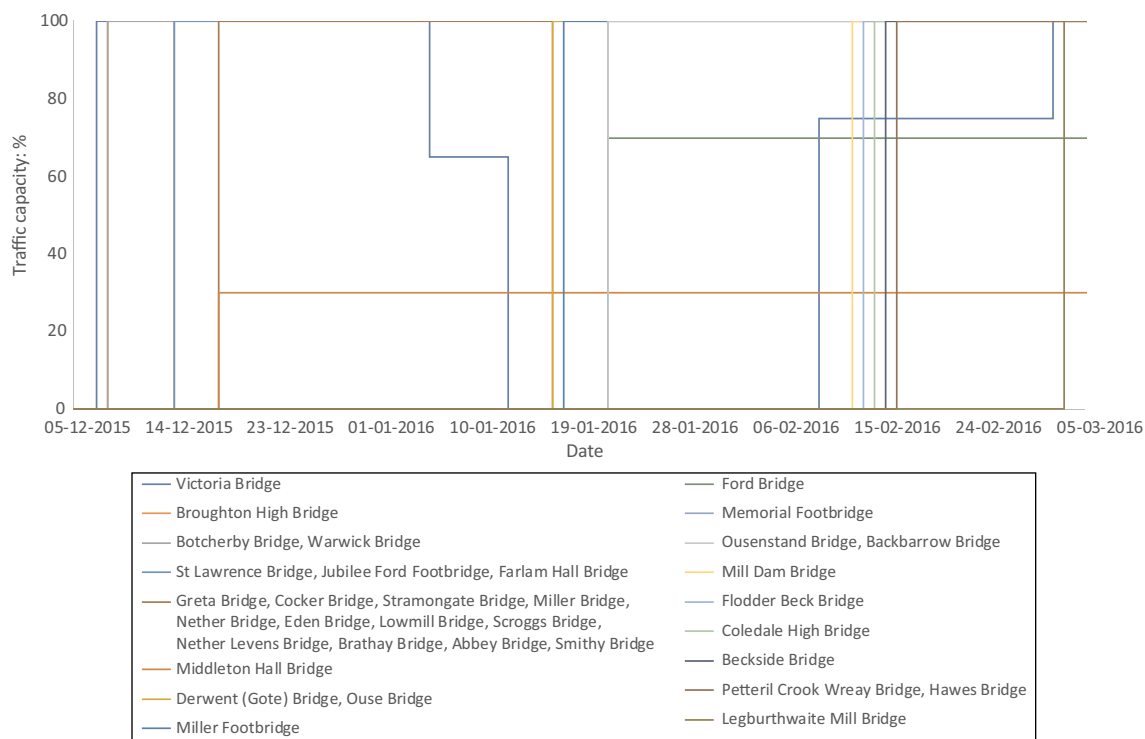
Figure 5. Traffic reinstatement model, for the 3 months following the initial floods, illustrating the post-flood gain of traffic capacity against time for the most affected bridges in the 2015 Cumbria floods (key in Figure 7)

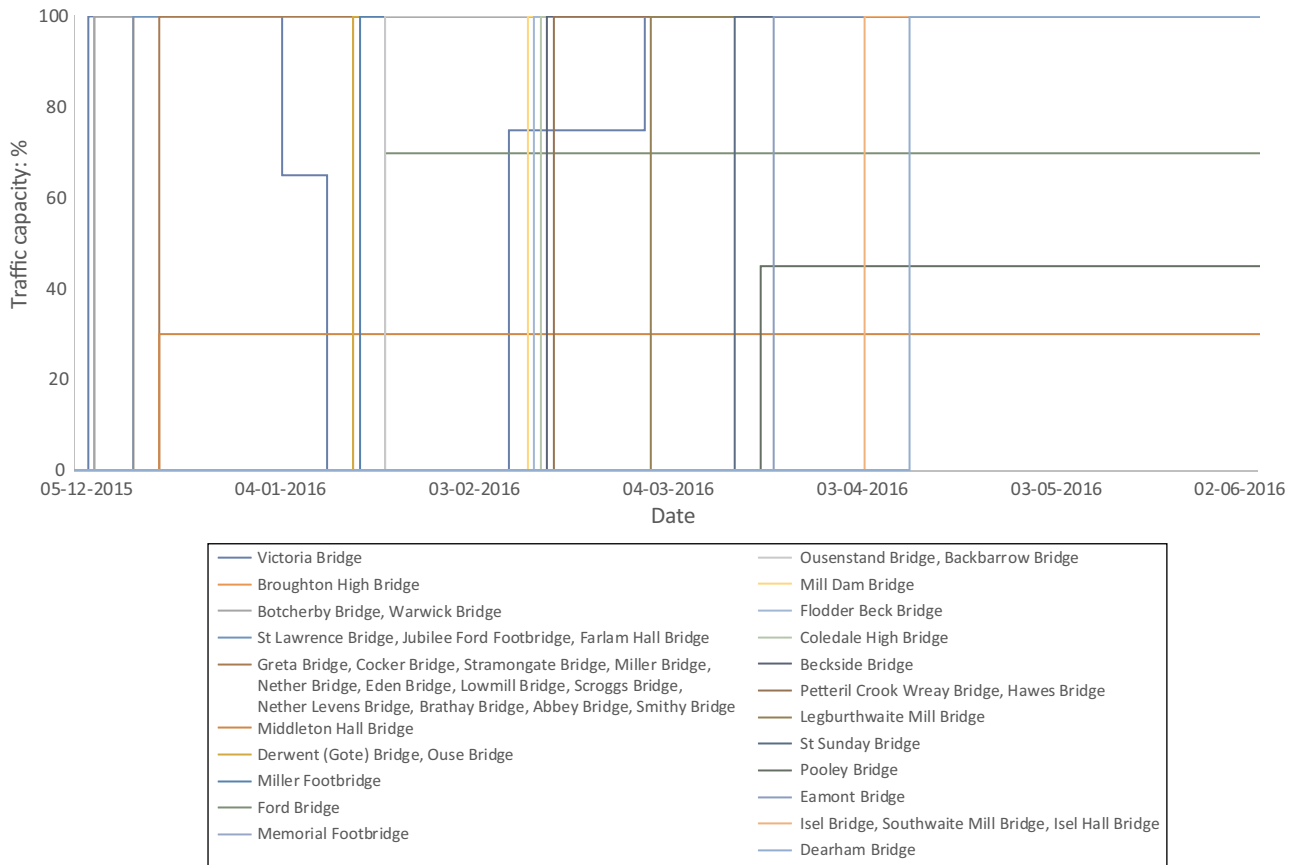
Figure 6. Traffic reinstatement model, for the 6 months following the initial floods, illustrating the post-flood gain of traffic capacity against time for the most affected bridges in the 2015 Cumbria floods (key in Figure 7)

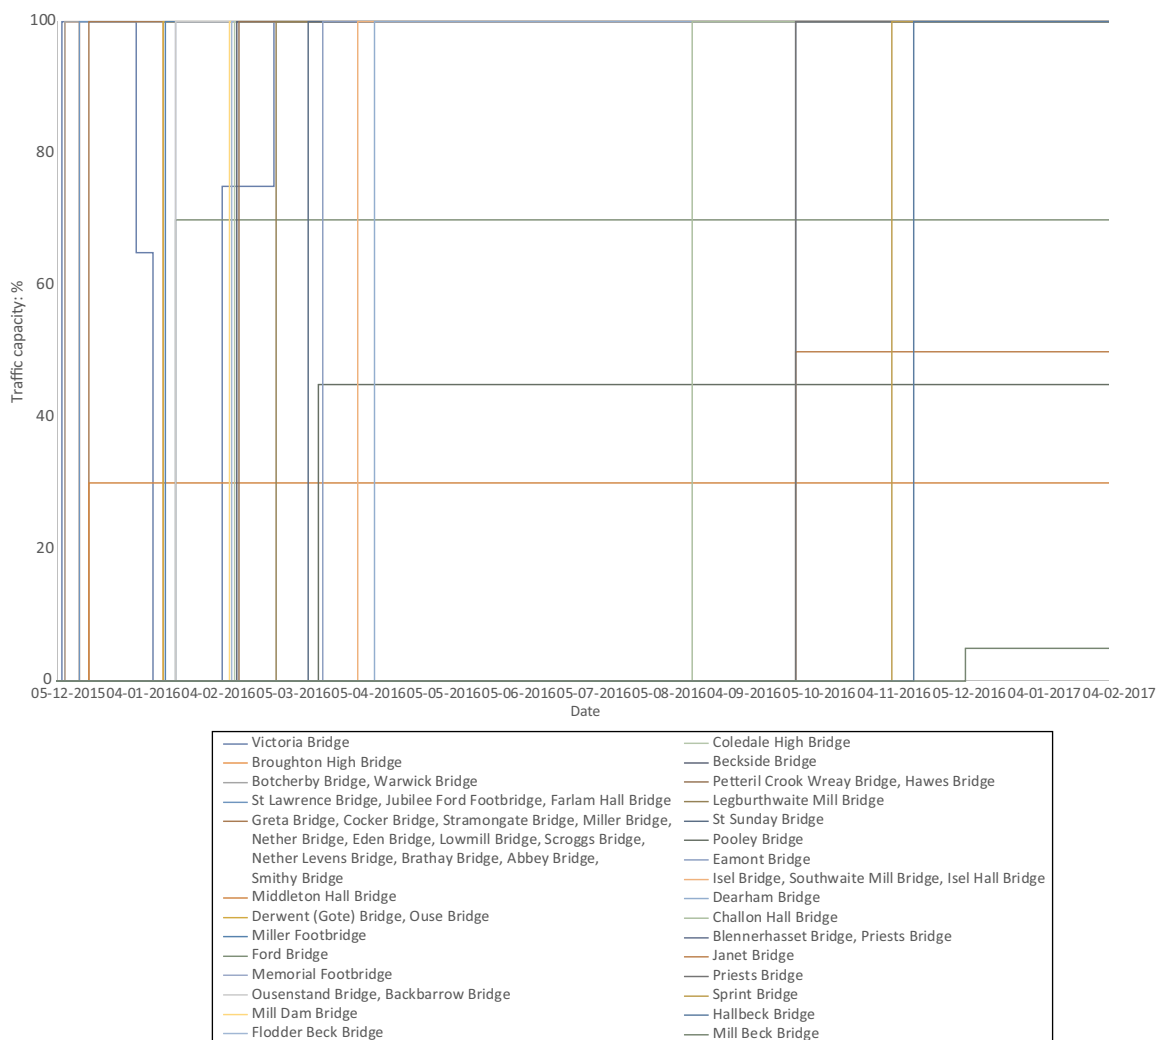
Figures 7. 14-month traffic reinstatement model illustrating the post-flood gain of traffic capacity against time for the most affected bridges in the 2015 Cumbria floods

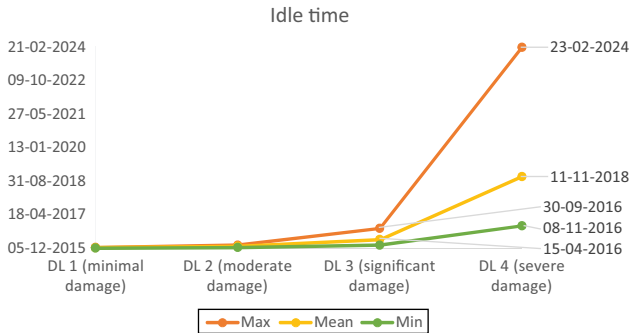
Figure 8. Plot of opening date against DL

A clear correlation between damage sustained against full traffic reinstatement date can be seen in Figure 8, which shows that the maximum, minimum and mean times increased for higher DLs.

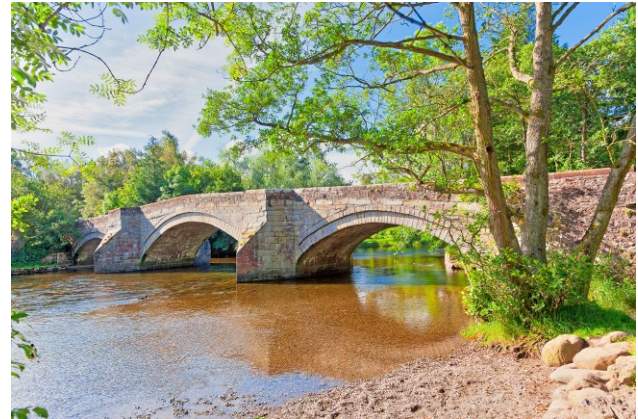
Figure 10. Pooley Bridge before collapse (Steele, 2012)

Pooley Bridge (Figure 10) was one of the worst affected bridges in the Cumbrian floods, scoring DL 4. This bridge was difficult to analyse directly with the restoration tasks (Table 1) laid out in the literature as no restoration task directly references a complete rebuild of a bridge, therefore a combination of information available was necessary. The temporary was assessed, not the permanent stainless steel bridge constructed nearly 6 years after the floods. While the new permanent bridge is significant in restoring the route to full capacity, it would be difficult to accurately analyse the complex restoration tasks completed, given the multiple years of planning, consultation and groundworks that took place during those 6 years (Snow and Tennant, 2022) including constructing a temporary pedestrian bridge while no vehicles could cross the river (Lytollis, 2019).

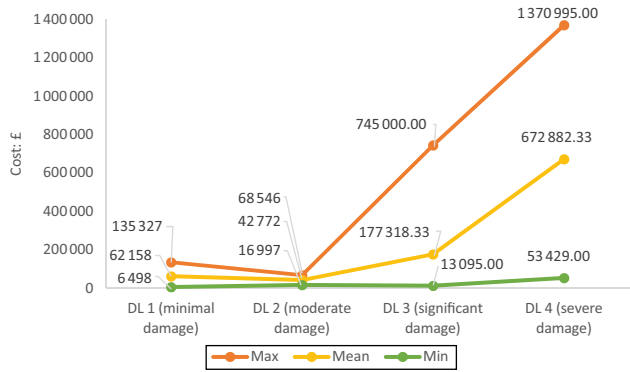
Figure 9. Plot of bridge restoration cost against DL

Following the floods, £117.6 million was allocated to CCC to help with reconstructing infrastructure in Cumbria; however, only 26 out of the 57 bridges assessed have financial information available online, with this information coming primarily from a freedom of information request in 2018 (CCC, 2018b, 2018c; WC, 2018) (see online supplementary data A, B, C and D). From this information, a graph of cost against DL was plotted (Figure 9), which shows bridges featuring higher DLs having significantly higher repair costs.

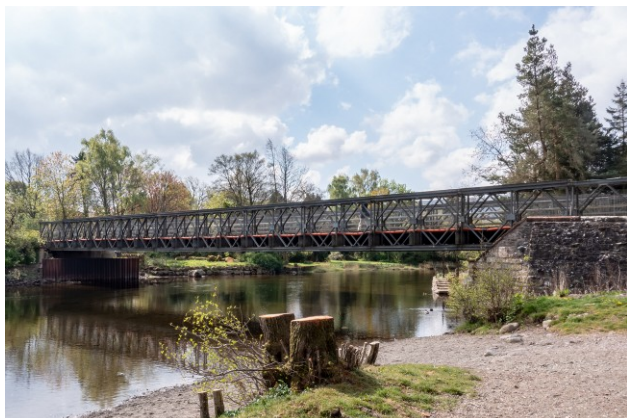
Figure 11. Completed temporary Pooley Bridge (Price, 2019)

The temporary road bridge opened 106 days after the floods, on 20 March 2016, constructed directly on top of the location where the collapsed bridge once stood. This is quite a significant achievement as the closest restoration tasks to resemble what likely occurred (R1, R3 (x2), R12, R13, R20 and R23 (Table 1) have a mean time of 281.5 days (Table 5). This calculation assumed that the restoration works were fully sequential (i.e. no tasks were carried out in parallel). In practice, some tasks could be completed concurrently, which would reduce the overall restoration time. Therefore, it is important to consider a maximum duration of 442.5 days and a minimum duration of 121.3 days are included. This is coupled with the common census being that the idle time (time before any restoration works) is usually a minimum of 30 days for severely damaged bridges, as shown in Table 4. Therefore, the actual time it took to plan and construct the temporary Pooley Bridge (106 days) is significantly better than the estimated minimum time of 151.3 days that would have been predicted using the method of Mitoulis *et al.* (2021).

It was also assumed that the abutments were likely to have been mostly reused because the temporary bridge was in the same location as the former bridge. In addition, given that sources (BBC News, 2016) show that the largest damage occurred over the river itself, this likely helped reduce the reconstruction time significantly. New temporary cofferdams and the original stonework are shown in Figure 11, resulting in tasks R1 (armouring countermeasures and flow-altering/cofferdam) and R3 (temporary support of one abutment) being used. Therefore, emitting task R17 (reconstruction/replacement of the abutment and wingwalls) helped to reduce the reconstruction time significantly.
