# Genoa, former church of Saints Gerolamo and Francesco Saverio and former university library: conservation, reuse and enhancement proposals

Stefano Francesco Musso and Giovanna Franco  
*Architecture and Design Department, University of Genoa, Genoa, Italy*

Journal of Cultural Heritage  
Management and Sustainable  
Development  
Vol. 15 No. 1, 2025  
pp. 89-113  
Emerald Publishing Limited  
2044-1266  
DOI 10.1108/JCHMSD-06-2023-0069

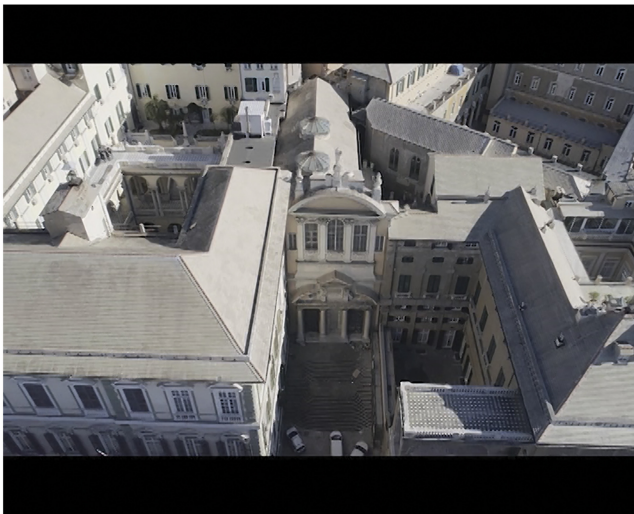
**Plate 1.**  
Aerial view of the former  
Jesuit College in Balbi  
street (left) and the  
former church of Saints  
Gerolamo and  
Francesco Saverio, set  
back from the street,  
formerly housing the  
university library  
(Source: Photo  
University of Genoa,  
property of the authors)

**Figure 1.** Cross-section of the former university library and former church. Photo composition with frescos in the apse and with the five levels of metal shelving for the library's book depository (Source: elaboration S. Acacia, property of the authors)

This article sets out to show how principles and questions of method that underlie a way of interpreting the discipline of conservation and restoration can find results in research and studies aimed at real operational repercussions for the whole community, also aiming to fill that “gap” between academia and society that often blames itself on the scientific world. The occasion is the very recent and lengthy work performed on the former Church of Saints Gerolamo and Francesco Saverio in Genoa, Italy, the Jesuit church annexed to the seventeenth-century College of the order, a small Baroque jewel in the heart of the ancient city, surrounded by Palazzi dei Rolli, today museum centres and university buildings, forgotten for years, inaccessible and awaiting a new use, shown in the aerial view as the building set back from street level and accessible by a staircase (Plate 1).

1915) and, starting from 1934 and until 2014, as the seat of the University Library. Above all, this use has led to profound internal modifications, first of all the division in height of the nave, with the insertion of a reinforced concrete floor (on a Hennebique patent, built by the Porcheddu company of Turin) to create the book deposits below, in metal shelving and the reading room above. The Porcheddu company also created a new roofing system in reinforced concrete equipped with two skylights (with relative cut in the vault) (Figure 1).

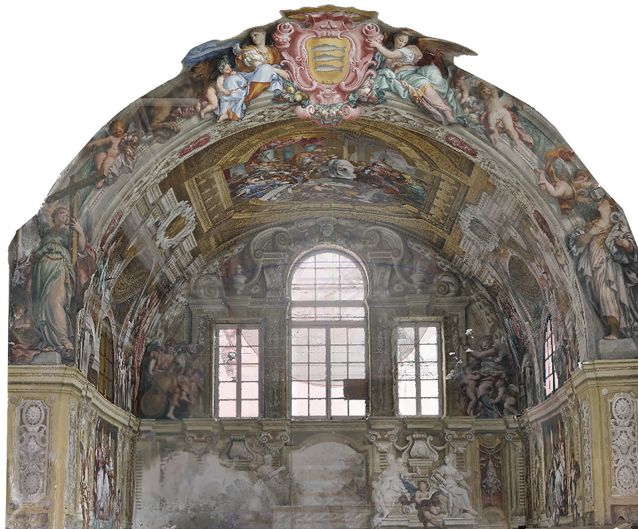
**Plate 2.**  
Photoscan survey,  
view of the apse and  
frescoes by Domenico  
Piola (Source:  
elaboration G. Garelli,  
property of the  
authors)

left, and Piety, on the right. Furthermore, on the sides of the coat of arms are painted two female allegorical figures depicting, on the left side, the True Christian Religion and, on the right side, Goodness. These representations express Francesco Maria Balbi's programmatic intention to celebrate his own virtues as a patron and, at the same time, to exalt the Society of Jesus (Plate 2).

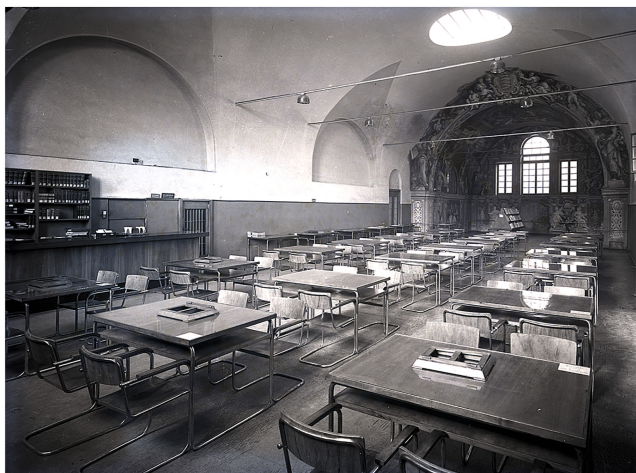
**Plate 3.**  
View of the reading  
room of the university  
library, with the  
furniture chosen by  
Mario Labò, and the  
frescoed abse at the  
time of the  
inauguration (Source:  
Archivio Fotografico  
del Comune di Genova,  
Fondo Cresta)

“admirable frescoes by Piola, which are some of the most remarkable of all Genoese painting”, while for the façade of the church, “after general plastering of the architectural and decorative parts of it will be reassembled integrally in the first aspect on the original structure, taking up the mouldings, the projections, the decorations, etc. according to the evident traces and the most reliable graphic memories” (Plate 3).

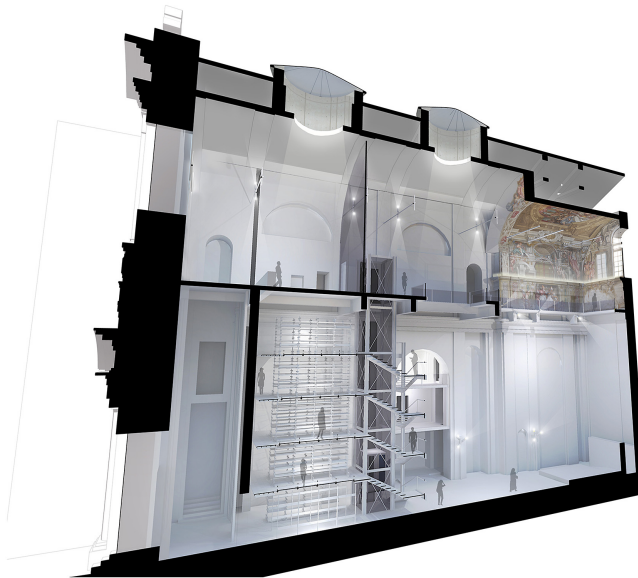
**Figure 6.**  
Perspective view of the sacred space in the design configuration. The considerable reduction of the book deposit and the lightening of the large reinforced concrete slab make it possible to see the frescoes even on the ground floor  
(Source: elaboration Andrea Fenialdi, Caterina Lavarello, Luca Marasso, property of the authors)

The reuse pre-project envisages a new lift system to serve the preserved portion of shelving, as the now existing vertical connection is missing, located in the centre of the former classroom and unusable in safety conditions, based on the previously described hypotheses.

The design choice of the new “staircase” and its positioning, in investigating the spatial, architectural and technical relationships of the new element with the preserved portion of

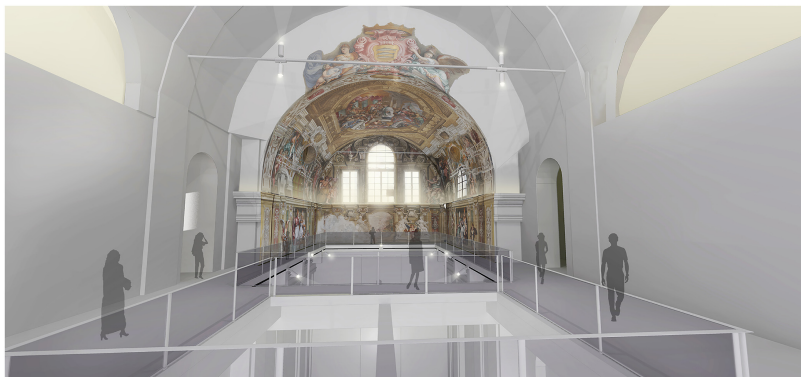
**Figure 7.**  
Render of the new arrangement of the public space around the apse, after the lightening in the huge concrete slab inserted in the 1930s (Source: elaboration Caterina Politi, property of the authors)

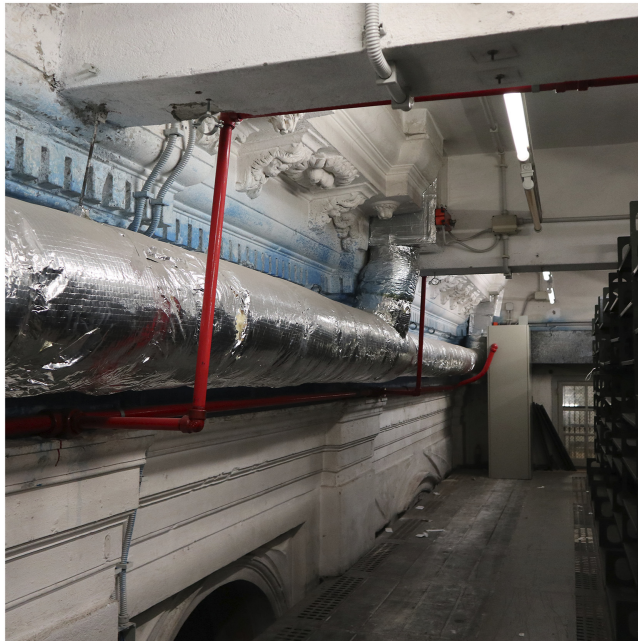
**Plate 4.**  
View of the huge plant  
system linked to the  
university library  
(Source: photo G.  
Franco, 2019)

The entire complex is also occupied by elements that are attributable to the electrical systems and numerous ventilation channels whose positioning has been the cause of many demolitions and vast destructions of portions of masonry, vaults and decorative elements; to date, the systems are oversized and incompatible with the lines of the new project and, consequently, it will be necessary to proceed with their removal and only then act on the surfaces to repair the damage caused by their installation (Plate 4).

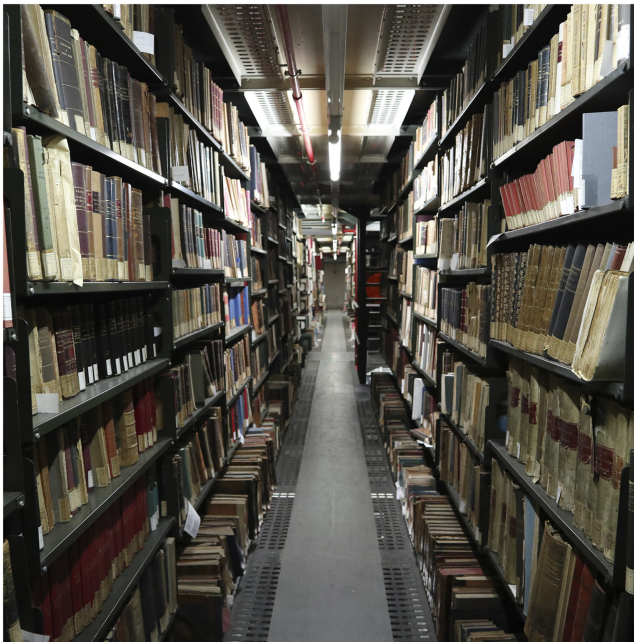
**Plate 5.**  
View of the book  
depository before the  
move, 2019 (Source:  
photo G. Franco)

The cuts due to the passage of the ventilation systems should be treated with the integration of the missing part of the masonry, through an operation of simplification of the existing geometric lines, to mend the cut and restore continuity to the decorative apparatus, always ensuring the recognition of the new construction works (Plate 5).

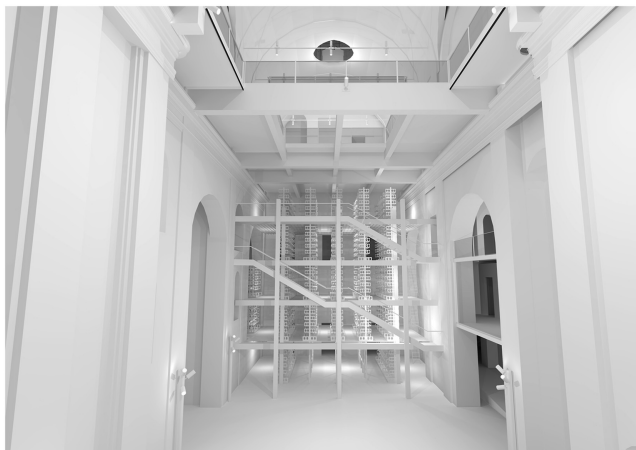
**Figure 9.** View of the new configuration of the space, from the apse, once a large part of the metal shelving has been dismantled. The new staircase, necessary to connect the remaining book depository, completes the ‘stage machine’ (elaboration Andrea Fenialdi, Caterina Lavarello, Luca Marasso, property of the authors)
