Bailey J, Middlebrook A, Brewis C and Patel D (2025)  
Former IBM building at 76 Southbank, London: a blueprint for adaptive reuse and addressing insurance risks with materials science.  
*Proceedings of the Institution of Civil Engineers – Civil Engineering* 178(2): 126–140,  
<https://doi.org/10.1680/jcien.24.01113>

# Former IBM building at 76 Southbank, London: a blueprint for adaptive reuse and addressing insurance risks with materials science

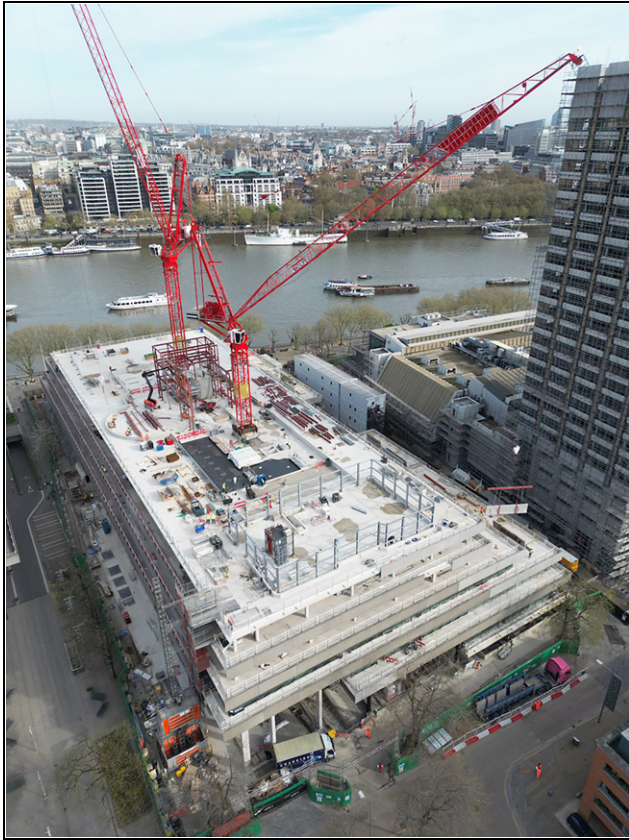
Figure 1. Site view/context

The 76 Southbank project, involving the adaptation and reuse of the iconic former IBM building on London's Southbank (Figure 1), serves as a landmark case study. Local planners rejected initial proposals that involved extensive demolition of the structure. Furthermore, during the process of securing planning permission for a larger building with more floor space, the building received a Grade II listing. This affirmation required the design response to deliver a shorter programme with lower associated risks, necessitating a complete re-evaluation of the design approach. As a result, the project team focused on maximising reuse of the building to ensure the scheme remained commercially viable while adhering to conservation guidelines.

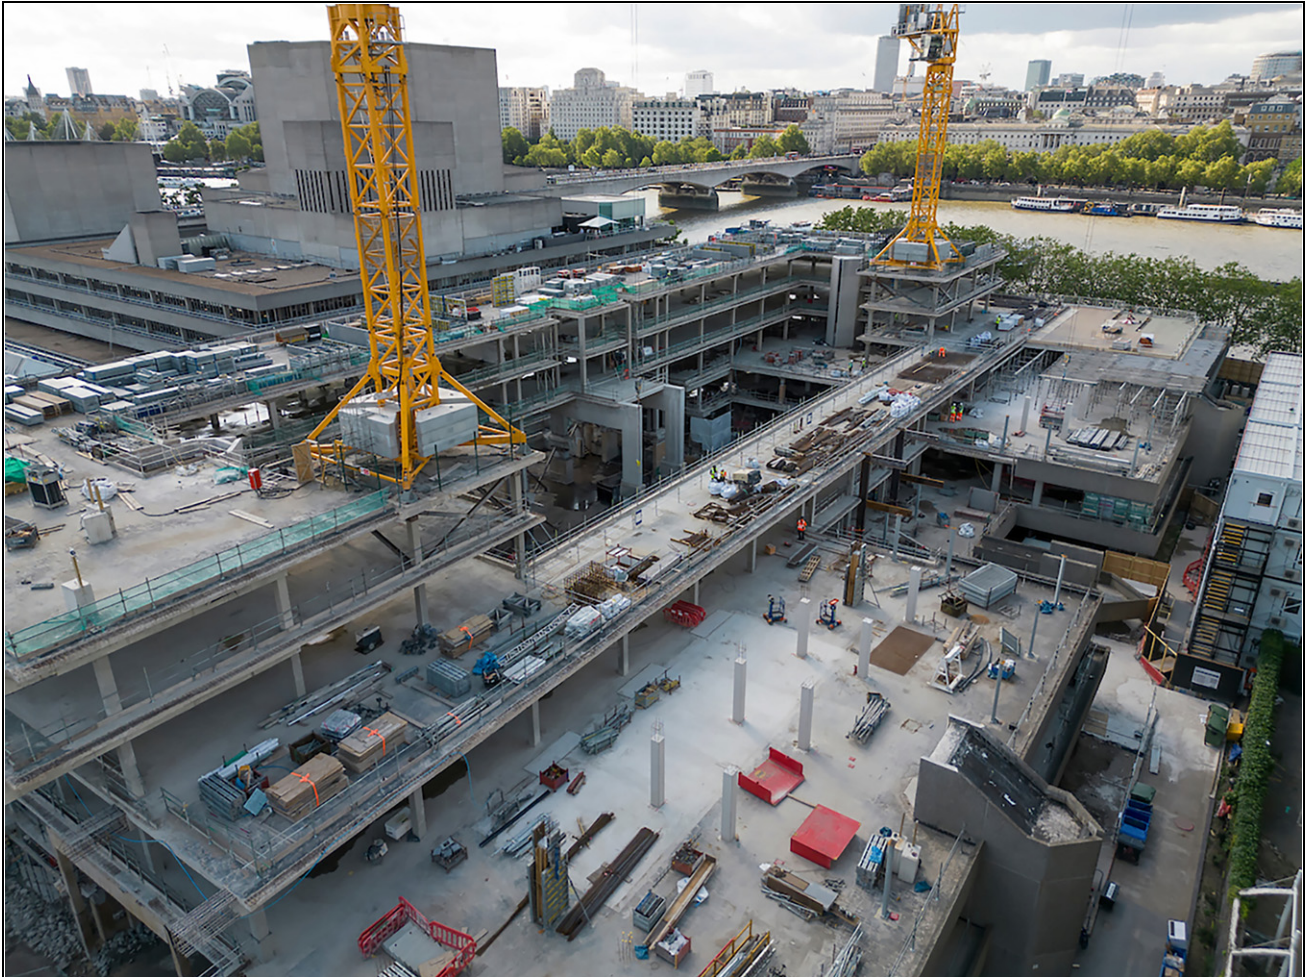
Figure 3. Demolition and construction works

The proposed refurbishment aimed to add an additional storey and extend the existing floor plates (Figure 2), increasing the usable area by approximately 40%. A core objective of the project was to retain and reuse as much of the original structure as possible, driven by both sustainability goals and the heritage status of the building (Figure 3).

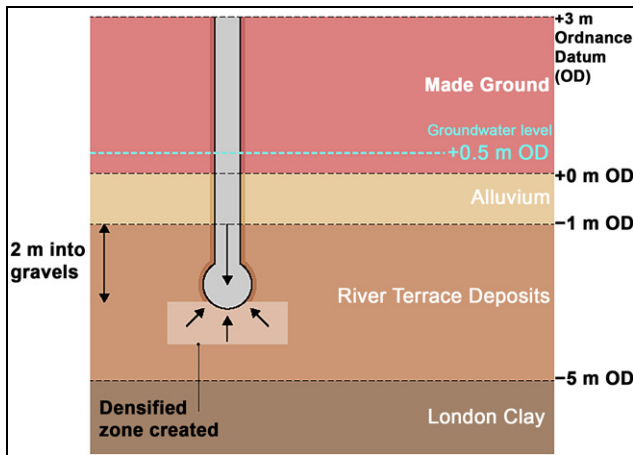
Figure 5. Franki piles

There were almost 460 existing Franki piles, each carrying nearly 1 MN (100 t), which today would be considered a very efficient and sustainable piling system. Franki piles are no longer in use, making the evaluation of their reuse a complex task due to several factors.

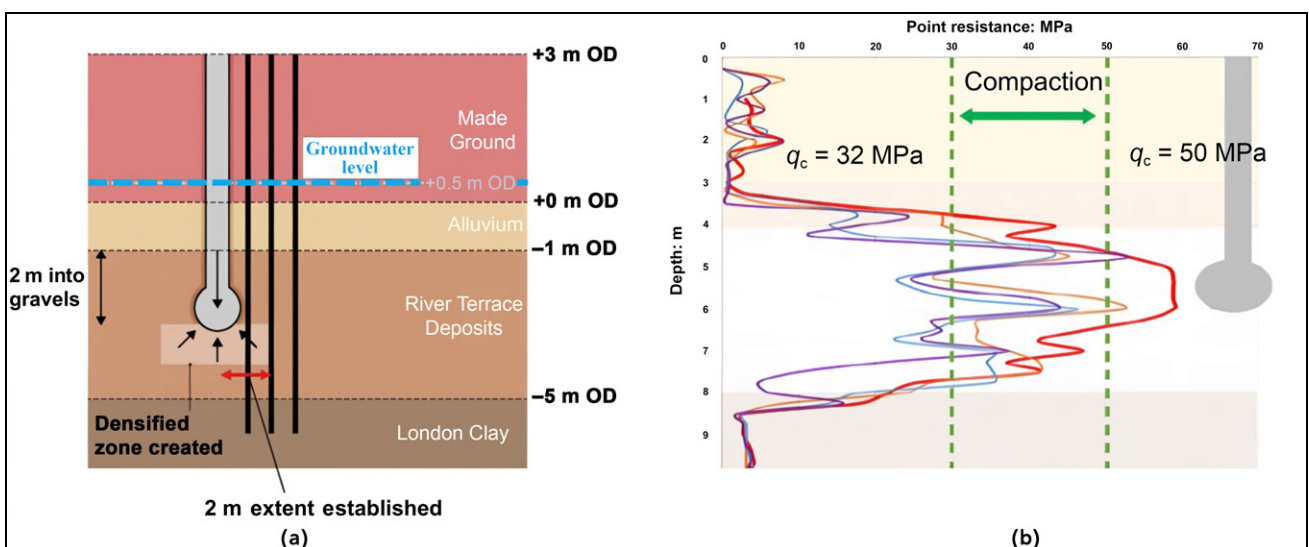
Figure 6. Ground investigation and CPTs: (a) CPTs carried out after pile installation; (b) CPT results showing 60% improvement in densified zone

The ground investigation strategy included boreholes, cone penetration tests (CPTs), and groundwater monitoring carried out by contractors RSK in 2022. The Franki piles pass through 4 m of Made Ground and Alluvium and are embedded approximately 2 m into water-bearing Terrace Gravels, which extend down to London Clay. The unique Franki pile installation method of driving a concrete plug to create a densified gravel zone was investigated further on site by comparing CPTs (Figure 6) in natural gravels and CPTs through the densified gravel adjacent to existing driven piles. These tests, along with dummy pile tests, provided invaluable data for evaluating the potential of foundation reuse.

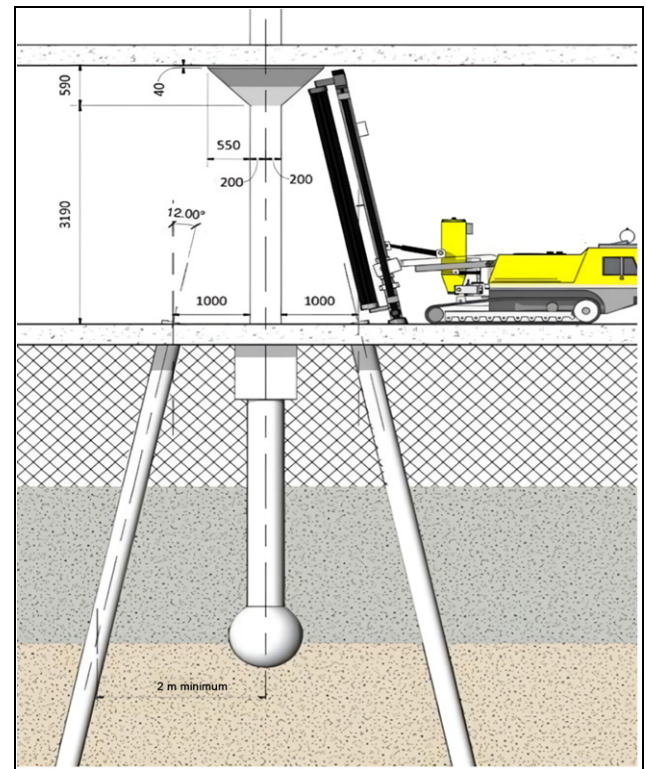
Figure 8. Franki pile strengthening with raked mini piles (dimensions in mm, UNO)

The new mitigation piles were raking mini piles up to 30 m deep. These piles were intentionally raked from the pile cap to avoid disturbing the densified gravel zone created 40 years ago, while still allowing efficient pile cap design for the integration of new and old components. A crucial aspect of the collaboration between HTS and Arup was the numerical modelling of the load distribution between the new mitigation piles and the existing Franki piles, ensuring the latter were not overstressed.

To prevent piling too close to the densified gravel zone around the Franki pile bulbs, while still minimising the load transfer distance from the column to the new piles, a raked mini pile system was adopted and installed by contractor Keller. This approach required specialised, low-headroom piling rigs operating beneath the first-floor ceiling. A monitoring system consisting of reflective targets on all existing columns was implemented by contractor SES in order to control any nearby building movements during the construction works.

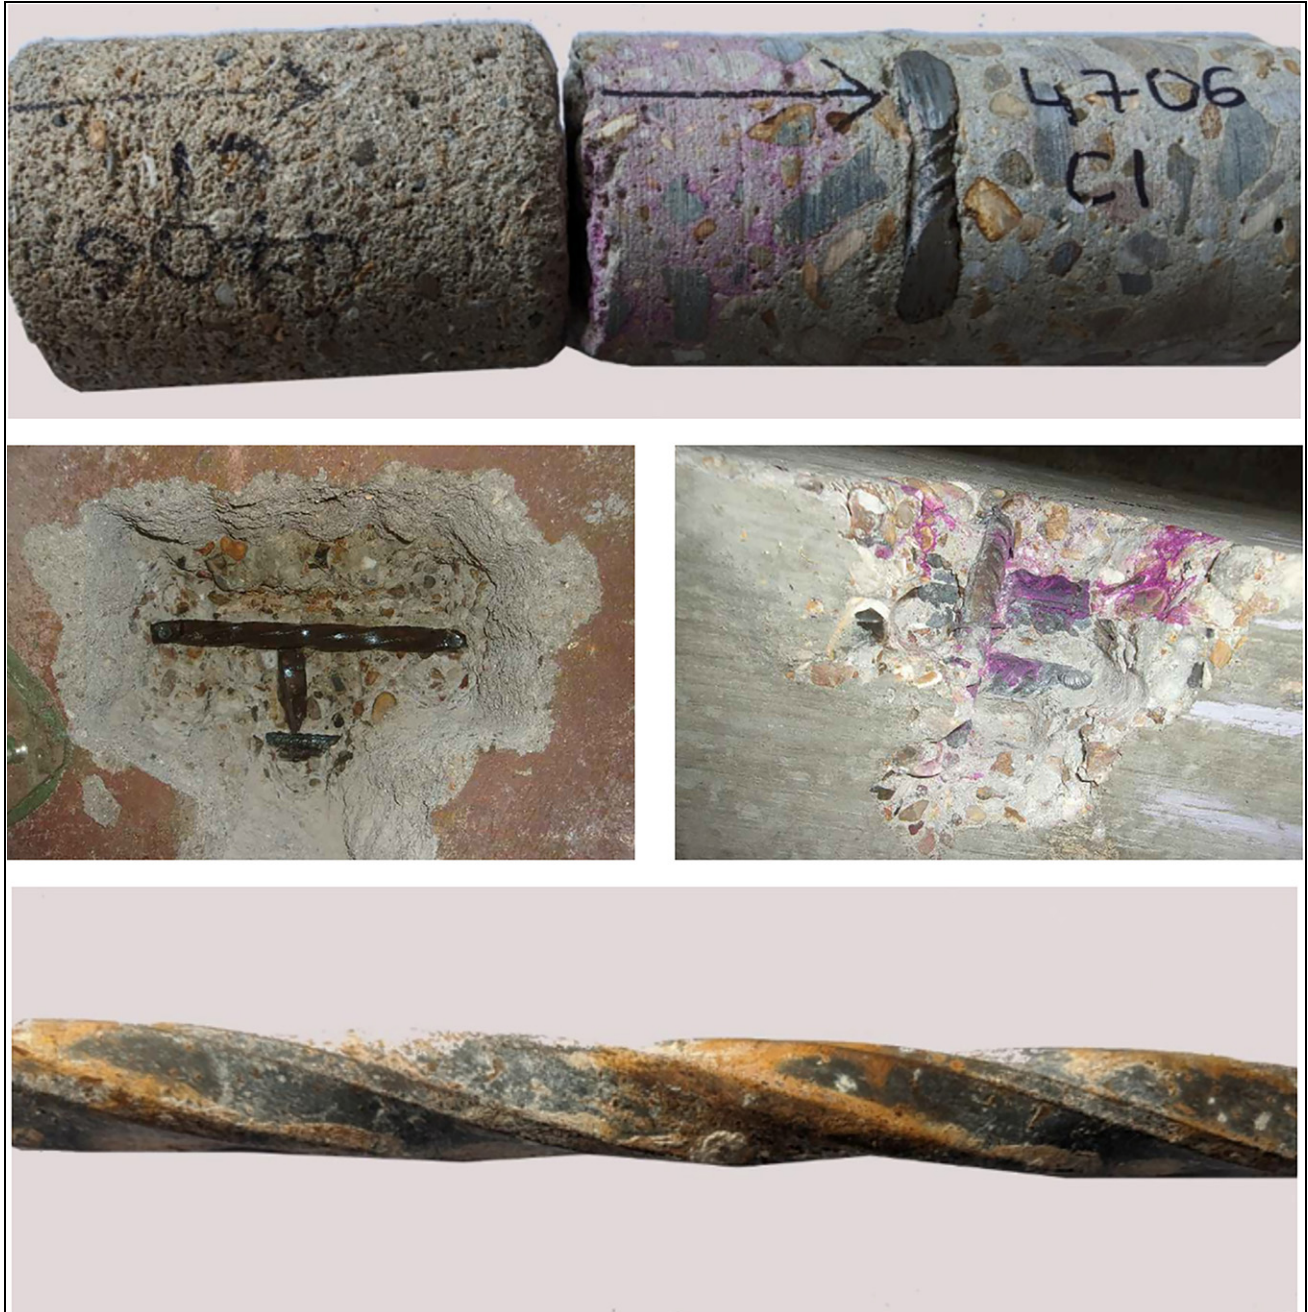
Figure 9. Examples of materials sampling & testing

Tests (Figure 9) on concrete cover, carbonation and chloride content in superstructure elements indicated a low to negligible risk of significant reinforcement corrosion. However, for ground-contact elements, such as the diaphragm wall, chloride ingress posed a moderate to high risk.

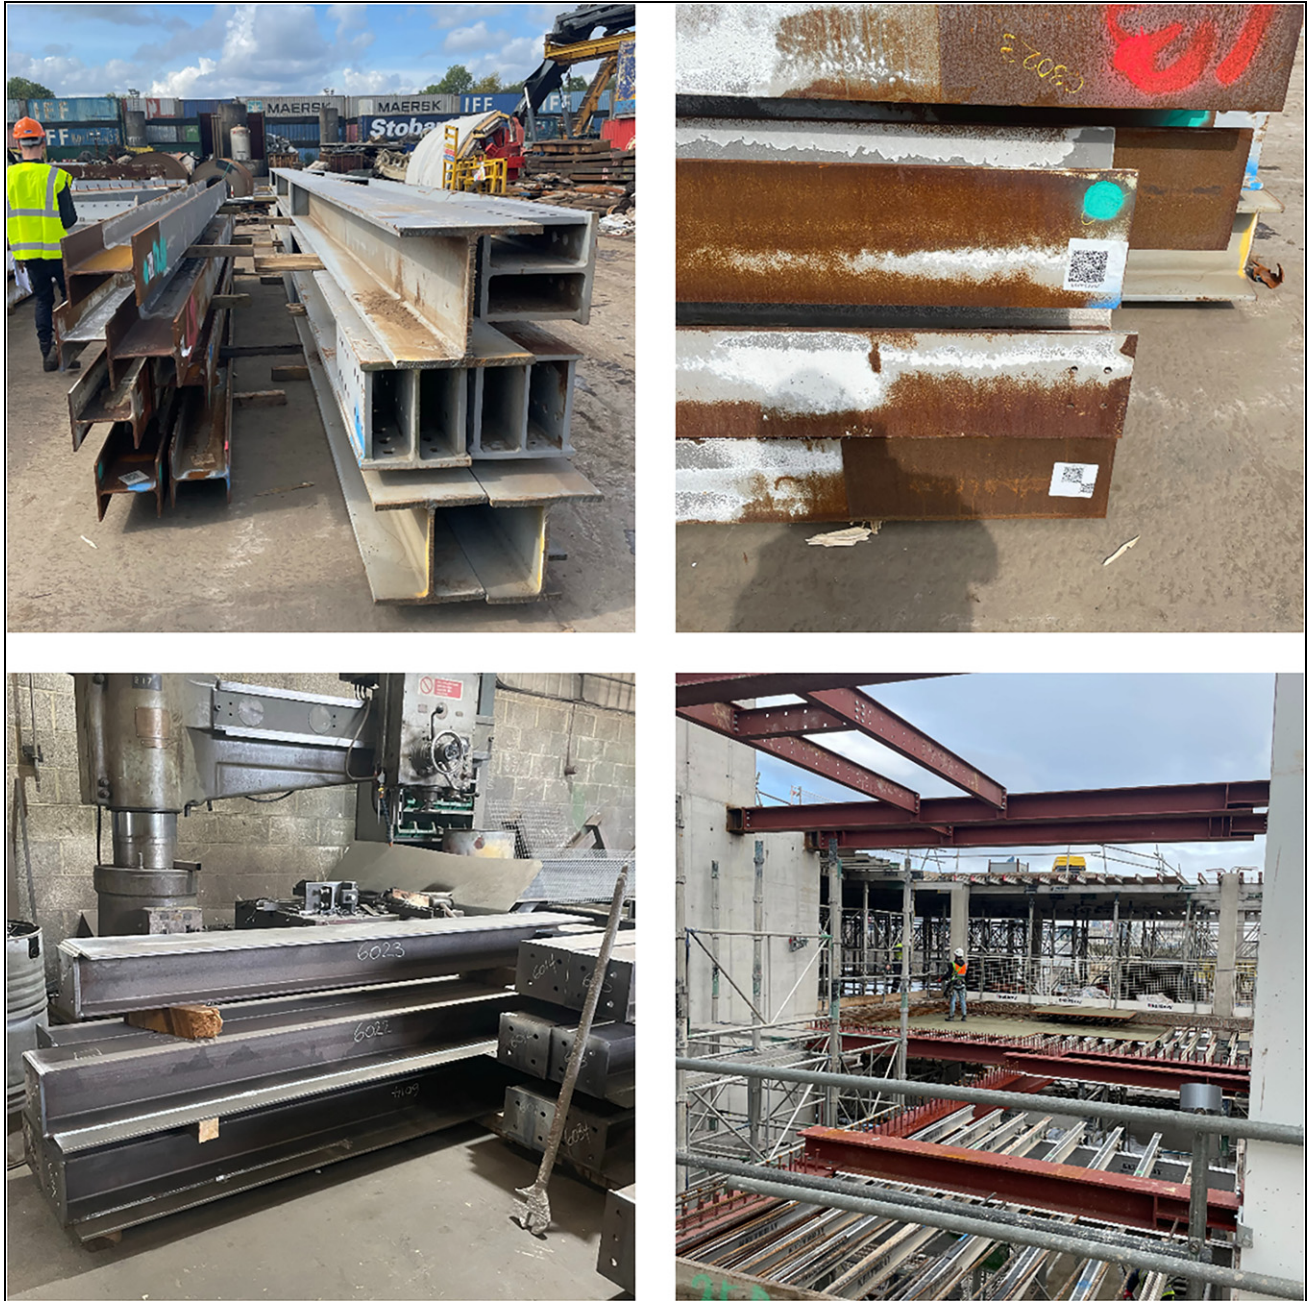
Figure 10. Reused steel process

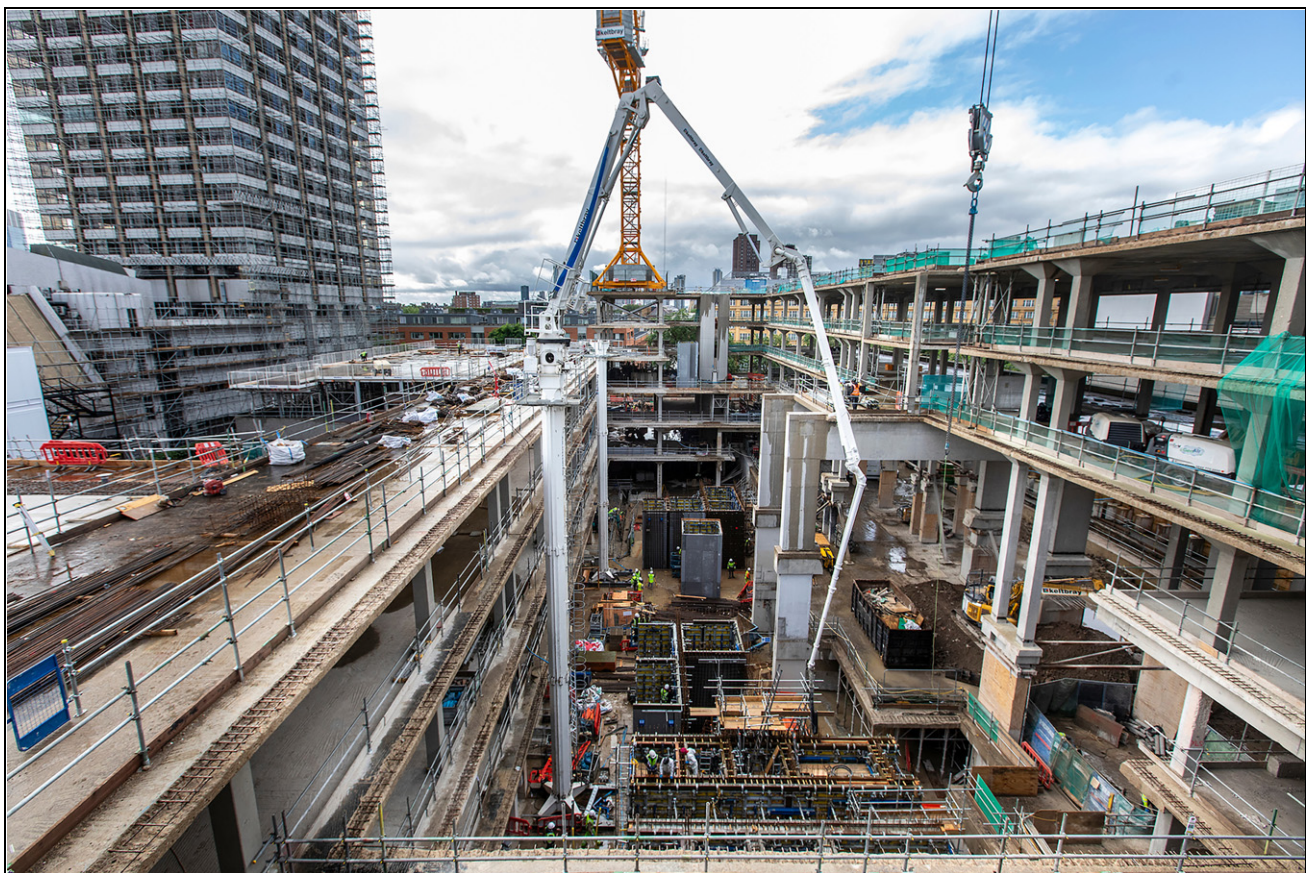
Figure 11. Demolition and construction

Sustainability in refurbishment projects encompasses not only environmental impacts but also community and workforce challenges. These projects often involve significant demolition activities (Figure 11), which can present more complex issues than new-build construction.
