Technical visit: BDS visit to Germany – 11–14 May 2011

Jonathan Hinks MA, MSc, CEng, FICE
Halcrow Group, Swindon, UK

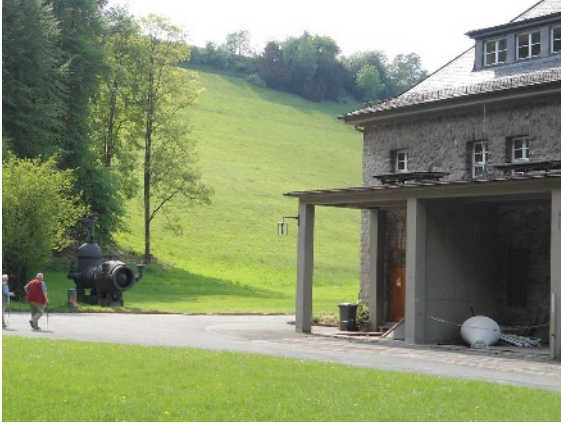
Figure 1. Downstream face of Sorpe dam

Trees are being allowed to grow at the top of the downstream face as can be seen in Figure 1.

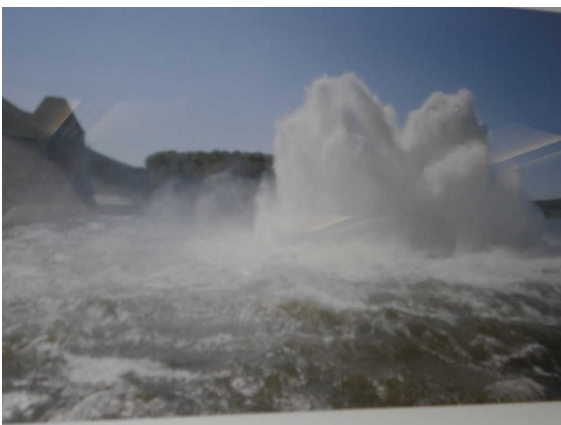
Figure 3. Flow from the bottom outlet is shot vertically into the air downstream of the dam

A bottom gallery was excavated in the dam in the early 1970s by drill and blast. Up to 20 m³/s flow from the bottom outlet is shot vertically into the air downstream of the dam (see Figure 3). Why don't we do this at UK dams?

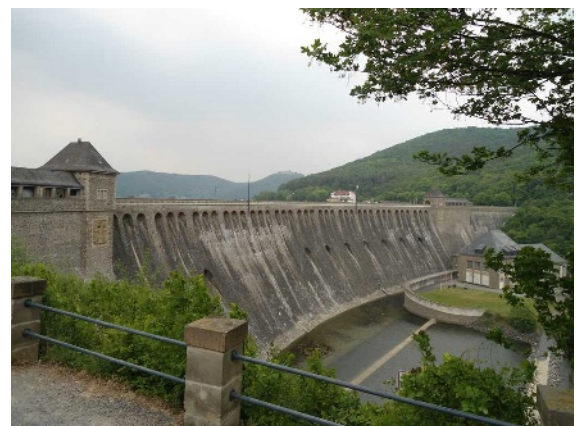
Figure 5. Eder dam

The Eder dam (Figure 5) is a 48 m high masonry dam which was also breached by the RAF on the night of 16/17 May 1943. It is intended to augment flows in the Fulda and Weser Rivers

and to supply water for the Mittelland Canal which carries traffic to Berlin. The dam also has a flood control function.

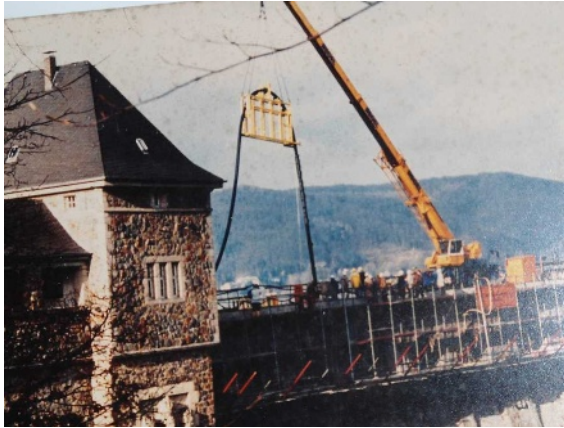
Figure 6. Old photograph showing installation of anchors in 1991–1994

In 1991 to 1994 the dam was stressed down to the foundation rock with 104 anchors which terminate in the Upper Gallery (see Figure 6). The anchors, which are at 2 m spacings are 65 to 75 m long and have an ultimate capacity of 7.5 MN. The operational load is 4.6 MN per anchor. It would have been useful to have compared notes with the designer of the post-tensioning as similar works were being designed for Mullardoch Dam in the UK at about the same time.

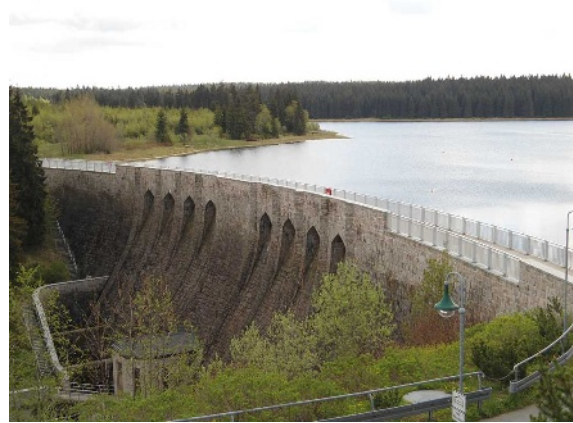
Figure 9. Carlsfeld dam

The Carlsfeld dam (Figure 9) is at an elevation of about 900 m ASL close to the border with the Czech Republic. It is a medium-sized masonry dam 31.8 m high. The main dam was repaired in 1997 when a concrete gallery (Figure 10) was added on the upstream side of the dam with Züblin as the contractor. At the same time the upstream face of the dam was sealed against the ingress of water.

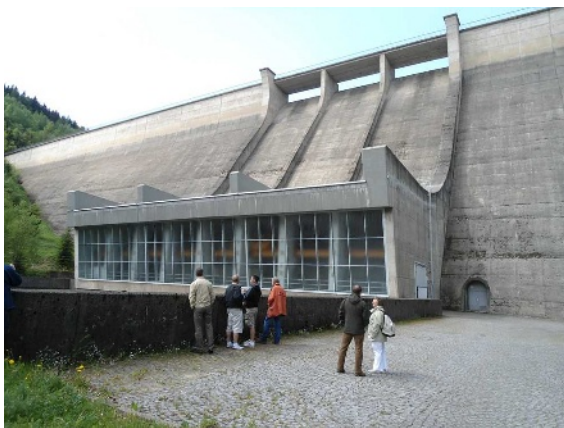
Figure 7. Eibenstock dam with spillway and valve house

After visiting the Eder dam the party moved eastwards towards Saxony where the first stop was the Eibenstock dam (see Figure 7). This is a concrete dam 65.5 m high completed in 1987 for drinking water supply, flood control, flow augmentation in the River Zwickauer Mulde and power generation (Figure 8).

The catchment area is 199.8 km² and the gross capacity of the reservoir is 81.7 Mm³.

There are normal and inverted pendulums in the dam; the cyclical movement of the dam is about 18 mm. The dam is provided with 208 piezometers of which 28 are measured with a manometer. Total leakage is very low.

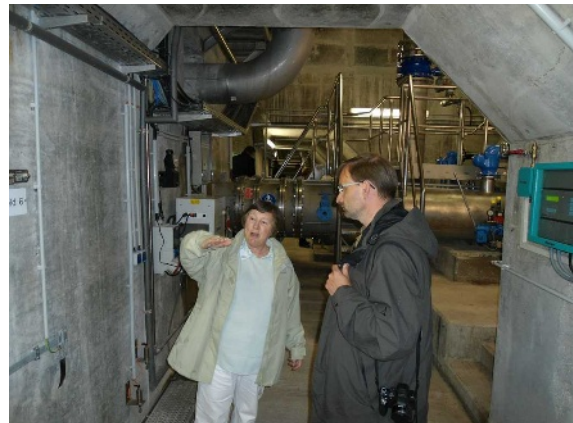
Figure 10. One of the party questioning Ingo Lux about the instrumentation in the gallery

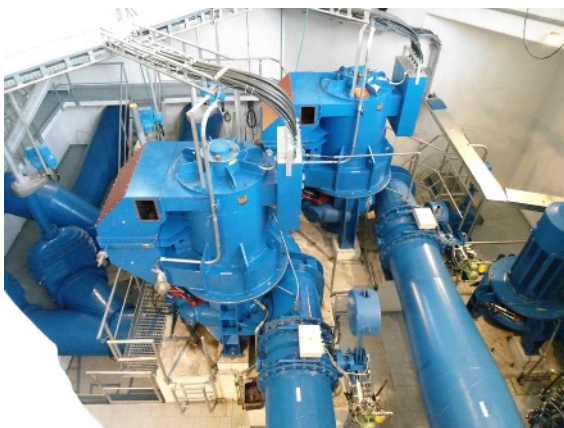
Figure 8. Compact power station with Francis turbines

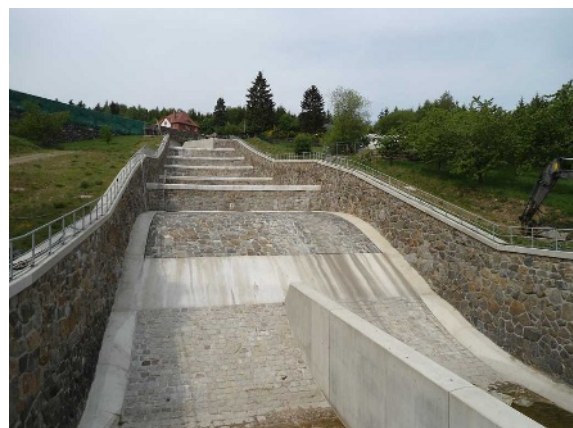
Figure 11. Restored spillway at Klingenberg

The 40 m high Klingenberg Masonry dam near Dresden was visited on 14 May. The spillway had been badly damaged by a flood event with a magnitude 175% of the design flood in 2002; which had recently been elegantly restored in masonry and concrete (see Figure 11 and Figure 12).

The reservoir supplies 60% of Dresden's water supply. The new spillway was a part of 80 M Euros worth of work presently in hand at the dam.

The catchment area is 89.4 km² of which 12.3 km² is in the Czech Republic. The PMF outflow (which must not be allowed to overtop the dam) is 320 m³/s. The party were relieved to hear that two bombs found in the reservoir were dropped by the Russians.

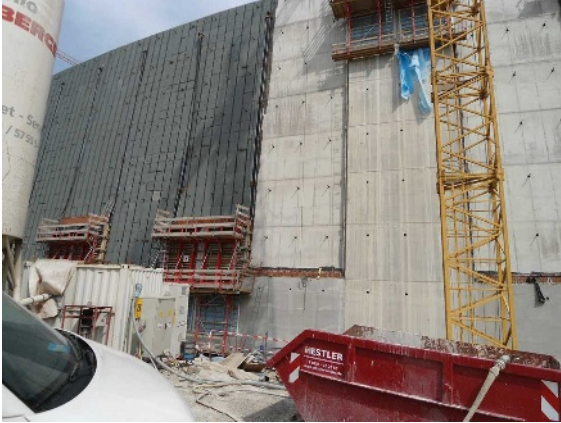
Figure 12. Application of impermeable facing to Klingenberg dam

At the time of the visit work was in full swing on a new upstream facing for the dam which was costing 7 M Euros for 7000 m². Grouting was also in progress at the heel of the dam – at an angle to intersect the vertical rock joints.
