# What does NDE need to achieve for cast iron pipe networks?

Faculty of Engineering and Physical Sciences, University of Surrey, Guildford, UK

Innovation, Thames Water Utilities Ltd, Reading, UK

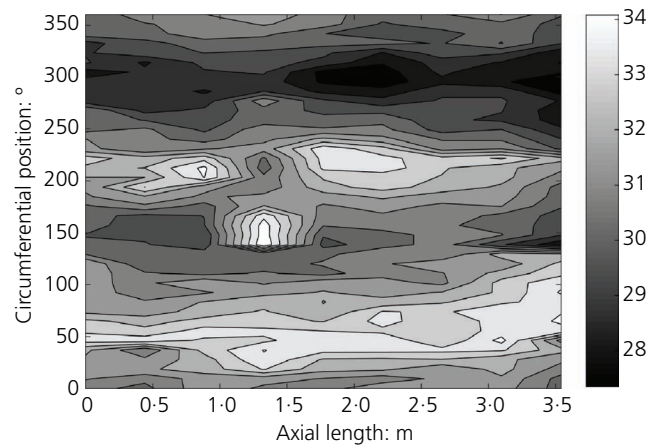
**Figure 1.** A wall thickness map showing the variation in wall thickness in millimetres from manual point measurements, taken with a calliper, around the circumference of a 3.54 m long, 42 in. (1.07 m) dia. vertical pit-cast trunk main sectioned into rings and each ring sectioned into quarters. The darkest point represents the thinnest point and the lightest the thickest. The wall thickness varies by  $\pm 4$  mm around a mean of 31 mm

Company. The pipe, which can be considered to be of the highest quality available at the time, still shows some  $\pm 10\%$  variation around a nominal average thickness.

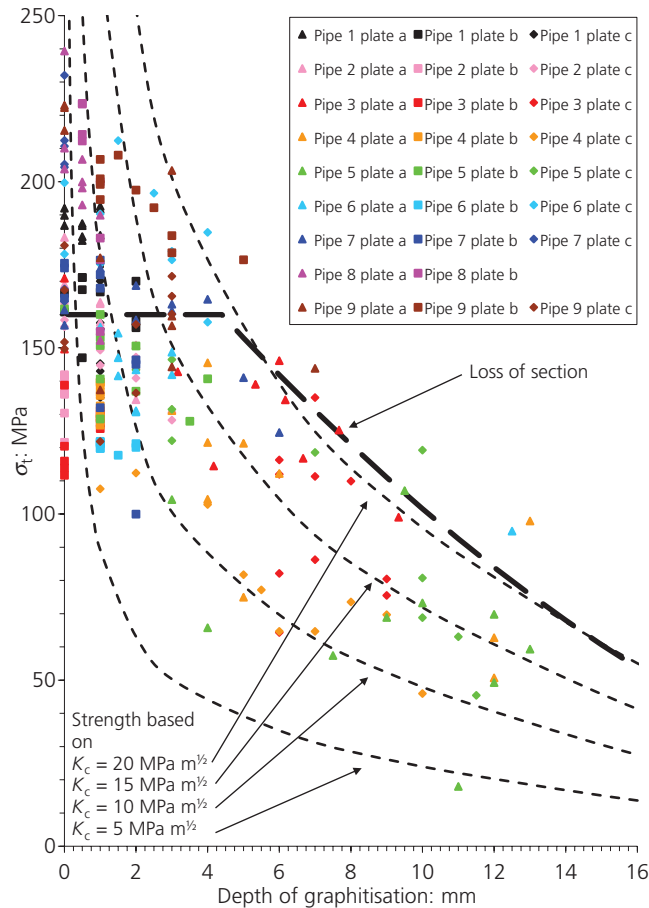
**Figure 2.** The strength of cast iron samples against the maximum depth of graphitic corrosion measured on the fracture surface of that sample. Ten samples were taken from a plate, and three plates were taken cut from each of the nine pipes studied. The plates were taken from random locations along and around the barrel of the pipe. It is worth noting that in a number of cases, the plates taken from a specific pipe exhibit very different properties. Models for strength based on loss of section and fracture mechanics approaches (values of fracture toughness  $K_C$  ranging from 5 to 20  $\text{MPa m}^{1/2}$ ) have also been superimposed (reproduced from Jesson *et al.* (2013) with permission from Elsevier)

Once in service, mains are subject to further mechanisms that can cause defects to form and grow until the defects are too large for the pipe to sustain. In places where the bitumen or tar coating is compromised (often as a result of the installation process as mentioned earlier), corrosion processes are initiated which can further undercut the coating, causing it to spall, expose bare metal and continue to corrode. Of particular concern is ‘graphitisation’, which should properly be termed ‘graphitic corrosion’ (Logan *et al.*, 2014a, 2014b). Despite anecdotal assertion, it is generally not possible to identify graphitic corrosion by visual inspection in exposed pipes since the corroded region does not change in volume (although the density decreases) and the pipe appears unaffected to the naked eye. This may reduce the residual strength capacity of the pipe (Figure 2).

Figure 2, two cases can be considered – that is, loss of section and fracture mechanics – with these two models providing an envelope capturing the majority of failures. For illustrative purposes, a thumbnail crack geometry is assumed (for which  $K = 1.26\sigma a^{1/2}$ ); the relationship between tensile strength for catastrophic failure and crack size is shown graphically in Figure 6 for a range of fracture toughness values for cast iron taken from the literature (Ashby and Jones, 2005). A value of 90 MPa was suggested by Marshall (2001) as the maximum value of stress that a pipe would experience in service. This stress would mean that crack lengths greater than 8 mm in a material with a fracture toughness  $K_c$  of 10 MPa  $m^{1/2}$  would cause fast fracture. Conversely, for cast irons with  $K_c$  greater than or equal to 14 MPa  $m^{1/2}$ , failure would occur by loss of section when the crack becomes 14 mm long, if the original wall thickness is 32 mm. More recent work by Rajani and Abdel-Akher (2013) suggests that this value of operating stress is higher than what is routinely seen in practice; based on this, a value of 30 MPa is used as a more ‘realistic’ estimate. In this situation, longer defects could be tolerated before catastrophic fracture.

The implication of the data presented in Figure 2 and the analysis in this section is that in order to be truly useful, an NDE technique must be able to detect reliably graphitic corrosion depths of the order of 4 mm and greater, to a resolution of  $\pm 1$  mm. The surface resolution would ideally be comparable to this, but in practice may be constrained by the physics of the NDE technique itself, by practicalities associated with data storage or by the time needed for scanning.

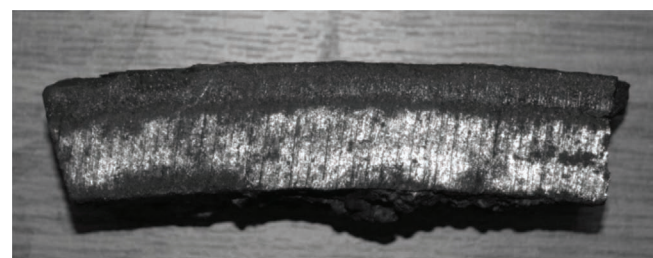
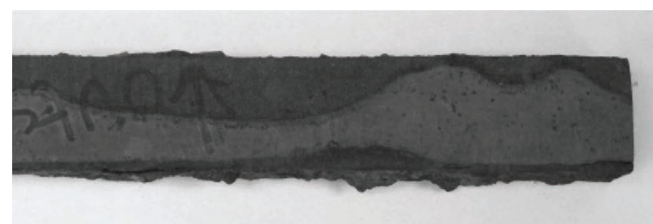
**Figure 3.** Full wall-thickness specimens (~30 mm thick) indicating the variation in graphitic corrosion morphology: (a) uniform and (b) more localised, pitting corrosion

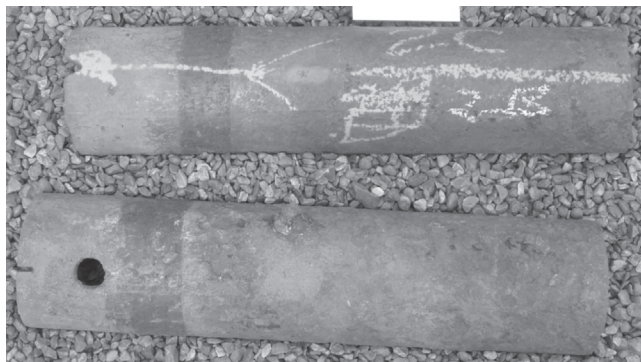
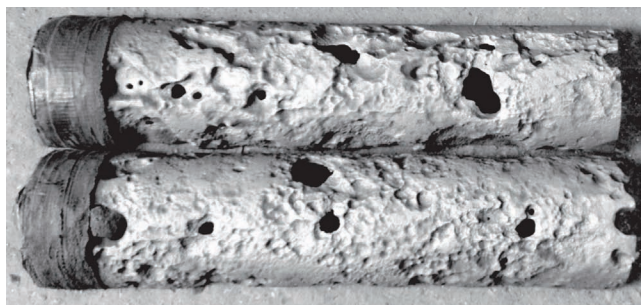
**Figure 4.** Digital photographs of a split section of 4 in. (102 mm) dia. distribution main illustrating the spread of corrosion and the amount of metal that can be lost to the graphitic corrosion process: (a) before shot blasting and (b) after shot blasting

In smaller-diameter distribution mains, graphitic corrosion has been shown to have a significant impact on the strength of the pipe and to be in competition with defects that have originated during manufacture and installation. Further, because of the combination of the size of the pipe and its interaction with the local environment, it is possible to comment on the behaviour of the main a significant distance (multiple casting lengths or ‘sticks’ of pipe, typically 3–5 m long) either side of a sampling point (Belmonte *et al.*, 2007, 2008, 2009). The size and spread of graphitic corrosion in distribution mains can be seen in Figure 4.

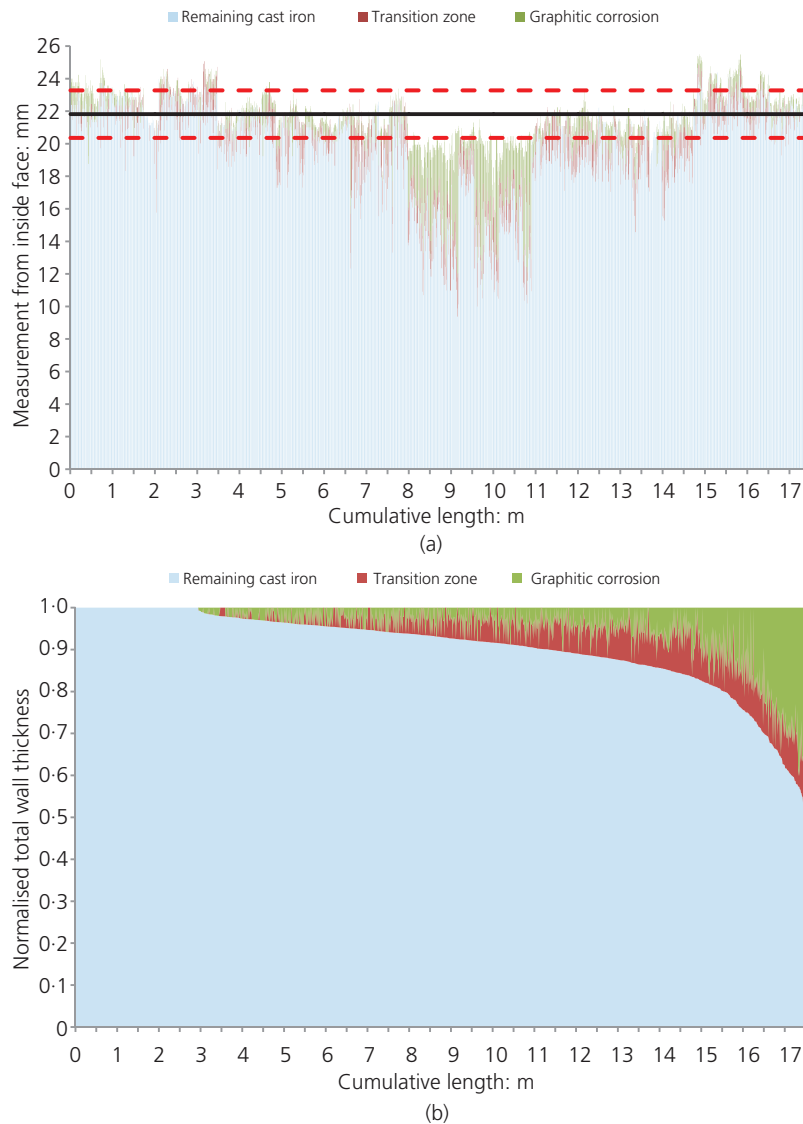
**Figure 5.** Stacked bar chart of measured values of total wall thickness  $t_w$  measured at 10 mm intervals along the sides of a series of ( $N = 23$ ) test samples (350–400 mm  $\times$  30 mm  $\times$  wall thickness  $t_w$ ) cut from pipe 4 (see Jesson *et al.* (2013)). The total length of pipe edge examined was 17.4 m. The values were obtained from direct inspection of the cut face by using optical microscopy. Note: The (assumed) total wall thickness  $t_w (= t_i + t_z + t_g)$  at any position is given by the sum of the remaining thickness of cast iron  $t_i$ , depth of transition zone  $t_z$  and depth of external graphitic corrosion  $t_g$ . (a) Data obtained from each sample are presented in sequence running from left to right. As a consequence, the position along the cumulative length has no physical meaning in relation to the original pipe, or to the plate from which each sample was cut. The solid black line shows the mean total thickness  $t_{wa}$  of all the samples examined, while the dashed lines are positioned at one standard deviation from  $t_{wa}$ . (b) Data from (a) have been replotted by normalising the value of  $t_w$  at each position (i.e. removing the absolute variation in total wall thickness) and then ranking the values of the remaining thickness of cast iron  $t_i$  in decreasing value from left to right. The resulting figure provides a measure of the distribution of wall thickness within all of the samples examined. It can be seen that of the 17.4 m of the total sample length examined, some 3 m showed no signs of corrosion loss, while there are positions where the loss of metal section exceeded 40%

In larger-diameter trunk mains, however, the size of the pipe and hence the volume of ground that it interacts with mean that similarly sized samples taken from different parts of the same stick can give very different results (Jesson *et al.*, 2013). As part of the present work, the distribution of the depth of graphitic corrosion over single sticks, from each of the mains for which strength data are shown in Figure 2, was assessed and observed to vary greatly across the stick. Figure 5 shows an example of the

data observed for one stick. The variability means that any evaluation technique must consider the whole surface of the pipe (albeit ignoring the difficult geometry of the bell and spigot) in order to provide a meaningful assessment of a pipe. In conjunction with the variation in the depth of graphitisation from point to point within the trunk main pipe, it should be noted that the stress, arising from a combination of vertical load (due for instance to soil and traffic) and water pressure, will vary with position around the pipe. These effects were considered in a recent paper by Fahimi *et al.* (2016).

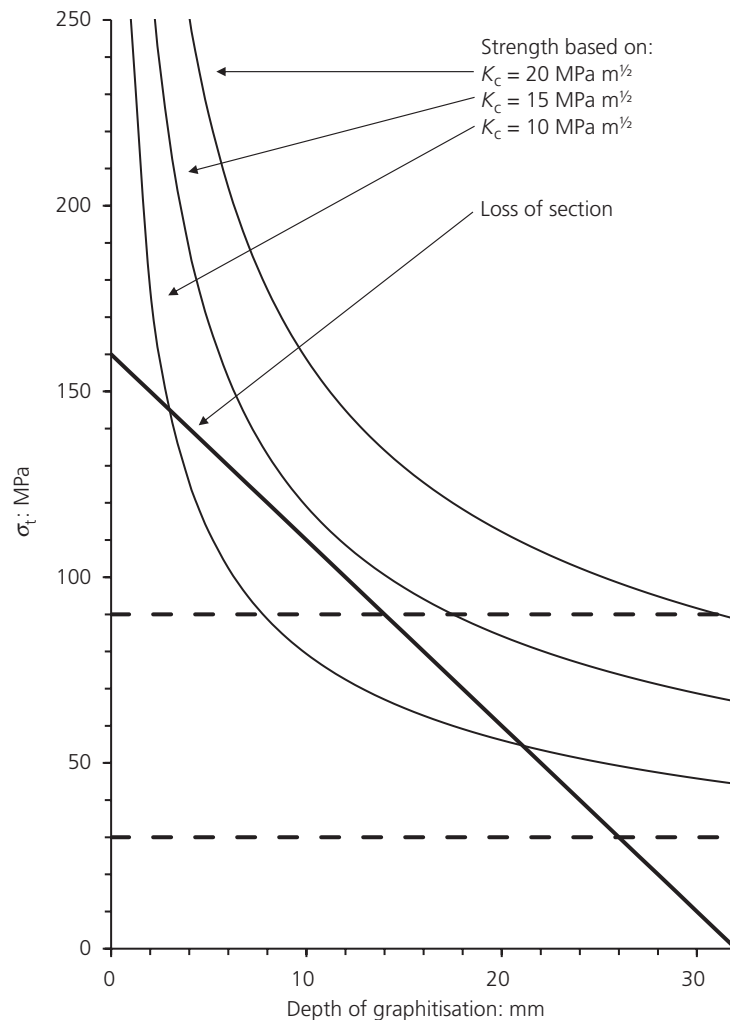
**Figure 6.** Tensile strength as a function of pit depth for progressive graphitic corrosion of a trunk main of wall thickness of 32 mm. The straight line is the prediction based on loss of section, while the curves are based on fracture mechanics analysis for cast irons with fracture toughness values of 10, 15 and 20 MPa m<sup>1/2</sup> and with a ‘thumbnail’ crack. The horizontal lines at 90 and 30 MPa represent two different levels of operating stress (see text)

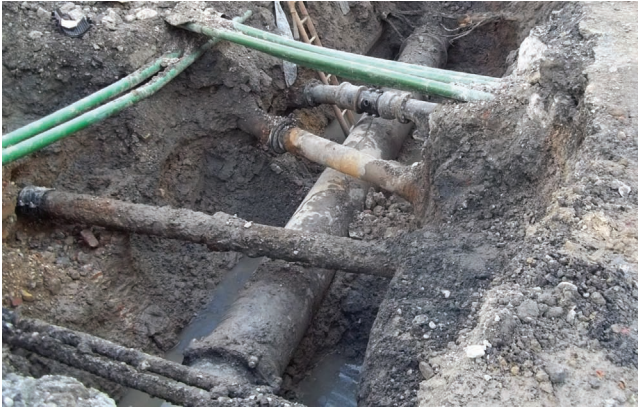
**Figure 7.** An exposed 20 in. (0.508 m) trunk main in situ at Regent Street in central London with several other pipes and services crossing it, showing the restricted space available around a main

Hence, conducting NDE from the outer surface of the pipe is currently preferable, even if it means that the pipe must be excavated for NDE to be conducted. Very often mains are exposed for routine work, which may present sufficient opportunity to assess the mains condition while the excavation is still open. However, this is still not without challenge. An excavation creates a muddy trench and may expose only a small section of main (approximately 1 m long), which is not significantly longer than the pipe’s diameter. This can leave limited access to the surface of the pipe, particularly underneath the pipe (Figure 7). Any NDE method will need to be capable of operating within the clearance around the pipe afforded by the excavation and the neighbouring utilities.
