Briefing Paper

South Stratford Canal

A. Jackson

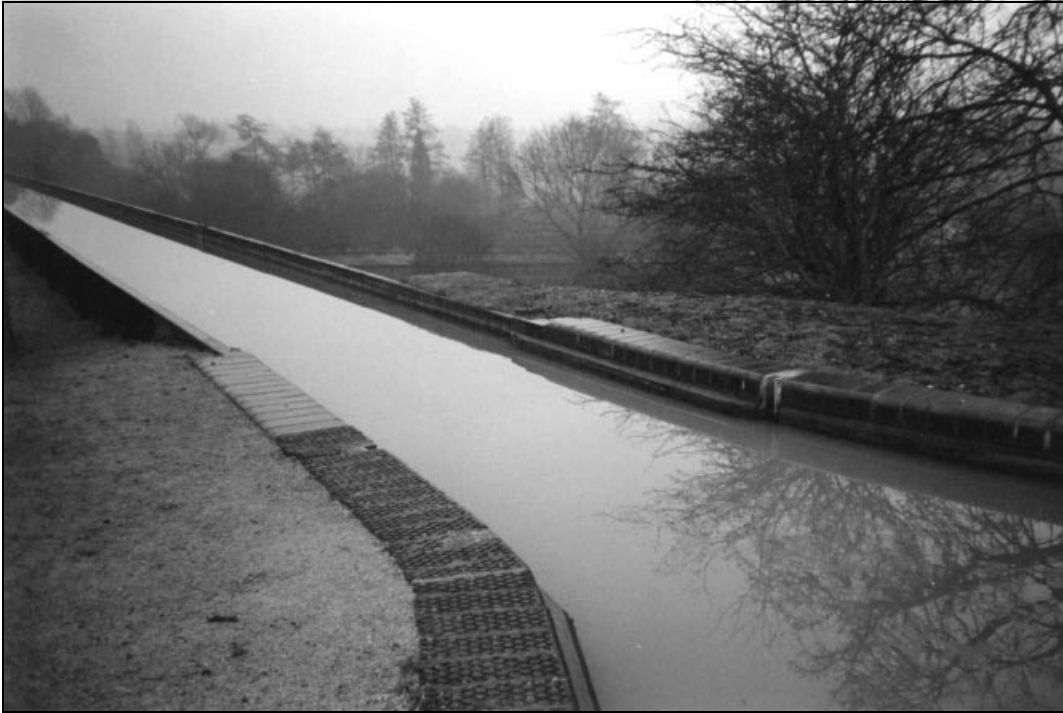
The restoration works to the channel and towpath have been carried out using materials which match those used in the original construction and which present a pleasing and workmanlike result (Fig. 1). However, although the strengthening of the abutment may give an adequate technical solution with a layer of gunite and drainage pipes, it is just as well that it is only seen by the inhabitants of the field and inspecting engineers (Fig. 2).

Fig. 1. Edstone Aqueduct—sympathetic restoration

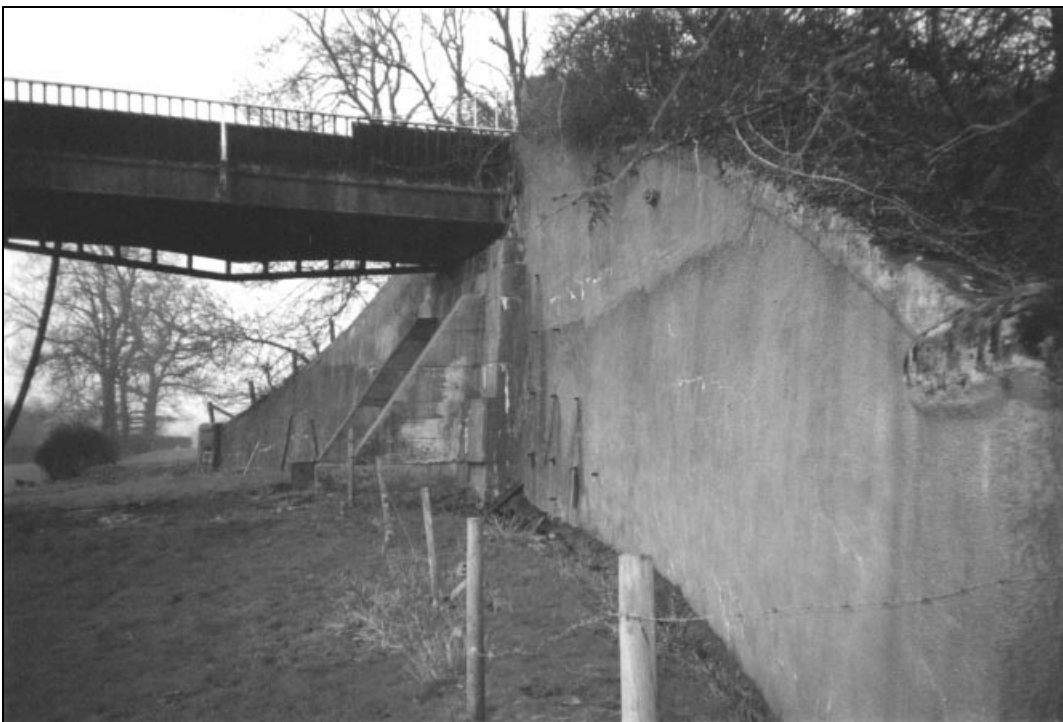
Fig. 2. Edstone Aqueduct—non-sympathetic restoration

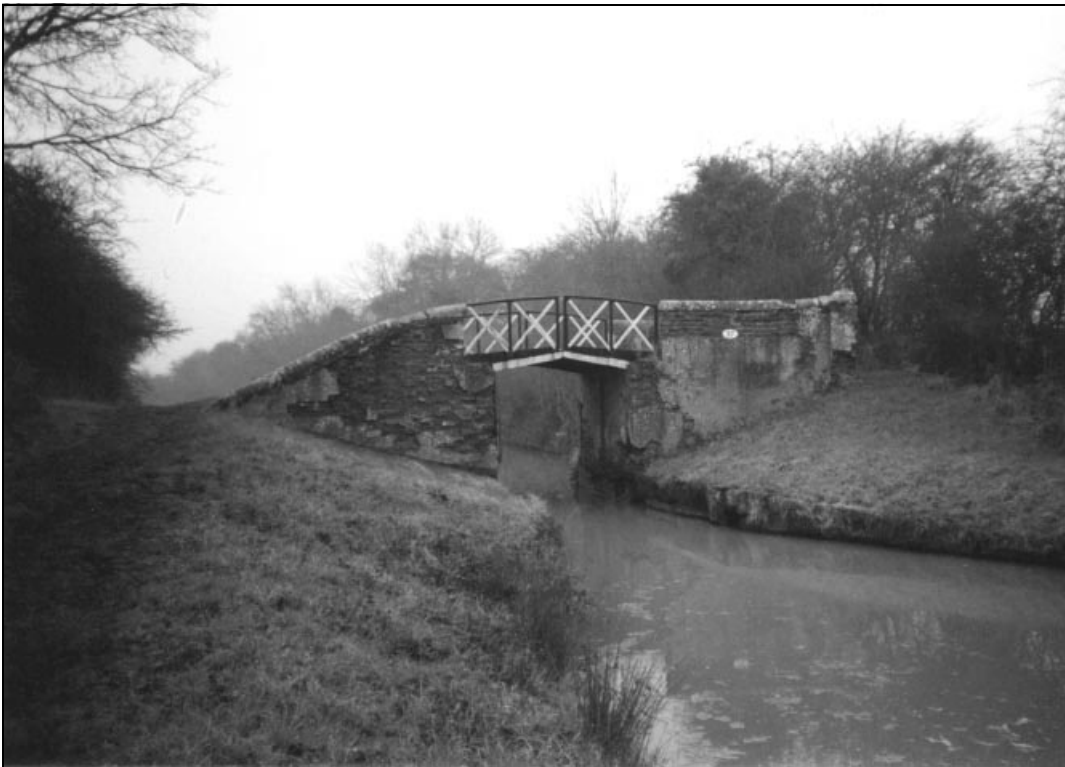
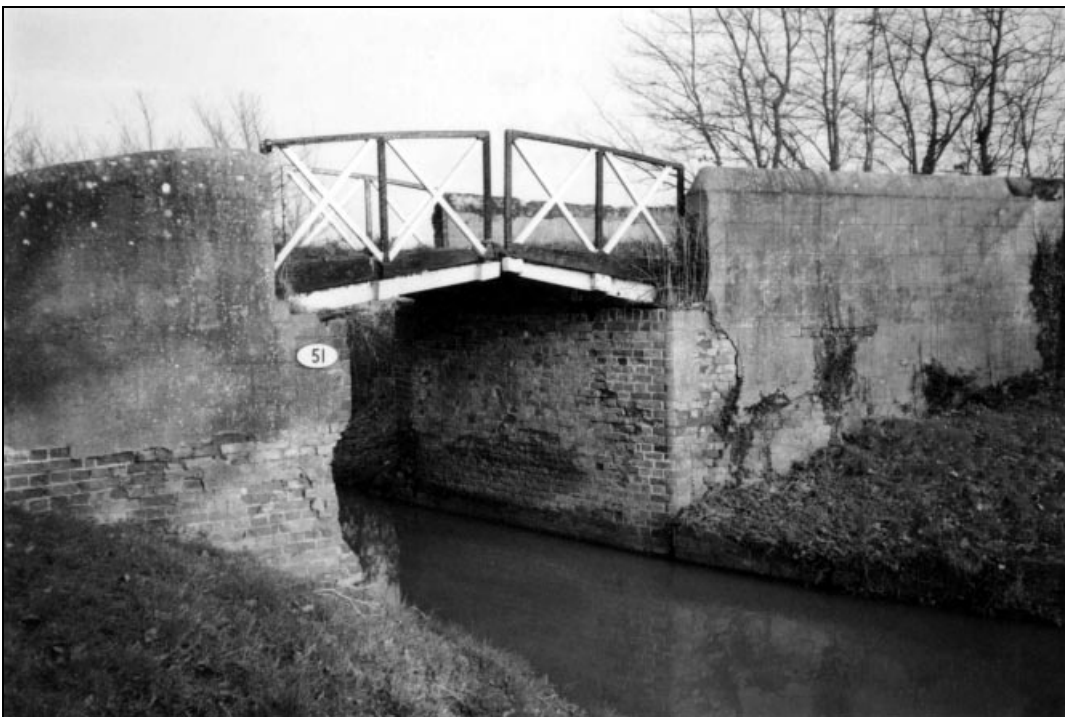
The original bricks used to build these bridges have suffered from frost damage in many locations. In some cases this is apparent over large areas of the elevation and in others it is concentrated in a band where water has permeated through the wall from the retained ground behind the wing walls. In some instances there has also been significant impact damage at the edges of the bridge and at the 'rubbing line' just above water level.

Fig. 3. Packhorse bridge—long-term damage and unsympathetic repair

Fig. 4. Packhorse bridge—long-term damage and unsympathetic repair

applying a mortar render to the brickwork. This has slowed down the deterioration but is unsightly and is now in need of substantial repair itself (Figs 3 and 4).

The current method of repair is to replace the defective bricks with a modern, harder brick and sometimes this can be done as patch repairs and in other locations requires a substantial rebuild (Fig. 5). Considerable research has gone into choosing the correct bricks to maintain the appearance and in specifying the mortar so as not to damage the original bricks along the interface.

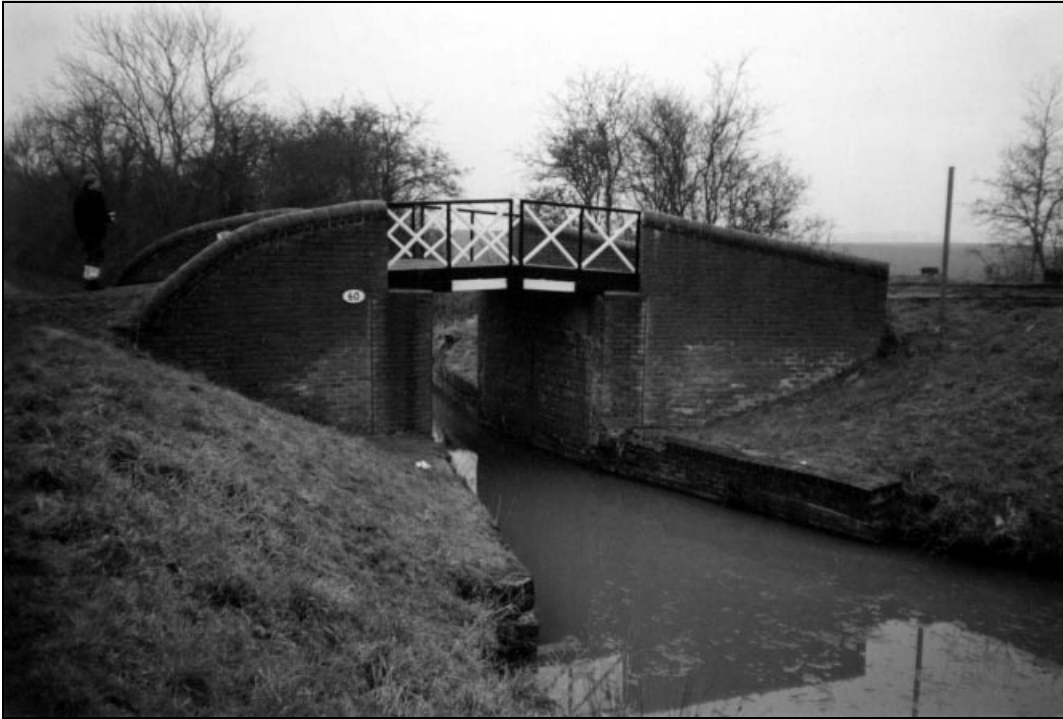
Fig. 5. Packhorse bridge—substantial rebuild

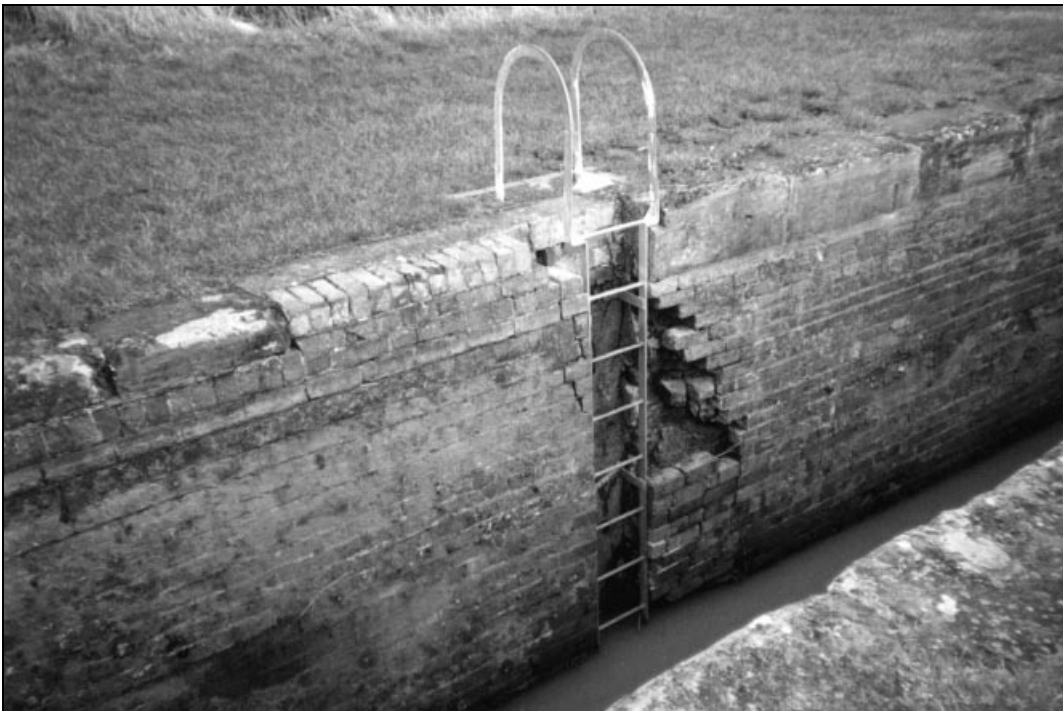
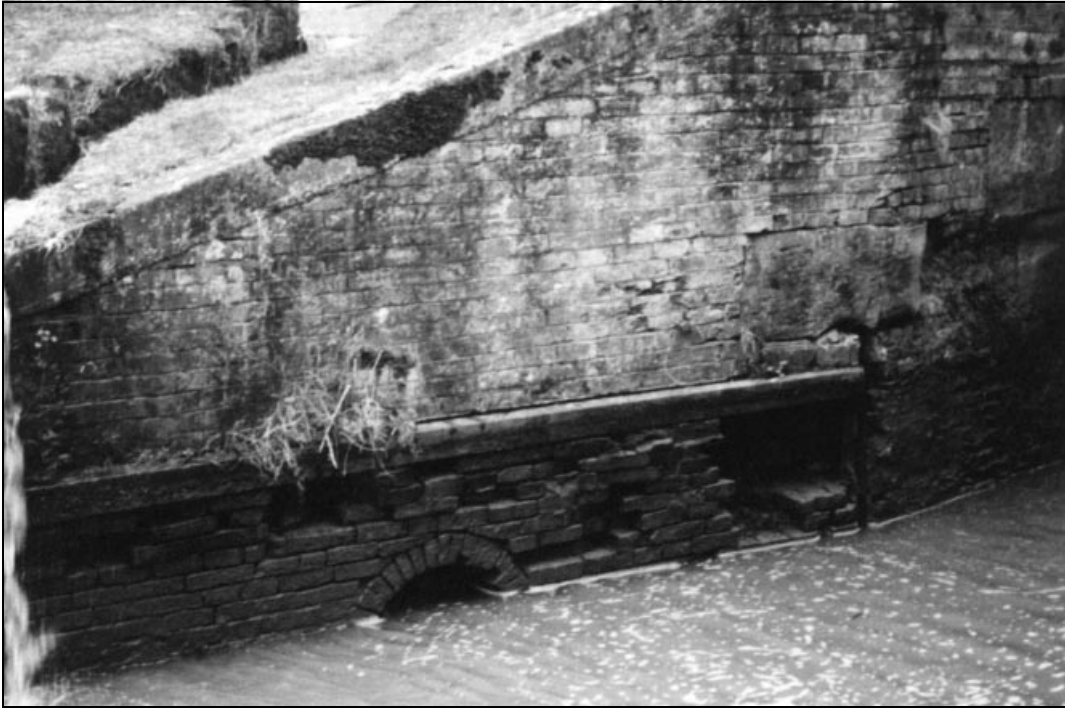
Fig. 6. Failure of unbonded facing skin to lock

Fig. 7. Severe damage above and below water line (lock 50)

brickwork suffered from frost and impact due to the soft bricks and this led to the wholesale repair of many locks by the Trust. The technique used in many instances was to take down the whole of the front skin of brickwork and then replace. Unfortunately, the new brickwork could not be effectively bonded into the remaining mass of the wall and it is now separating to form an independent skin that is one or one-and-a-half bricks thick (Figs 6 and 7).

Techniques are being considered that involve pinning and grouting the front skin but in cases where there are other problems to be addressed then the most cost-effective solution is to replace the defective areas with a fully bonded wall (Fig. 8).

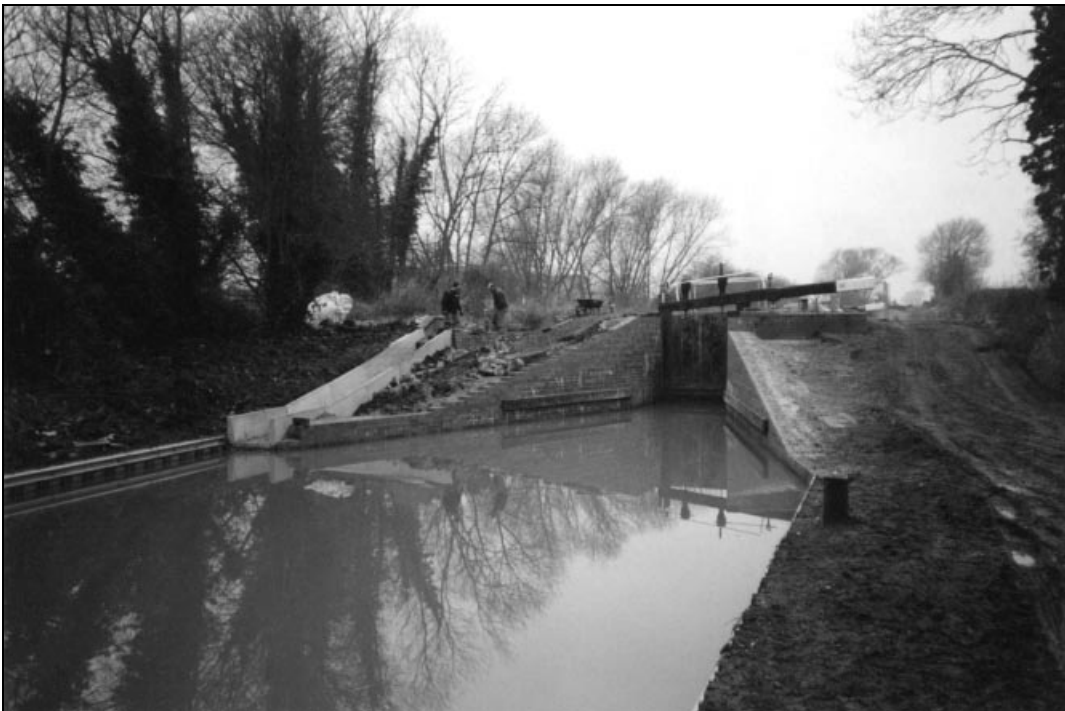
Fig. 8. Major repair of lock walls (lock 50)
