Paper No. 6537

**Three prestressed concrete railway bridges†**

**Frank Turton**

*Discussion*

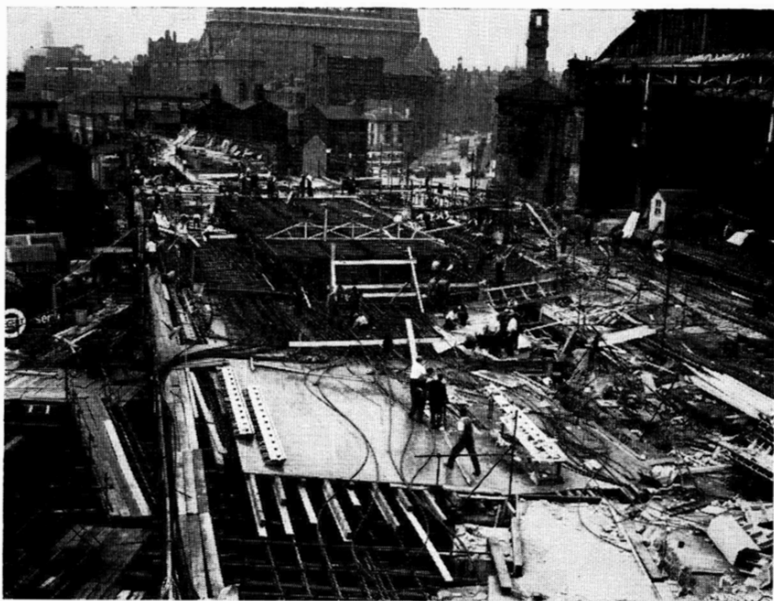
FIG. 18.—FAIRFIELD STREET BRIDGE AT AN EARLY STAGE

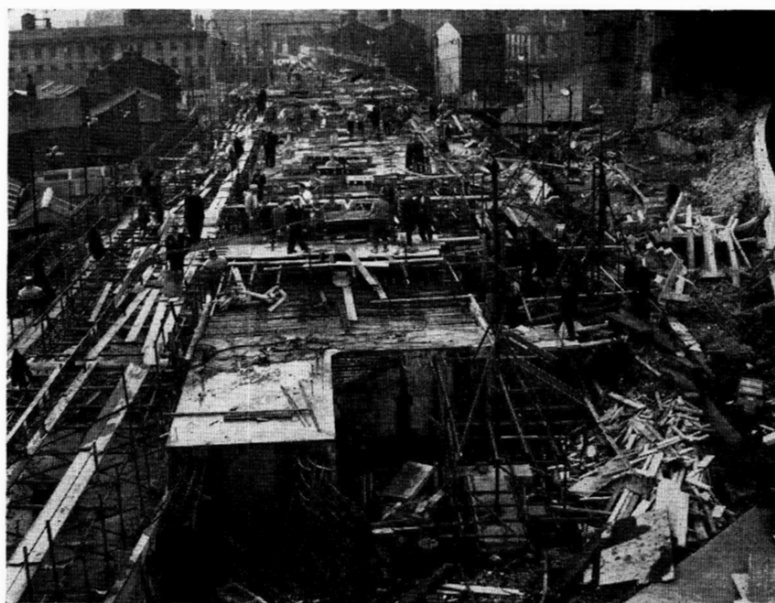
FIG. 19.—FAIRFIELD STREET BRIDGE AT AN ADVANCED STAGE

136. Fig. 19 illustrated an advanced stage in its construction. It could be seen that the bridge was concreted in short bays to reduce shrinkage and to a pattern to load the temporary works evenly. The usual care was taken with the curing and special care was taken to ensure that the stressing wire and cables were free in the ducts after every concreting operation. That was especially difficult for the cables with buried anchorages. To avoid risk of damage, the supervisors had special instructions on the care that should be taken in vibrating the concrete.
