Paper No. 6542

**The Selsey coast protection scheme†**

**Jack Duvivier, B.Sc., M.I.C.E.**

*Discussion*

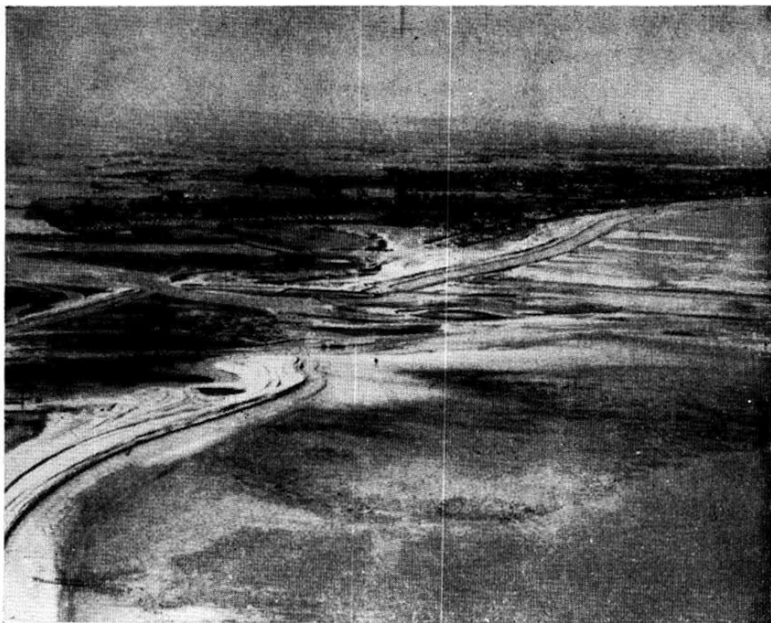
FIG. 23.—PAGHAM HARBOUR MOUTH, AERIAL VIEW JUNE 1959, LOOKING NE FROM SELSEY BILL

158. Fig. 23\* was a photograph of the approach towards Pagham Harbour. The harbour, which was roughly a square mile, had been enclosed in the period 1876 to 1910, but eventually the sea had broken through again in the winter of 1910, and the drainage from the land between there and Chichester now found its way out of various channels out to the sea through the shingle banks.

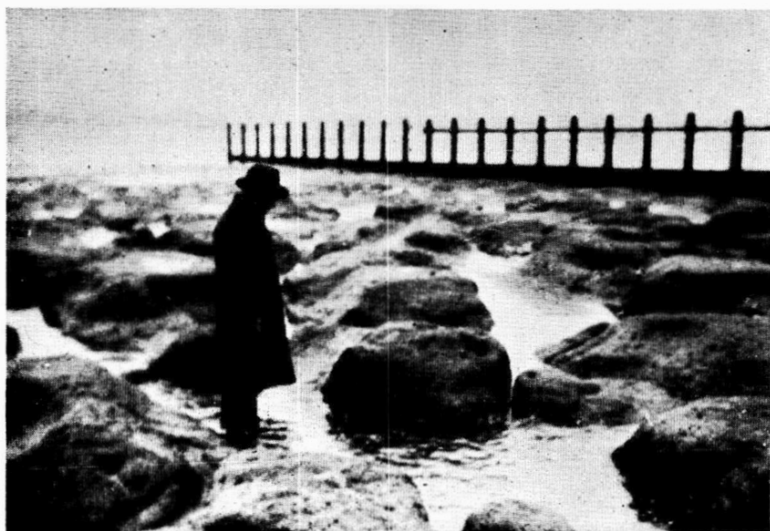
FIG. 25.—FORESHORE SCOUR BETWEEN SELSEY AND BRACKLESHAM

164. The type of foreshore scour experienced on this section of the coast, and referred to in § 95, was shown in Fig. 25, and it could be seen that there was deep scouring in the clay base as soon as the sand was removed. The scouring shown occurred in a matter of two or three tides under extreme conditions.

the lower foreshore became stable, and in a case where the lower foreshore was of erodable material, such as clay, when it reached a level at which it was covered permanently by a thin layer of sand or shingle it remained stable; whereas once it was exposed, as in Fig. 25 which Mr Garland had shown, it could erode extraordinarily rapidly.

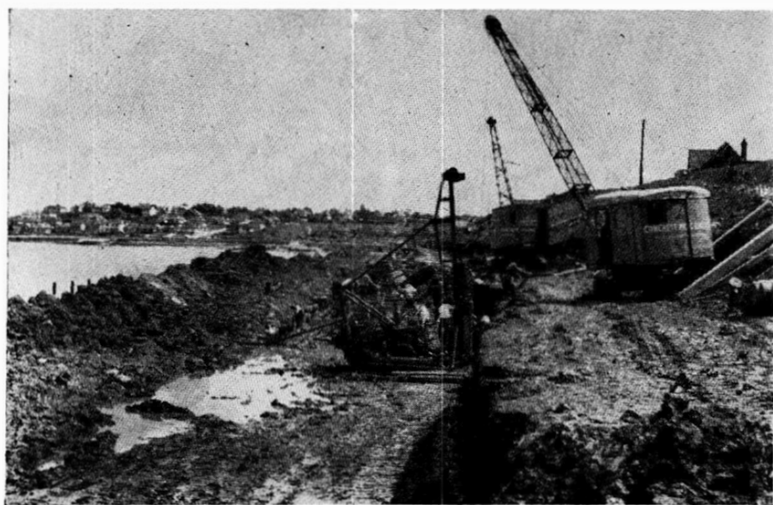
FIG. 28.—HERNE BAY, STUDD HILL, WORK IN PROGRESS BEHIND CLAY BANK

181. Fig. 28. A wall was constructed in front of the cliff and the contractor had used the excavated clay to form a bank to keep out the sea. Owing to the rapid erosion of silty materials, this had proved effective only in very calm weather; as soon as there were any fierce storms, the bank of clay had been completely carried away.

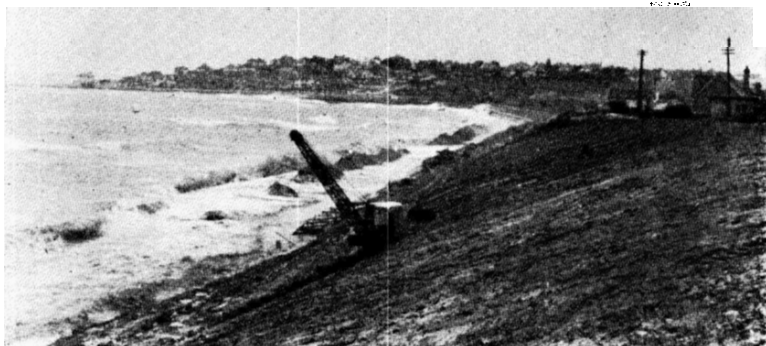
**FIG. 29.—HERNE BAY, STUDD HILL, STORM 16 MAY 1958**

182. Fig. 29. On 16 May, 1958, a very severe storm, of force 9 gale or thereabouts, had blown up from the north, and the contractors' clay bank was severely eroded.

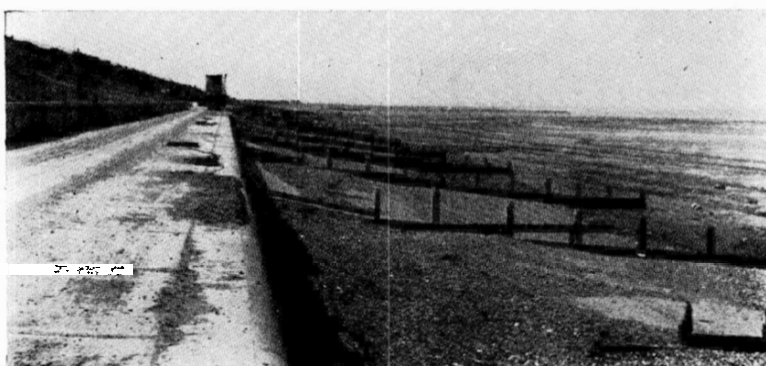
**FIG. 31.—HERNE BAY, STUDD HILL, WORK NEAR COMPLETION SHOWING GROYNES HOLDING SHINGLE BEACH**

184. Fig. 31 showed the work nearing completion. The groynes had been built and the shingle was lying up against the wall. This photograph had been taken at one of the worst points. It showed the groynes holding the shingle over the foreshore, and the state was virtually the same today, two years after the photograph had been taken.
