*Discussion on Paper No. 6588\****Cofferdams**

**Savile Packshaw, B.Sc., M.I.C.E.**

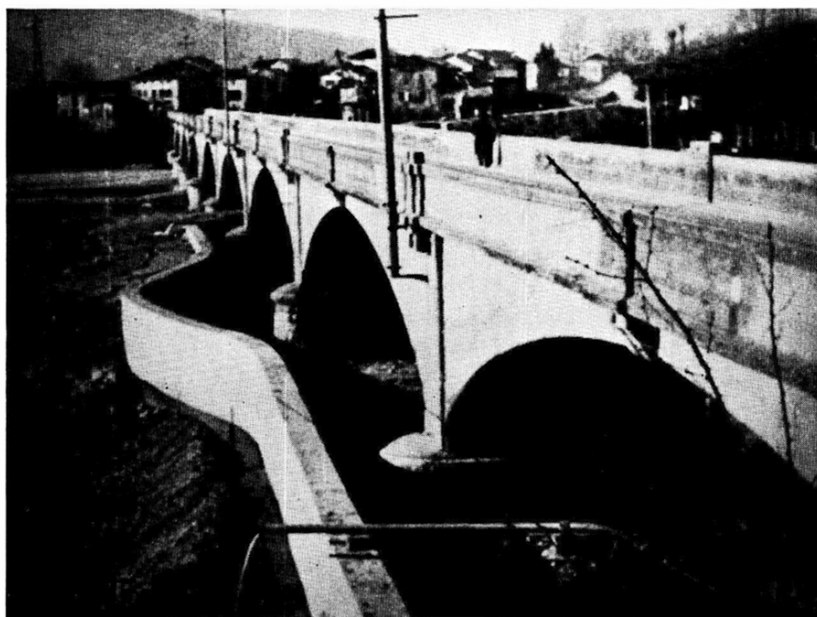
FIG. 50: COFFERDAM PROTECTING FOUNDATION TO OLD BRIDGE AT BUSCHE POWER STATION INTAKE

88. Fig. 50 showed the cofferdam protecting the foundations of the old bridge.

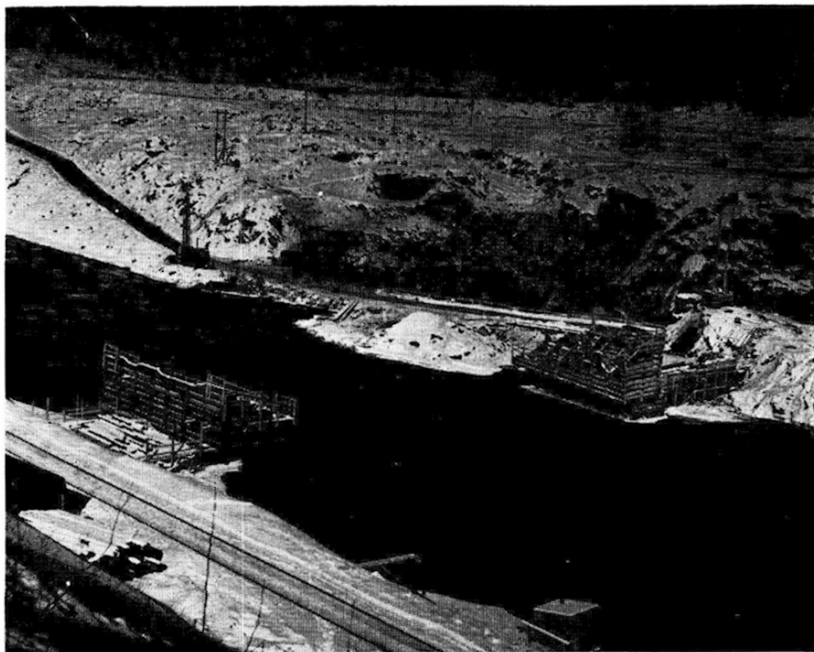
**FIG. 53: ST MAURICE RIVER, BEAUMONT DEVELOPMENT. UPSTREAM COFFERDAM, TIMBER CRIBS BEFORE LAUNCHING**
