DISCUSSION

## London Bridge

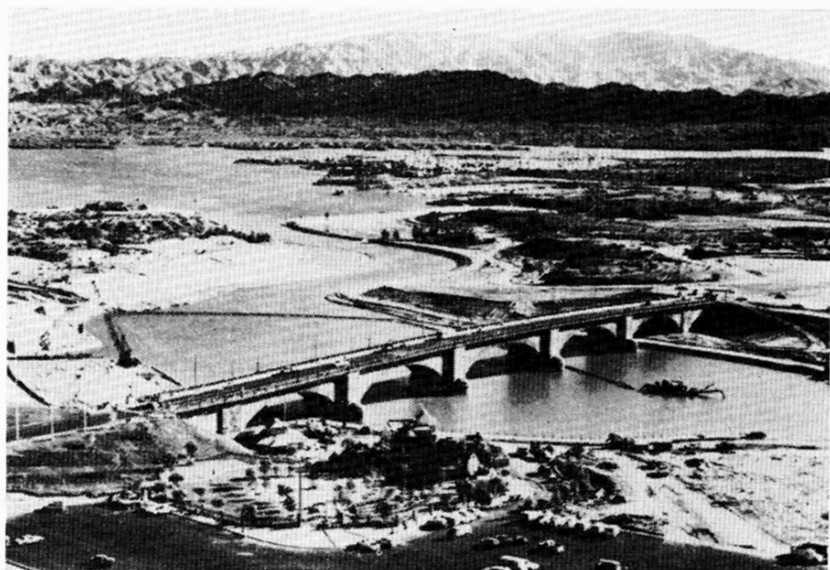
Fig. D7

D60. This initial cavity was later extended until all the arches stood free with a clear 5 ft gap between the soffit and the sand. This technique contrasts strikingly with the methods that Rennie was forced to use by the presence of the Thames. The stonework, amounting to some 10 000 assorted pieces varying between a few pounds and 8½ tons, was assembled well in the circumstances. The erection of the granite facing presented a problem in so far as the Union of Masons' three year working agreement terminated at precisely the point of laying the first stone. Unusual measures were called for while the protracted negotiations continued, and in fact the contract with M. M. Sundt of Tucson was terminated, and the stonework completed under direct labour. Masons were hard to find, but eventually we gained the services

D59. Trouble was avoided by carefully timing the closure of each arch and relieving the passive pressures against the steeper parts of the arch by blowing through with air and water, so effectively loosening the sand at the arch springing points.
