Thermomechanical behavior of Glulam-beam connected to CLT-wall assemblies with steel doweled connections before, during and after fire

Paper type Research paper

Journal of Structural Fire
Engineering
Vol. 14 No. 3, 2023
pp. 365-384
Emerald Publishing Limited
2040-2317
DOI 10.1108/JSE-02-2022-0007

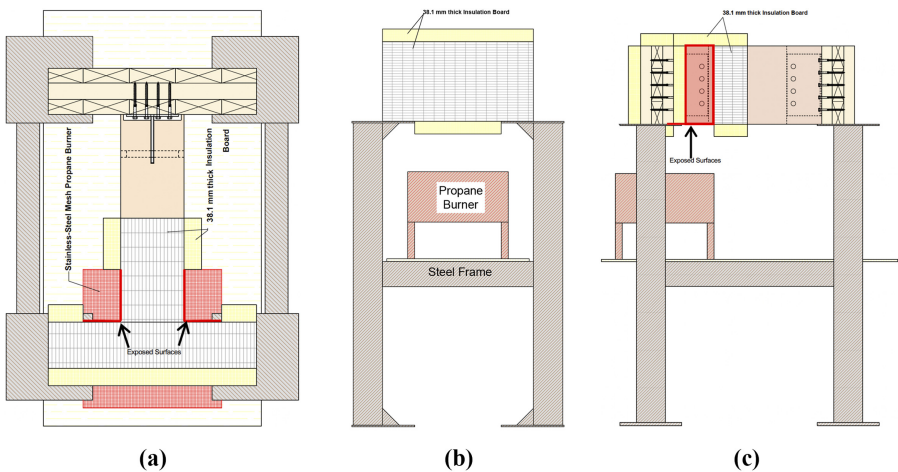
Figure 5.
PFP fire test set-up,
(a) top view, (b) side
view and (c) front view

Plate 1, Figure 5 and 6 show the experimental setup for the AT, PFP and FP tests performed on the Glulam-beam to CLT-wall connections. AT experiments considered only mechanical load on the assembly that was imposed by a SATEC uniaxial testing machine (UTM), PFP tests considered sequential (uncoupled) thermal and mechanical loading, and FP tests considered coupled thermal and mechanical loading. PFP tests were performed after 30 (PFP30) and 60 (PFP60) min of nonstandard fire loading. FP tests were performed with a constant load applied, equivalent to 65% of the AT capacity of the assembly, along with a nonstandard fire exposure. Additional detailed information on the test set-up is provided in related research (Shabani and Braxton, 2022).

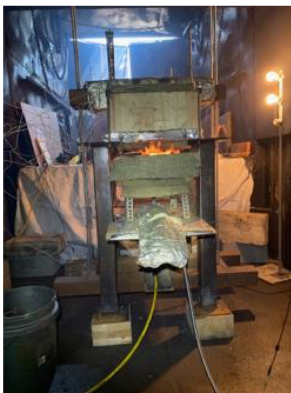
Figure 13.
Heat distribution along the exposed area of the assembly during FP test

The FP tests were conducted to study the fire resistance (FR) of a loaded assembly partially exposed to a non-standard fire. The sample was loaded with a constant downward load of 110 kN at the mid-span of the Glulam-beam during the fire test. Figure 13 shows the heat distribution along the exposed area of the Glulam-beam during the fire test. According to this figure, the Glulam-beam ignited after 2 min. During FP test, the temperature of the burner was held constant at approximately 650 °C. Although, the beam bottom temperature increased up to 760 °C and decreased afterward when the

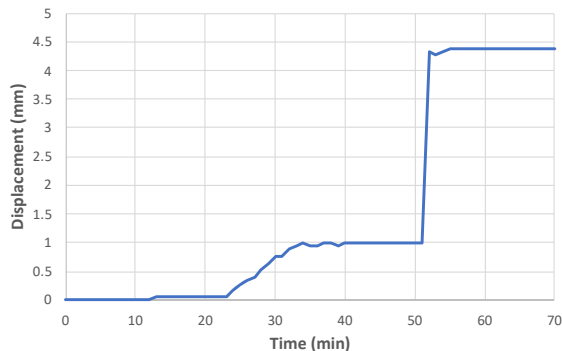
Figure 14.
(a) FP test set-up,
(b) time-displacement
at the mid-span of the
Glulam-beam

According to Figure 14 and based on the visual observation, the maximum displacement of the sample occurred 51 min into the non-standard fire exposure. The maximum rate of displacement occurred at this time, and it was 3 (mm/min). At 51 min into the fire, the average temperature recorded over the steel connection was approximately 480 °C, at this temperature, the steel is expected to maintain 80% of its AT yield strength and 58% of its AT elastic modulus based on Eurocode prescribed reduction factors for the properties of steel at elevated temperatures. While the mechanical properties of the steel connection were degraded, the reserve capacity of the connection prevented failure within the connection itself.
