# A model test on an open-cut tunnel structure under the effect of a stick-slip normal fault

Zhiqiang Zhang, Xingyu Zhu and Ronghua Wei

School of Civil Engineering, Southwest Jiaotong University, Chengdu, China and  
Key Laboratory of Transportation Tunnel Engineering, Ministry of Education,  
Southwest Jiaotong University, Chengdu, China

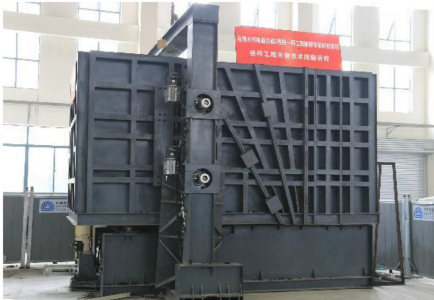
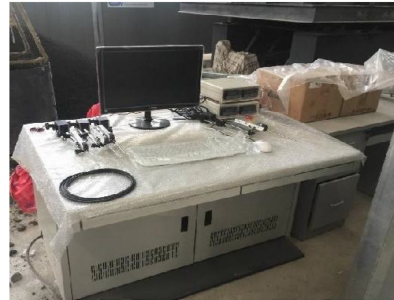
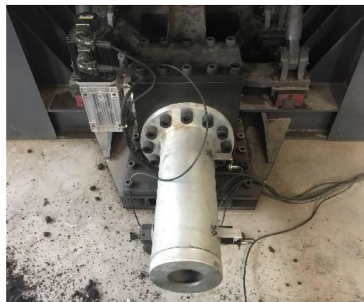
Test system to simulate loading and fault rupture  
(a)

Data acquisition and loading control system  
(b)

High-speed screw loading system  
(c)

**Figure 5.**  
Images of the test device and components for simulating loading and fault dislocation

The model test system was designed to simulate loading and fault rupture (as shown in Figure 5a), which was monitored with a data acquisition and loading control system (as shown in Figure 5b). The loading model test system was mainly composed of the box body,

a vertical screw loading device, a horizontal screw loading device, a thrust transmission device, a reaction frame and a base. The box body of the device ( $5 \times 2.5 \times 2.5$  m) was provided with shear-slip joints of  $60^\circ$ ,  $75^\circ$  and  $90^\circ$ . The bottom of the box was the base; and a reaction frame was fixed onto the base on both sides of the box. The high-power-high-speed screw loading system was installed underneath the bottom plate of the left footwall box body (as shown in Figure 5c), which caused the box body to move along the preset shear joints. The supporting computer digital servo control system controlled the screw loading rate and recorded the loading-time history curve. The system device had the following characteristics: (1) The large proportions and the size of the test device realized the coverage of the fault hanging wall, the footwall and tunnel structure within 125 m of the longitudinal range of the tunnel, ensuring the monitoring of the affected area of strata and tunnel structure under the simulation of fault dislocation, and provided better boundary conditions. (2) It realized multi-angle fault dislocation, and in the process of dislocation, the high-speed screw loading system provided a high-speed and stable loading rate, and the data acquisition system realized real-time monitoring of test data.

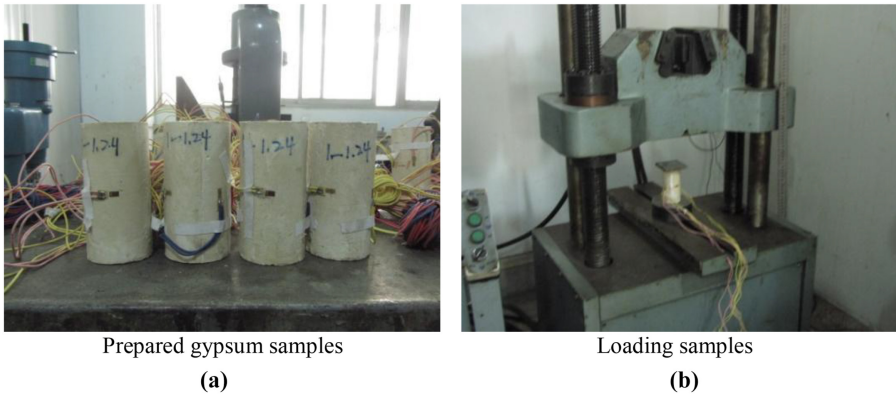
Figure 6. Testing the gypsum samples

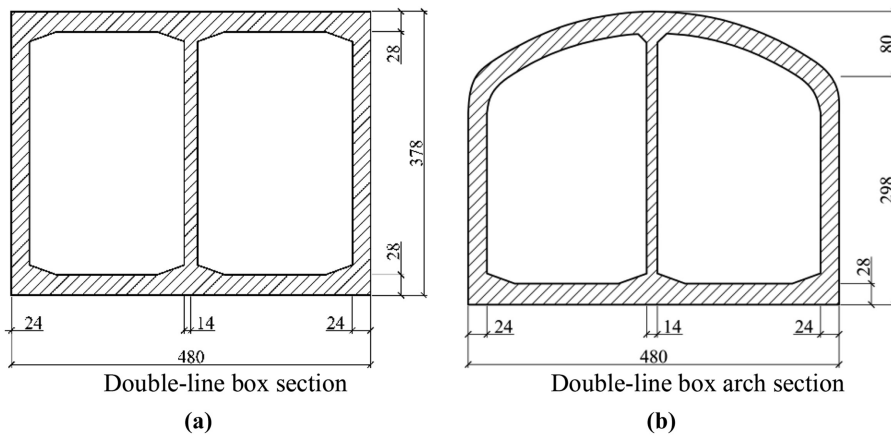
**Figure 7.** Size of the cross sections (unit: mm)

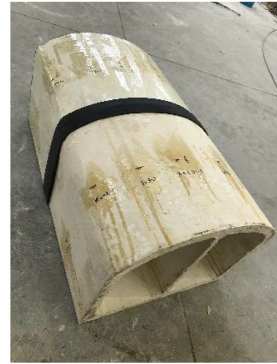
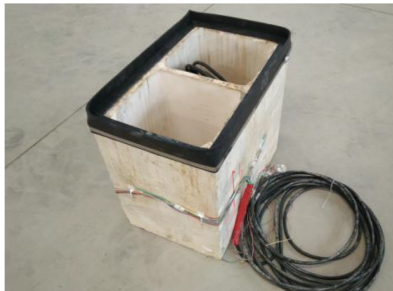
Special “T”-type rubber waterproof belt

Double-line box arch tunnel

Double-line box tunnel

In this model, two comparative test conditions using a double-line box section tunnel and an improved double-line box arch section tunnel were designed and conducted (as shown in Table 3). The longitudinal length of the plaster tunnel model was divided into 24 cm and 36 cm segments, and the T-section rubber ring was used to connect each segment (as shown in Figure 9). The rubber material was the same as the actual project EPDM (Ethylene Propylene Diene Monomer) rubber, and the material strength was customized by the manufacturer according to similar theoretical requirements. This special flexible, joint water-stop belt had strong elasticity, good water insulation, corrosion resistance and other advantages (see Table 4 for physical and mechanical parameters). It was applied to simulate the flexible hinged mode and water-stop belt connection between the sections and constituted a complete tunnel model with a total length of 5 m.

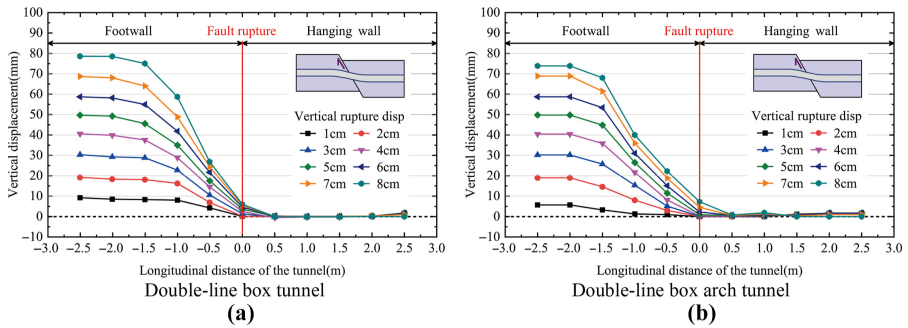
Figure 12. Surface displacement curve

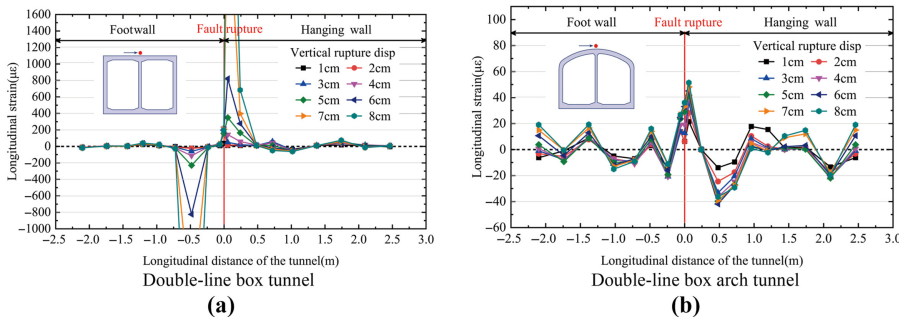
Figure 14. Longitudinal strain curve outside vault

Figure 14b gives the distribution curve of the longitudinal strain outside the vault of the double-line box arch tunnel. The longitudinal strain of the vault fluctuated violently near the fault and increased rapidly in the range -0.24-0.24 m (-0.5-0.5 D) from the fault trace, indicating that the region was the main longitudinal tensile area of the vault, and the maximum longitudinal strain occurred at 0.06 m (0.125 D). When the fault distance reached 8.0 cm (actual 2.0 m fault distance), the longitudinal strain reached the maximum value of 52  $\mu\epsilon$ ; in the range 0.24-1.0 m (0.5-2.1 D) from the hanging wall to the fault trace, the strain value was significantly reduced and negative. The larger the offset, the smaller the strain value, indicating that the region was the main longitudinal compression area of the vault; the minimum longitudinal strain appeared at 0.06 m (0.125 D), and the minimum was -42  $\mu\epsilon$ .

Compared with the double-line box tunnel, the peak strain of the double-line box arch tunnel was significantly reduced. The ultimate tensile strain of 106  $\mu\epsilon$  was used as the tensile failure standard. The analysis demonstrated that the longitudinal tensile strain of the double-

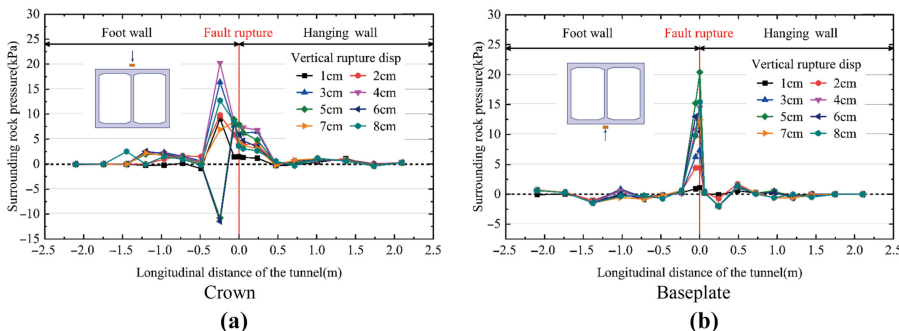
Figure 18. Pressure curve of rock surrounding the double-line box tunnel

Figure 18 shows the variation curves of the surrounding rock pressure along the longitudinal position of the crown and the baseplate of the box tunnel. As seen in the figure, the surrounding rock pressure of the crown increased rapidly in the range  $-0.5$ — $-0.25$  m ( $-1.04$ — $-0.52$  D), and the maximum value appeared at  $-0.24$  m from the fault trace in the footwall. With the increase in the offset, the peak value of the surrounding rock pressure was also larger. When the offset reached 4.0 cm (the actual 100 cm offset momentum), the maximum value reached 20 kPa. With the further increase in the offset, the soil on the tunnel in the fault zone was loosened and voided from the influence of the fault movement, resulting in the rapid

decrease in soil pressure. When the offset reached 6 cm (the actual offset was 150 cm), the soil pressure dropped to the minimum value of  $-11.5$  kPa.

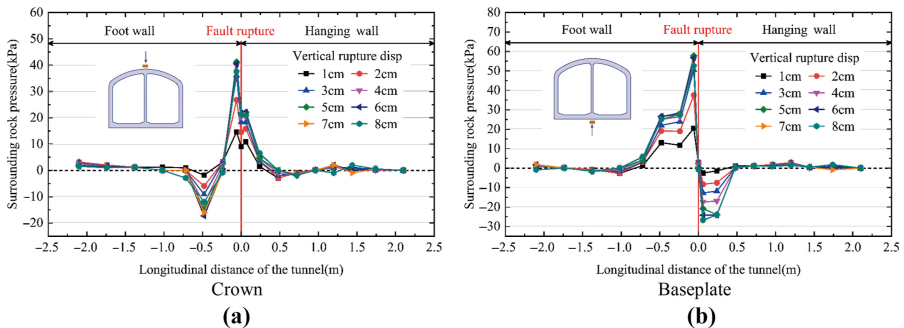
Figure 19. Pressure curve of rock surrounding the double-line box arch tunnel

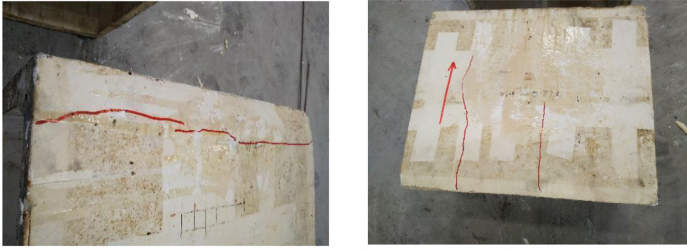
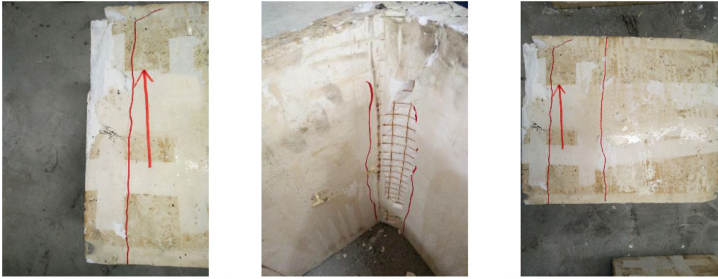
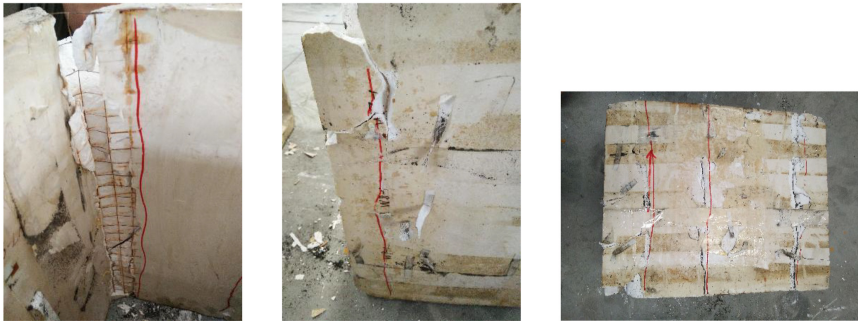
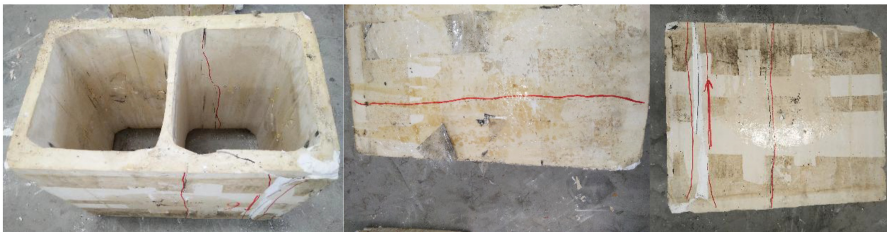
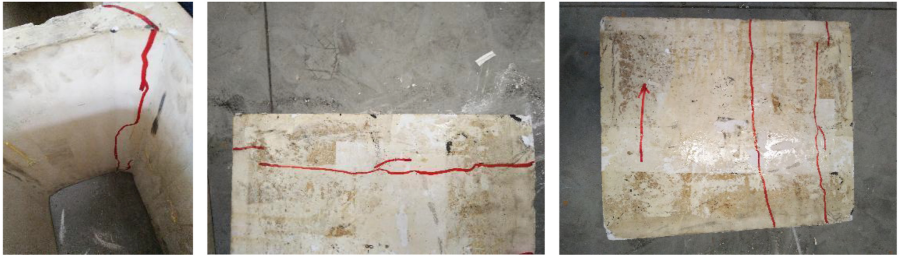
**Figure 20.**  
Tunnel segment  
cracking

Cracked segment of lining structure (7#)  
**(a)**

Cracked segment of lining structure (8#)  
**(b)**

Cross-fault cracked section of lining structure (9#)  
**(c)**

Cracked segment of lining structure (10#)  
**(d)**

Cracked segment of lining structure (11#)

Cracked segment of lining structure (12#)

4.5.1 Double-line box tunnel. Figure 20 shows the damage pattern of the double-line box tunnel lining at the end of the test. According to the distribution of tunnel cracks, the continuous crack expansion diagram of each segment is drawn, as shown in Figure 21. The crack pattern, number of cracks and crack locations are summarized in Table 5.

- (1) Cracks appeared in the #7–#12 segments of the tunnel lining, with only longitudinal cracks.

- (2) The largest number of cracks and the most serious damage were found in the #9 segments, which were affected by the direct shear of the fault surface.
- (3) The longitudinal crack depth was the largest in the #9–#10 segments, and there were many fractures along the longitudinal cracks. The longitudinal fractures were mainly concentrated at the intersection angle of the middle wall with the baseplate and roof, accompanied by a large number of spalling blocks and obvious exposure of the reinforcement mesh. There were also obvious longitudinal cracks at the middle wall. Since the middle wall and multiple right-angle structures improved the shear and

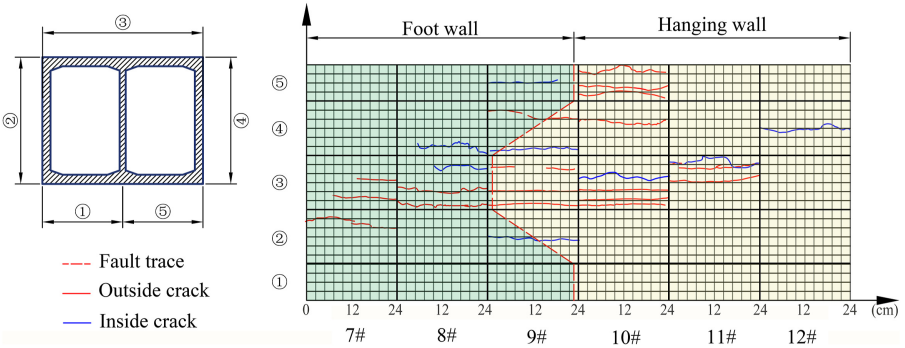
Figure 21.  
Tunnel crack  
expansion diagram

It can be seen from Figures 21 and 23 that the damage degree of the double-line box tunnel is obviously serious compared with the double-line box arch tunnel. The length and number of

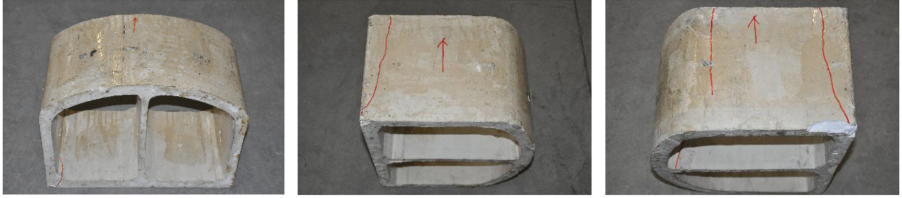
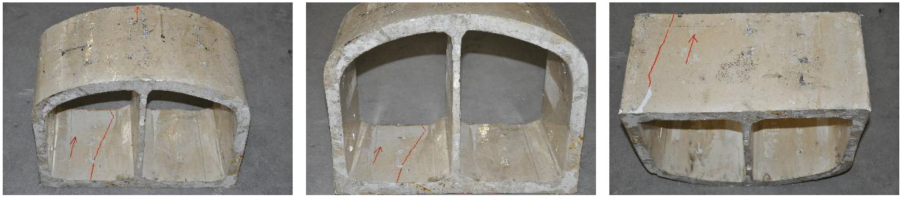
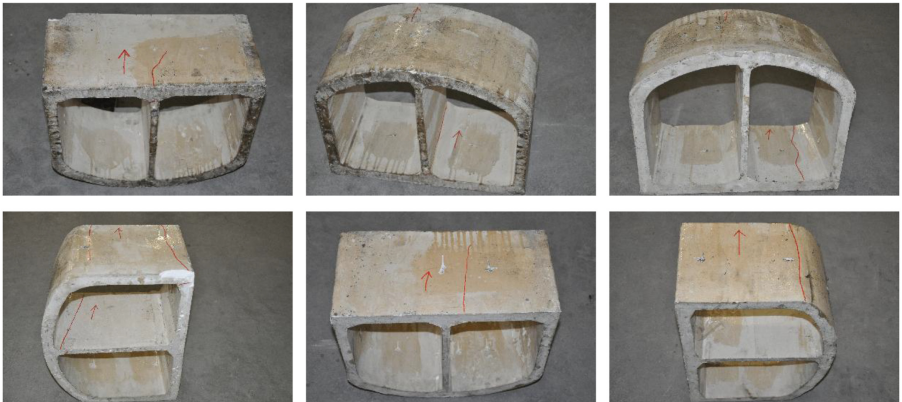
Figure 22.  
Tunnel segment  
cracking

Cracked segment of lining structure (7# ~ 8#)

Cross-fault cracked section of lining structure (9#)

Cracked segment of lining structure (10# ~ 12#)

**4.5.2 Double-line box arch tunnel.** Figure 22 shows the damage pattern of the structure of the double-line box arch tunnel at the end of the test. According to the distribution of tunnel cracks, the continuous crack expansion diagram of each segment is drawn, as shown in Figure 23. The crack pattern, number of cracks and crack locations are summarized in Table 6.

- (1) Cracks appeared in the #7–#12 segments of the tunnel lining, with longitudinal cracks dominating. The cracks mainly appeared on the inside and outside of the baseplate, the outside of the wall foot and the outside of the arch foot.

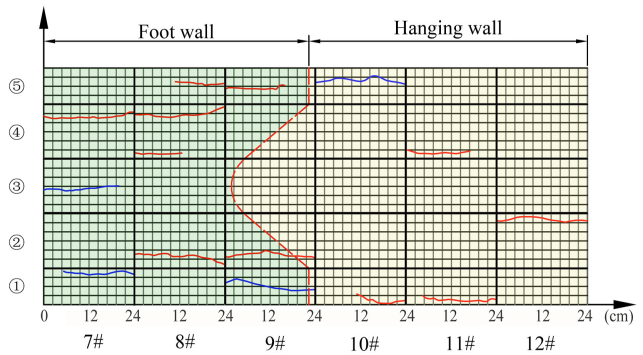
Figure 23.  
Tunnel crack  
expansion diagram

cracks in the lining failure are much larger than those in the double-line box arch tunnel. The failure segments of the double-line box arch tunnel are mainly concentrated in 8#, 9# and 10#, while the failure segments of the double-line box arch tunnel are mainly concentrated in 7#, 8# and 9#. In terms of fracture morphology, the longitudinal fracture is the main failure mode of the two sections of tunnels, which indicates that the failure mode is the large eccentric tensile failure. In practical engineering, it should be considered to add the circumferential reinforcement.
