The impact of metal cleaning agents on components of air conditioning piping systems in EMUs

Railway Sciences

Paper type Research article

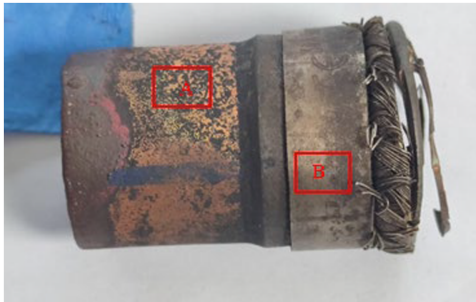
Figure 2. Corrosion sample of air conditioning copper tube. **Source (s):** Authors' own work

The corrosion test specimens of air conditioning copper tube were sourced from Changsha EMU Depot, measuring 40 × 20 mm. Section A represents the tail end of the copper tube, while Section B denotes the head end, as illustrated in Figure 2. The high-pressure shock-absorbing hose for air conditioning compressors was procured from Beijing Zhuoxu Company, measuring 50 × 2 cm, as shown in Figure 3.

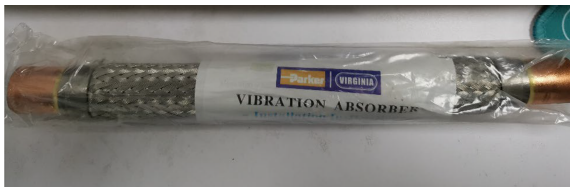
Figure 3. High-pressure shock absorber hose. **Source (s):** Authors' own work

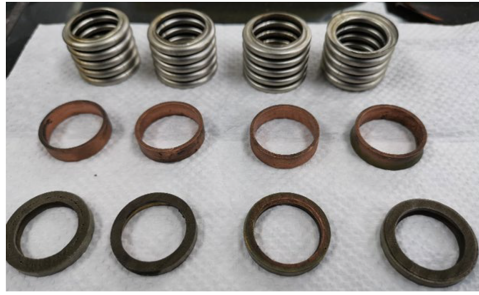
Figure 4. Appearance of the sample after cutting the suspension hose of the air conditioning unit. **Source (s):** Authors' own work

Following GB/T1690-2010 “Test Methods for Resistance of Vulcanised Rubber or Thermoplastic Rubber to Liquids” (National Standardization Administration, 2011), the high-pressure shock-absorbing hose of an air conditioning compressor was sectioned into 3 components: corrugated hose (304 stainless steel), pressure-bearing section (carbon steel), and copper tube (TP2 deoxidised copper). Each section underwent full immersion testing in cleaning agents, as illustrated in Figure 4 and detailed in Table 1.

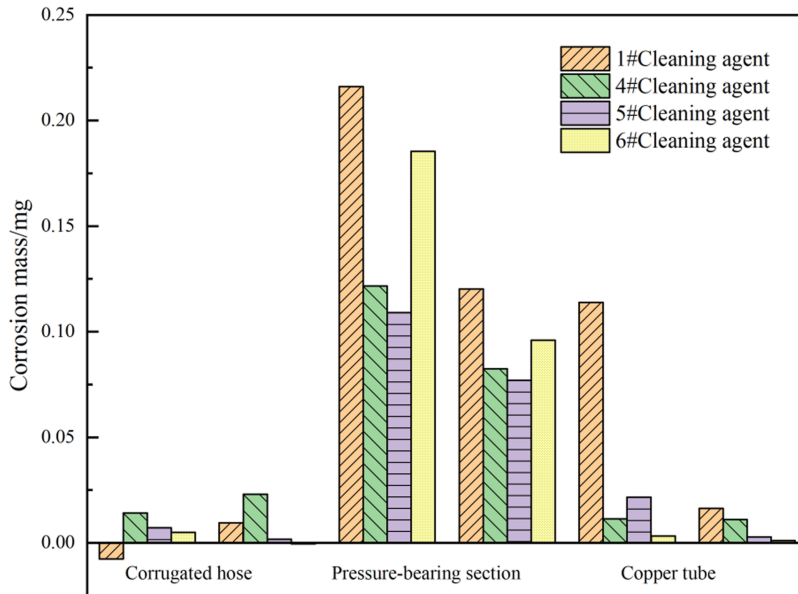
Figure 11. Changes in corrosion quality. **Source (s):** Authors' own work

It is also evident that the cleaning agent exerts a significantly greater impact on the pressure section (carbon steel) than on the corrugated hose (304 stainless steel) and copper tubing, as illustrated in Figure 11. Due to the higher chromium content in 304 stainless steel, the corrosion resistance of the stainless steel surface relies on the passivation film Cr_2O_3 formed by chromium. This film layer effectively isolates the corrosive medium from the base metal
