Kawajiri S, Kawaguchi T, Ogasawara A, Minabe Y and Nakamura D (2025)
Geotechnical characteristics of levees subjected to sand boil due to high water levels.
Geotechnical Research **12(1)**: 29–42,
<https://doi.org/10.1680/jgere.24.00020>

Geotechnical characteristics of levees subjected to sand boil due to high water levels

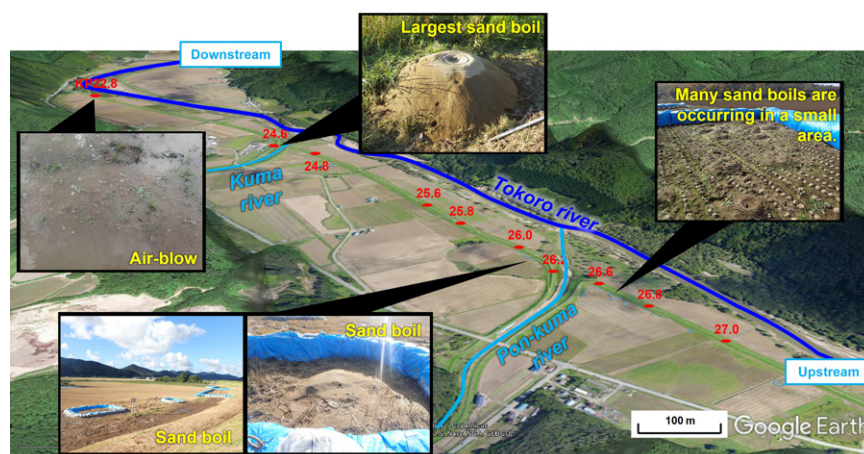
Figure 2 shows the locations within the Hiyoshi and Fukuyama regions of Tokoro-cho, Kitami City, and Hokkaido, where river levee deterioration due to sand boils was particularly concentrated. The annotation 'K.P.' in the figure indicates the distance from the river mouth, which is set to '0.0 km'. As shown, the Tokoro River meanders through a mountainous terrain, traversing a constricted pass. Consequently, the river channel typically spans a width of 100–200 m narrower than its upper and lower reaches, with the

Figure 2. Sand boil locations in Hiyoshi and Fukuyama areas, Tokoro-cho (additions to Google Earth)

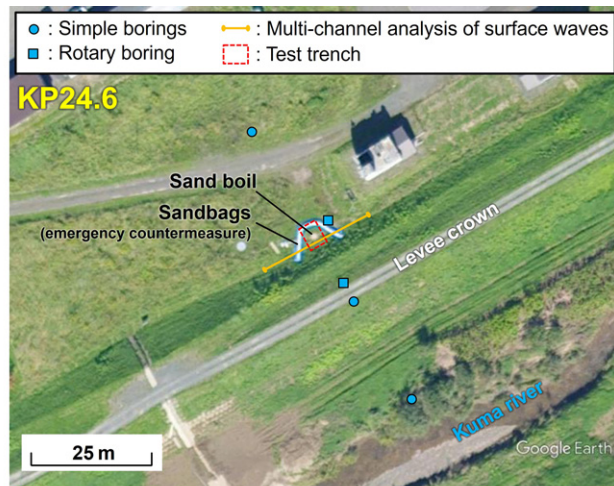
Figures 4(a) and 4(b) show the plan view of the sites designated for geotechnical investigations and the comprehensive details of said investigations, respectively. Notably, a sand boil, measuring approximately 2.0 m in diameter and 0.5 m in height, emerged at the slope toe on the landside near KP24.6, representing the largest among those engendered within the Tokoro River during the 2016 flood. A meticulous survey was conducted at this locale to discern the soil profile traversing the transverse axis of the levee, with the specific objective of elucidating the provenance of the sand boil. Simplified and rotary boring techniques were employed to probe landside, riverside soils, and levee foundations. After sample acquisition from sand boils and boreholes, a subset underwent particle size analysis to augment the investigative scope.

Figure 4. Summary of geotechnical investigation locations and survey contents. (a) KP24.6. (b) KP26.2

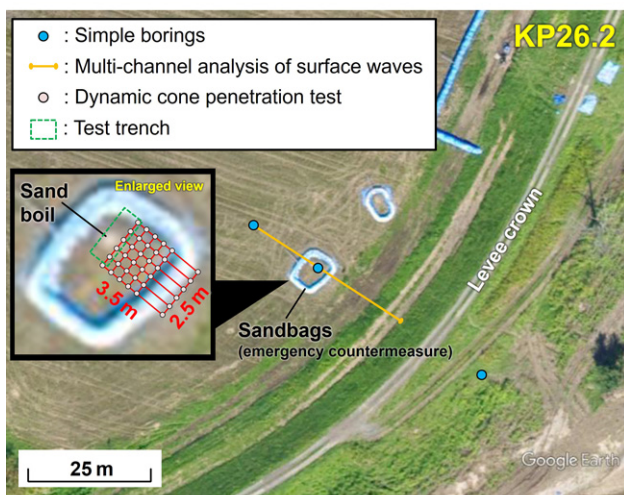
(b)

Around KP26.2, sand boils, measuring approximately 1.5 m in diameter and 0.3 m in height, manifested at a distance of roughly 8 m from the slope toe on the landside, indicative of a distinctive occurrence pattern compared with that observed at KP24.6. Concurrently, simplified boring operations were undertaken at this site to elucidate the genesis of the sand boils predicated upon the lateral soil composition of the levee. Moreover, to facilitate a more direct assessment of the geotechnical attributes of the ground surrounding the sand boil epicentre, measurement points were strategically positioned at 0.5 m intervals (occasionally 1.5 m intervals) within a delineated area measuring 2.5 m × 3.5 m, spanning between the site of sand boil occurrence and the sloping toe on the landside of the levee. A dynamic cone penetration test (DCPT) was conducted at this measurement point. In this study, the DCPT measures the blow count (N_d value) required to penetrate a 25 mm diameter cone 100 mm with a 5 kg weight dropped

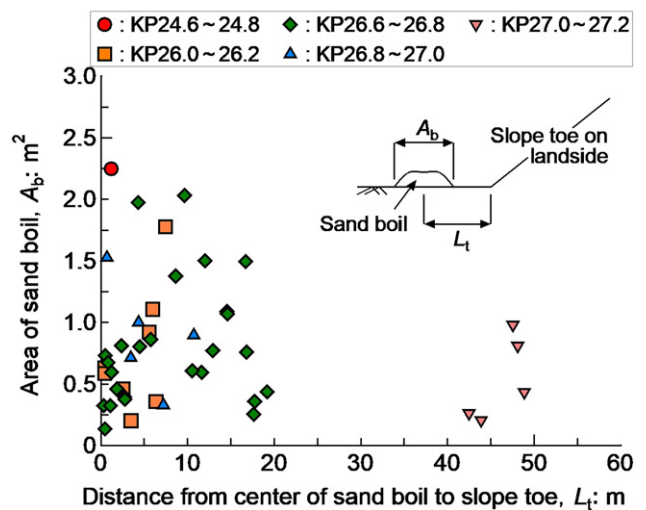
Figure 7 shows the correlation between the area of the sand boil, A_b , and the distance from the toe of slope at the landside to the centre of the sand boil, L_t , concerning the slope toe on the landside across various KP designations. While it would be desirable to employ indices such as eruption volume or mass for gauging eruption scale, the challenge of ascertaining elevation from orthophotographs necessitated the adoption of sand boil area as a surrogate metric. Although caution is required because the amount of data is not uniform, the relationship between A_b and L_t differs for each KP. In KP27.0–27.2 and KP26.8–27.0, there was a tendency for A_b to increase as L_t decreased. In these KP, it was possible to predict that sand boils would occur due to a simple mechanism, as shown in Figure 1. In other words, large-scale sand boils were observed at the toe of the landslide, where water pressure is easily released. On the other hand, at KP26.8–27.0 and KP26.6–26.8, small-scale sand boils with small A_b values were observed, especially near the toe of the landside slope. This result suggests that the occurrence of sand boils is influenced by complex underground structures that differ from the simple mechanism shown in Figure 1. The differences in the relationships between A_b and L_t shown above may be due to the influence of the levee's height and geological structure. However, detailed data sets were not available for the levee's height. Therefore, this study focused on the influence in geological structure.

Figure 7. Relationship between the area of the sand boil and the distance from the toe of slope at the landside to the centre of the sand boil
