Assessment of a fire-damaged concrete overpass: the Verona bus crash case study

Verona bus
crash and fire

Roberto Felicetti

Civil and Environmental Engineering, Politecnico di Milano, Milan, Italy

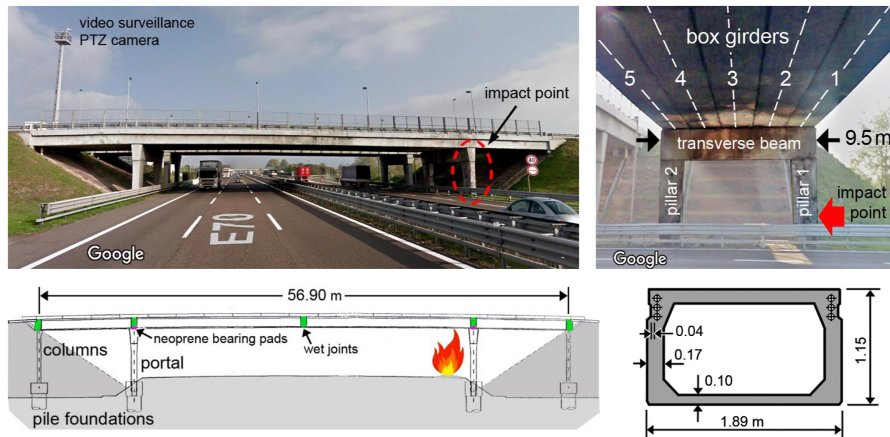
Figure 1.
General views of the
overpass under study,
elements nomenclature
and size

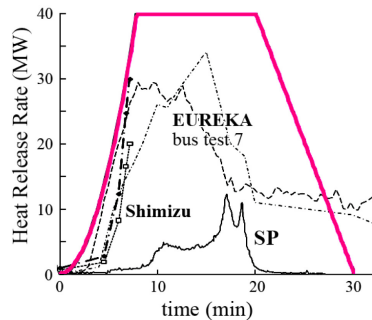
The technical specifications of the burnt coach are summarized in the table in Figure 4. The diesel fuel was contained in two tanks anterior to the front wheels, one of which was destroyed by the impact. A supplementary tank was also installed in the central part of the chassis. The surveillance camera installed across the highway (Figure 1) was not framing the accident area, but the impact instant was indicated by image blurring due to vibration of

Figure 4. Technical specifications of the coach and assumed HRR curve compared against results from the literature

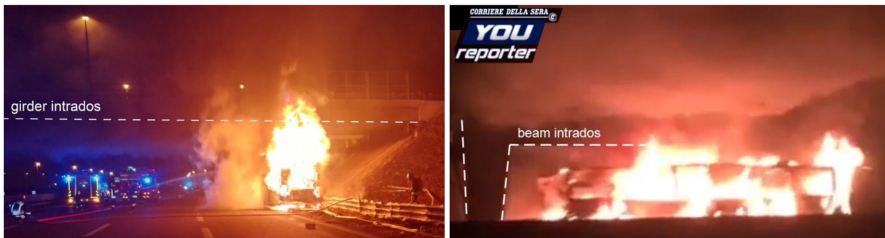
the supporting pole. Later, the camera was directed towards the vehicle, though the view was obstructed by the overpass deck. Nonetheless, it was possible to spot some smoke 3 min after the impact and long flames sticking out the parapets 1 min later. Pictures and videos shot by witnesses recorded the flame height (Figure 5). Two fire engines reached the place 16 min after the accident and flame extinction was completed about 15 min later.

Figure 5. Pictures showing the flame height in the fully developed stage of the fire

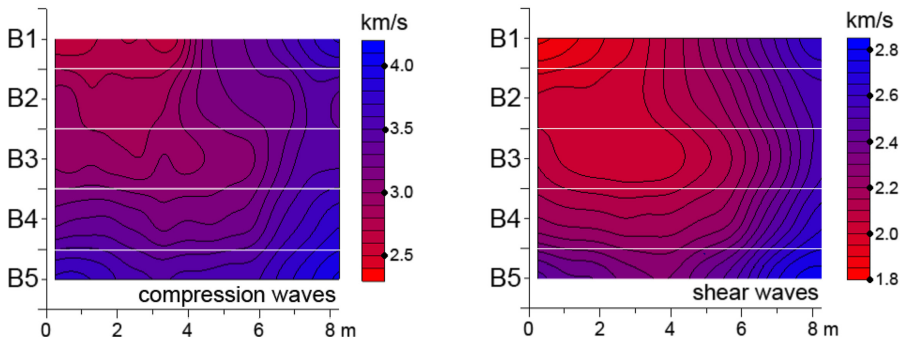
Figure 7. Setup for fast UPV mapping via the indirect method and the A1040 MIRA tomograph; their respective pulse velocity maps detected at the intrados of the five box girders composing the deck (abscissa measured from the portal edge)

This setup was used to scan the central axis of the girders flange (0.5 m step) and several vertical alignments along the pillars (0.25 m step) and horizontal sections along the transverse beam (0.5 m step). The results pertaining to the deck intrados were collected in the form of a map (Figure 7), clearly illustrating the remarkable pulse velocity reduction in the area right above the burnt coach. Damage tends to vanish at a distance exceeding 8 m from the portal edge and in the farthest beam. It has to be stressed that the minimum indicated values represent the mean pulse velocity along a curved ray path plunging to about 20 mm in the damaged cover (see the wavefront trajectories in Figure 10).

Besides the different magnitude (shear waves are 40% slower than compression waves), the resulting map (Figure 7) is very similar to the one obtained by means of the traditional UPV method. However, merging 66 waveforms in one measurement allows offsetting the local disturbance due to cracks, rebars and other defects, producing a smoother output. To be mentioned is that both mapping techniques were implemented at the pace of 25 test points per hour, minimizing the traffic disruption in this strategic highway.

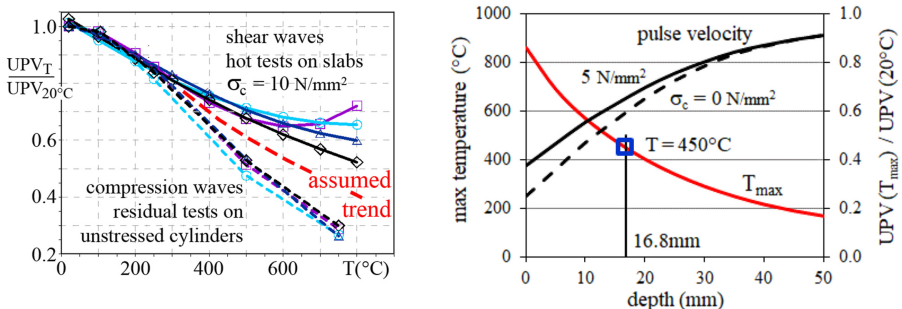
Figure 9. Thermal decay of Ultrasonic Pulse Velocity as a function of the sustained stress (Felicetti and Lo Monte, 2016); profiles of the max temperature and corresponding UPV for a 100 mm thick plate submitted to the localized fire as per §3 (including the depth of the 450 °C isotherm detected by the dehydroxylation test)

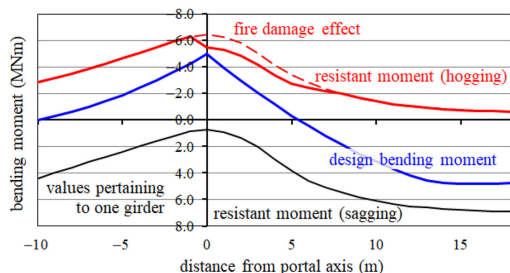
Figure 13. Design loads and diagrams of the design and resistant bending moments for the most fire-damaged girders
