# Editorial: 20th Biennial BDS Conference 2018 – Binnie Lecture: the role of inspection and monitoring in risk and asset management

**Mike Cambridge** BSc, Eur Eng, FICE, FGS, C.Env  
Managing Director, Cantab Consulting Ltd, Ashford, Kent, UK  
([mrccambridge@outlook.com](mailto:mrccambridge@outlook.com))

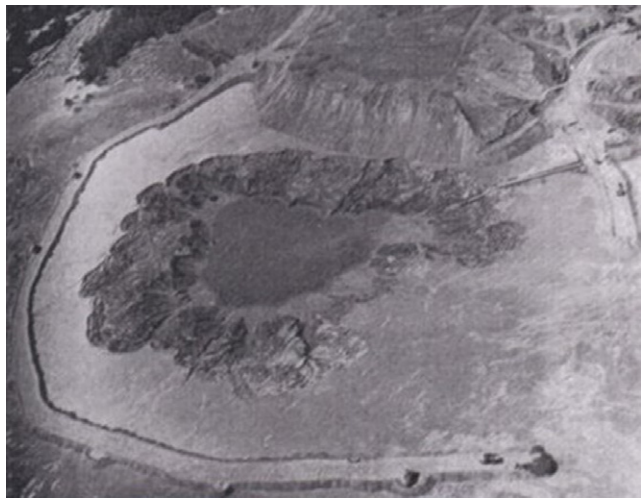
**Figure 5.** Aerial view of the post-incident Mufulira crater  
(Norman Kenward – independent photographer)

development above mined-out areas is a well-documented feature of underground extraction and the risk of such features daylighting had been addressed in guidance documents in the UK and elsewhere (Figure 5). A detailed risk assessment based on well-documented historic events (Cambridge, 2005) would have informed this assessment and unknown geological conditions in the overlying strata would have been identified as a principal risk to TD3. The development of a risk register would have highlighted the potential failure modes and enabled mitigating measures to be developed once the warning signs of impending failure had been investigated, thus preventing this tragedy.

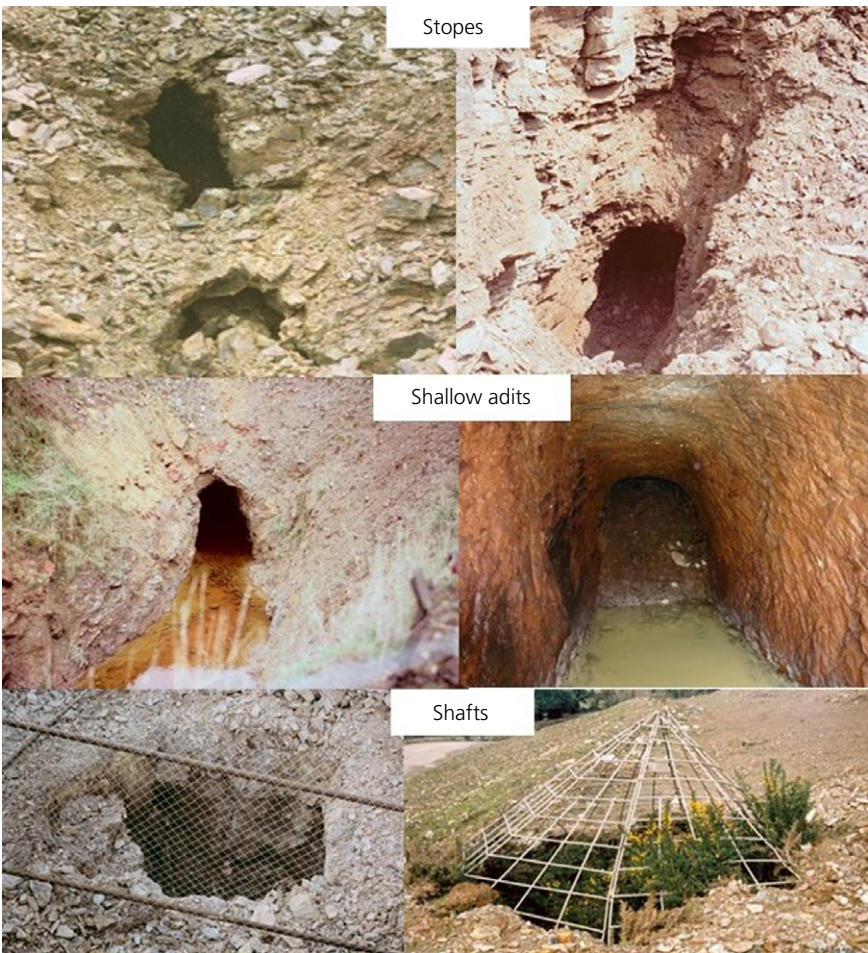
**Figure 6.** Typical old workings

failures at Mufulira and Martin County (Blight and Fourie, 2003). The designer of any dam therefore needs to be aware of the geological setting of the structure as well as of any anthropogenic influences/disturbances. One of the principal issues associated with design and construction of dams in historic mining locations is the presence of old workings. These may comprise deep stable water-bearing adits, shallow timber-supported adits, loosely backfilled mine shafts or indeed collapsed or partially backfilled stopes (Figure 6). Such underground structures are ubiquitous in the UK and have had, and continue to have, major implications both for surface stability and for the environment in the downstream catchment. They are generally difficult to locate by conventional site investigation techniques due to the means used by the old men to backfill them, with even geophysics proving to be of limited application. In Cornwall, for instance, the old men regularly cut down holly trees, inverting them in disused shafts and backfilling the remaining void with local earth/rockfill immediately prior to abandoning the site. Over time, as the trees rot,

During my career I have been surprised that designers of new tailings dams, particularly in Europe, have been guilty of taking little cognisance of previous mining activity and thus of the risk of the often well-documented evidence of shafts and shallow adits being located within the footprint of a facility. On these projects, the engineers have been unprepared when surficial excavations for dam foundations or other infrastructure have revealed extensive networks of shallow adits and shafts throughout, resulting in major re-design of the embankment and the concomitant programme delays and increased construction costs. Fortunately, in the UK these design omissions have not to date resulted in major inflows of tailings or destabilisation of the confining embankment. However, old workings from Neolithic flint to recent coal and tin mines are commonly encountered in the UK, and thus few areas are unaffected by historic mining (Ford, 1998). Such workings are often unstable and deterioration is an ongoing issue (Irish Times, 2019), increasing the risk not only to the dam engineer and facility owner but also, in many areas, to the safety of the public. All reservoir panel engineers (ARPEs) should be aware of the presence of mine workings and should take into consideration the potential impact that the collapse of shallow shafts and stopes can have on dams. In particular, public safety elements should not be ignored, and capping such as that carried out in Cornwall, Derbyshire and Devon using simple steel bat-friendly structures (Figure 6) provides ample protection. However, I have also encountered numerous

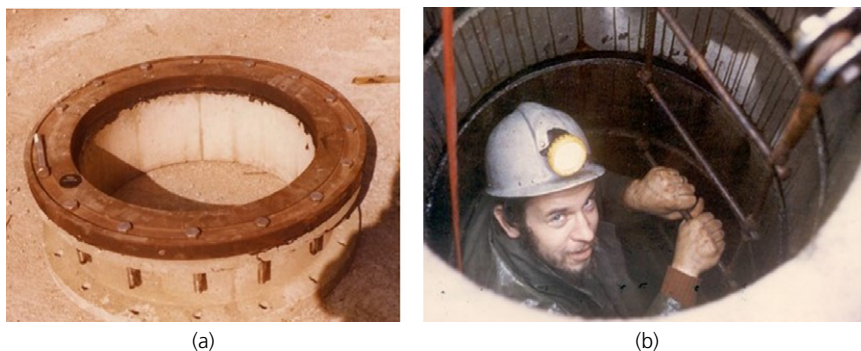
Figure 8. (a) Typical detail of neoprene ring and (b) the decant inspection

Old workings may well have been implicated in the failure of the central decant at the CVTD, an example which demonstrates how a detailed risk assessment involving a review of historic decant failures enabled risks to be mitigated, in particular, through a rigorous inspection and reporting regime. This decant comprised a 600 mm-diameter vertical concrete tower constructed in the centre of the reservoir and intended to carry the routed design flood in combination with the return water flow from the disposal operations (Forbes *et al.*, 1991). The design had been informed by a study of a number decant towers, particularly in Africa, which had failed at a height of about 20 m, primarily due to consolidation stresses. For the CVTD, therefore, the principal risk mitigation measure incorporated into the design was the inclusion of thick neoprene rings between each concrete unit, restrained for lateral stability by stainless-steel bolts inserted through the peripheral flange. The rings were designed to absorb consolidation loading and to reduce the risk of crushing (Figure 8(a)). The risk assessment led to the development of a rigorous inspection and monitoring regime to mitigate against a collapse (Figure 8(b)). The subsequent annual internal inspections of the tower highlighted the progressive development of asymmetric deformation of the neoprene rings (Figure 9). In 1984, with the height approaching 20 m, the tower was shown to have suddenly moved out of the vertical plane (Figure 10). An urgent investigation was commenced and concluded that continuing deviation from the vertical was likely and would lead ultimately to a collapse, resulting in an untoward discharge of water and tailings into the downstream catchment. The investigation report could not reach definitive conclusions regarding the
