Paper No. 6290

**The Volta Bridge†**

*Discussion*

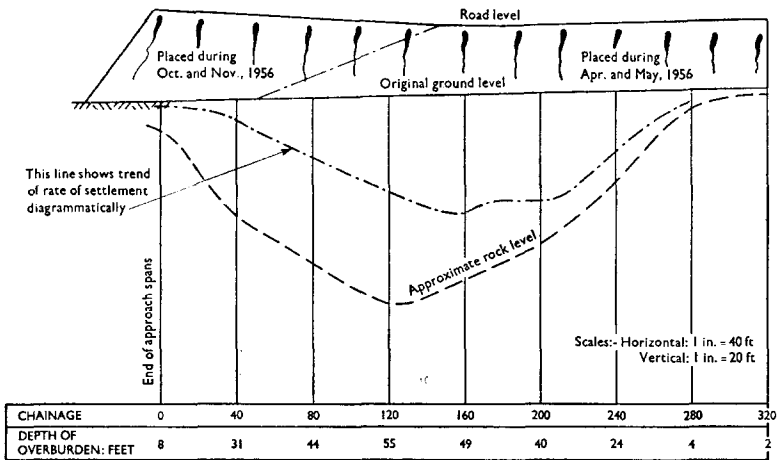
FIG. 33

190. There appeared to be a relation between the settlement and the depth of overburden (Fig. 33), and the conclusion which might be drawn was that the major part of the settlement was taking place in the overburden and not in the embankment itself.

189. The settlement of the east approach embankment, amounting to 10 in. (§ 111) had continued to be the object of study. Figs 33 and 34 illustrated the course the settlement had taken.

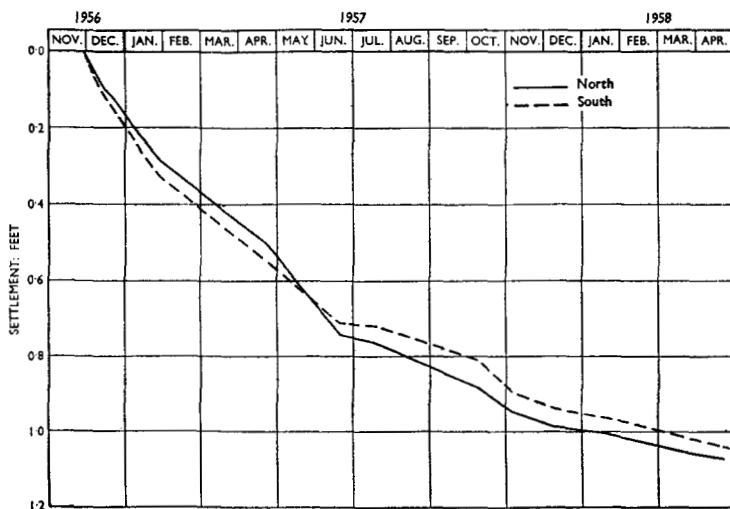
FIG. 34

191. Settlement appeared to be decreasing reasonably steadily (Fig. 34), although there appeared to be a flattening of the settlement/time curve after June and October 1957, which suggested that settlement might be affected by the water-table; the river level had reached a minor peak in June/July, the main flood occurring in October.

192. Some settlement must have occurred before the commencement of recordings.

and a rough estimate showed that this might have been as much as 12 in. Including this figure, the maximum settlement since construction of the embankment might now have reached about 2 ft 4 in. Some compensation for settlement had been made after the placing of the main fill, so that the apparent settlement was not more than about 1 ft 4 in. In this case it appeared to be more practical and economical to await events, and subsequently to reinstate the road if required, rather than to carry out expensive soil investigations and/or expensive works in order to predict and forestall this contingency.
