Oil jetties at the Port of Hull

W. J. Leaman, B.Sc., A.M.I.C.E.

R. K. Postlethwaite, B.Sc., A.M.I.C.E.

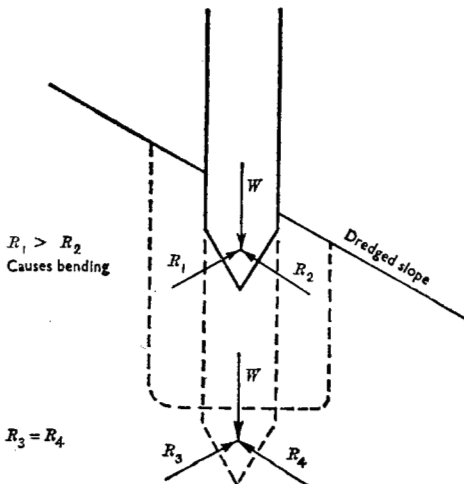
FIG. 13: VERTICAL PILE

107. The first time he had encountered this difficulty was when driving 10-ton precast piles in a bank. When a 5-ton hammer was used on them, the piles cracked. They entered the ground, but there was less resistance on one side than on the other. When held in guides above the ground, the piles cracked. The difficulty was overcome by having a level seating of some depth in the bank into which the pile was pitched (Fig. 13).

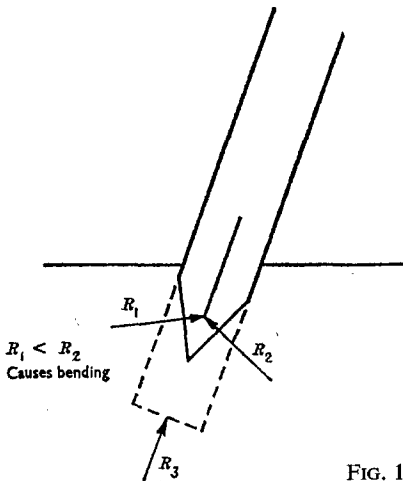
FIG. 14: RAKING PILE

108. There was a similar position in the present instance. The pile was driven on a rake. When the pile was driven vertically, there were forces normal to the sides of the toe. As soon as a raking pile was used (Fig. 14), the reaction at one side must be higher than at the other. As soon as this occurred, there would be a bending force in the pile which cracked it.

109. There were two possible answers. One was to have special shoes made which were calculated out to the right angle, but this could be difficult. Probably the real answer was to have a flat bottom to the pile.

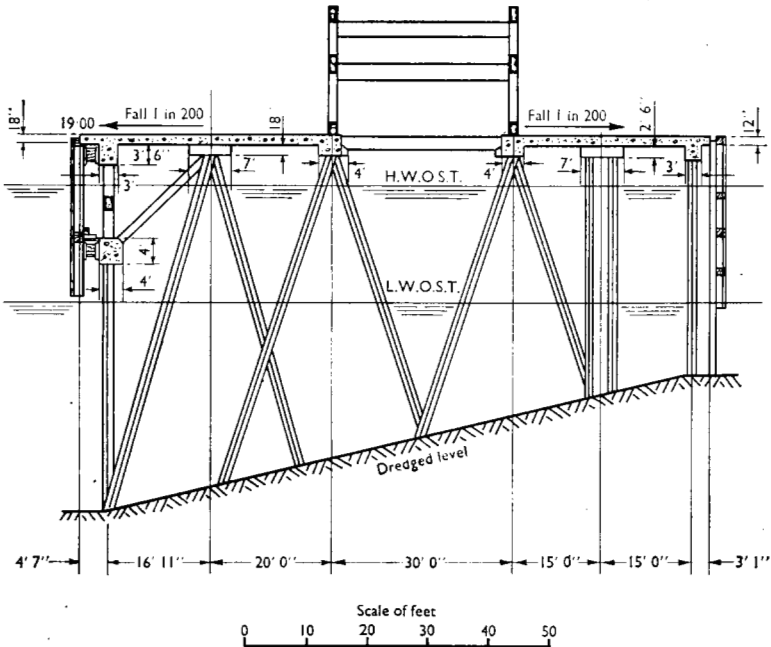
FIG. 15: NO. 3 JETTY HEAD—CROSS SECTION

169. The cross section of No. 3 jetty head (Fig. 15) had been supplied by the Authors in response to the request from Mr Boyce in § 135.

131. Dealing firstly with the head of jetty No. 3, the ground conditions found during the construction must have caused the designers many anxious moments when considering the strength of the raking piles and he would like to know at which level below the sea bed fixity was finally taken.
