## **The reconstruction of King's Wharf, Suva, Fiji**

**J. A. Williams, M.I.C.E., M.I.Struct.E., M.Cons.E.**

Partner, Messrs Sandford, Fawcett, Wilton & Bell, Consulting Engineers, London

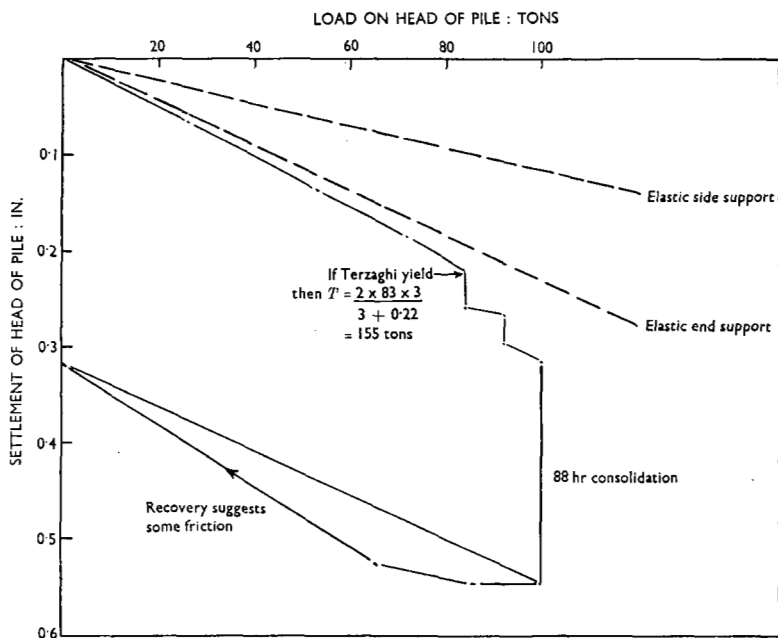
FIG. 15: MR BULLEN'S REDRAWING OF FIG. 6

87. He had ventured to re-draw part of Fig. 6 (Fig. 15) in a way which he found easier to follow. This diagram seemed quite normal for a partially tested pile. If the pile were considered as having been entirely supported at the toe, with no friction around it, and the load were applied at the head, the movement of the head would be in the following form added to the diagram. If, on the other hand, the pile was entirely supported by friction, then the movement of the head would be as shown in the diagram.

77. Referring to page 538, Fig. 6, what was the progressive settlement of the test pile during the 88 hours of the second cycle for which the 100 ton load was held? It had seemed to settle quite a bit and he wondered whether it had started off at a rapid rate and then faded out to virtually no settlement over the last quarter or so of the 88 hour period.

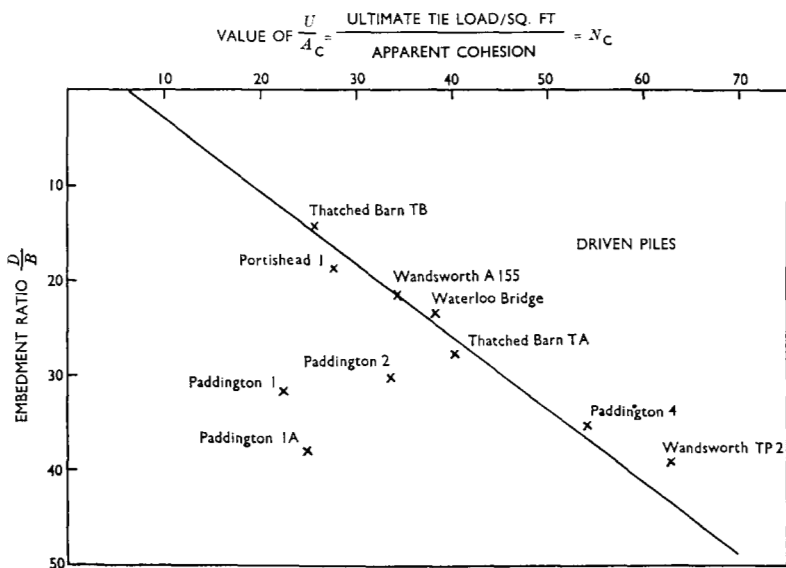
FIG. 16

90. On the piles that were being discussed (Fig. 16), taking the embedment length over the diameter, he found that  $N_c$  was about 50 (he was sure this was wrong by all the soil mechanics arguments, but this was what one found by experience). Taking this value the toe value would be about 120 tons, and if one could then offer the suggestion that the average friction or adhesion on the piles would be about 0.1 ton, or 2 cwt/sq. ft (the sort of friction one would think of in sinking a caisson or something like that), one obtained 70 tons or so in friction, so that there was a total value for the pile of 190 tons at ultimate.

**Mr F. R. Bullen** (Consulting Engineer) said that he had noticed the spacing of the piles was 7 ft 6 in. for a 2 ft 6 in. diameter pile. Some had thought that for friction piles the spacing should be a little larger than that, and possibly the circumference of the pile. On the other hand, if they were end bearing piles, twice the diameter of the pile was thought to be sufficient; clearly it was assumed that the load was carried partly in friction and partly in bearing!
