Discussion

Mr H. C. Adams observed that the Northam Bridge had been constructed on the most up-to-date principles, in spite of the fact that its design had been started 5 or 6 years previously.

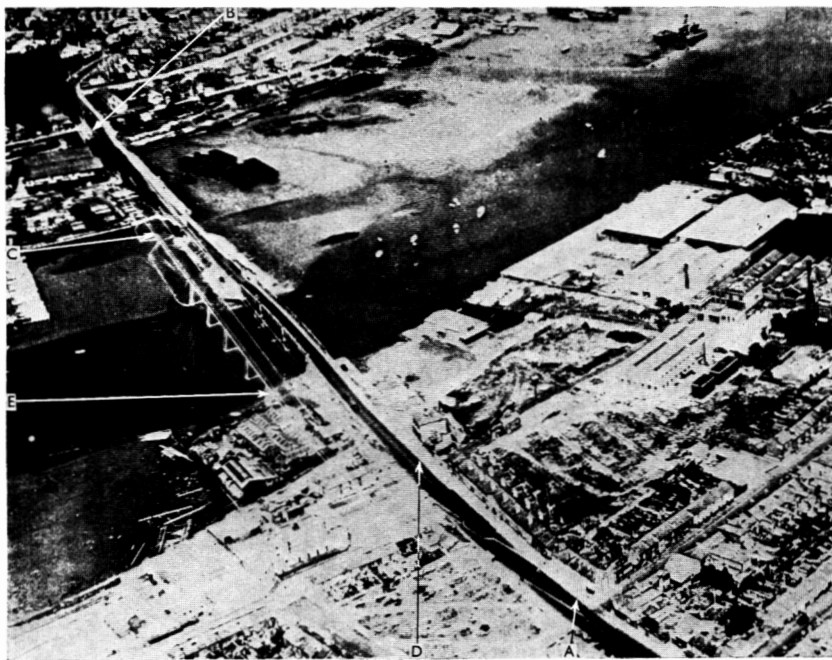
FIG. 16.—AERIAL VIEW OF SITE

Fig. 16 was a view of the area rather than of the site itself. It showed how close to the old bridge the new bridge had been sited. On the Southampton side, the bridge alignment joined on to the existing road as shown (A). On the north side it carried right through as indicated (B), the whole of the outer stretches being embankment, to a total length of about 2,000 feet. The scour span mentioned in the Paper was shown. Its purpose was to preserve the foreshore levels in the timber pond upstream of the bridge. The embankment over the tidal flats between the scour span and main bridge was also shown. The railway, which had been diverted, originally ran behind the cinema, straight across the road at D and on through the works area. The diverted route was from a point behind the cinema, over the made-up foreshore to the railway span E, and thence *via* a cutting through the old bridge approach.

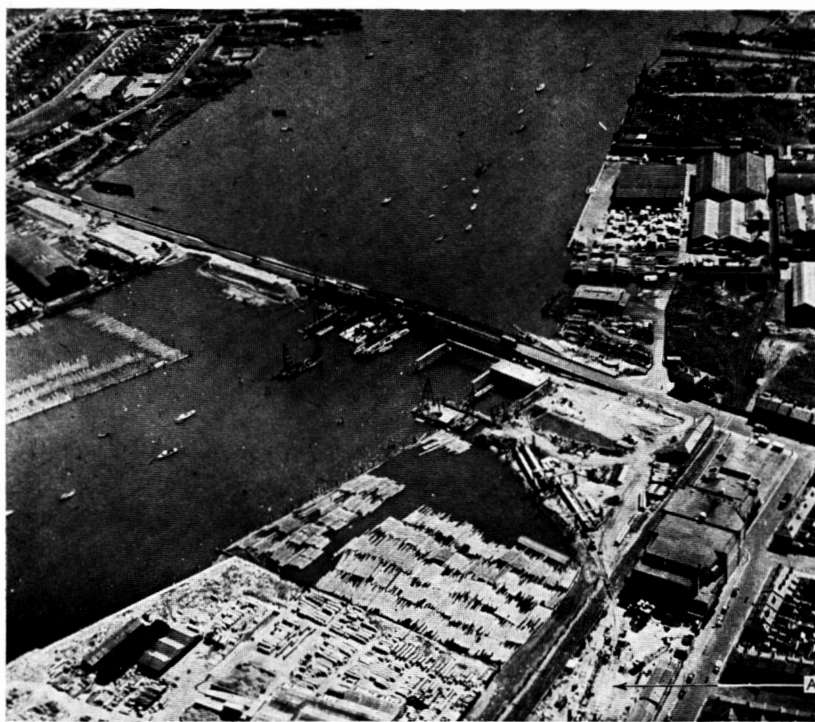
FIG. 17. AERIAL VIEW SHOWING AREA OF CONSTRUCTION YARD

Fig. 17 showed the casting yard (A) in which the beams had been made and the journey they had had to make out to the bridge. First, they had

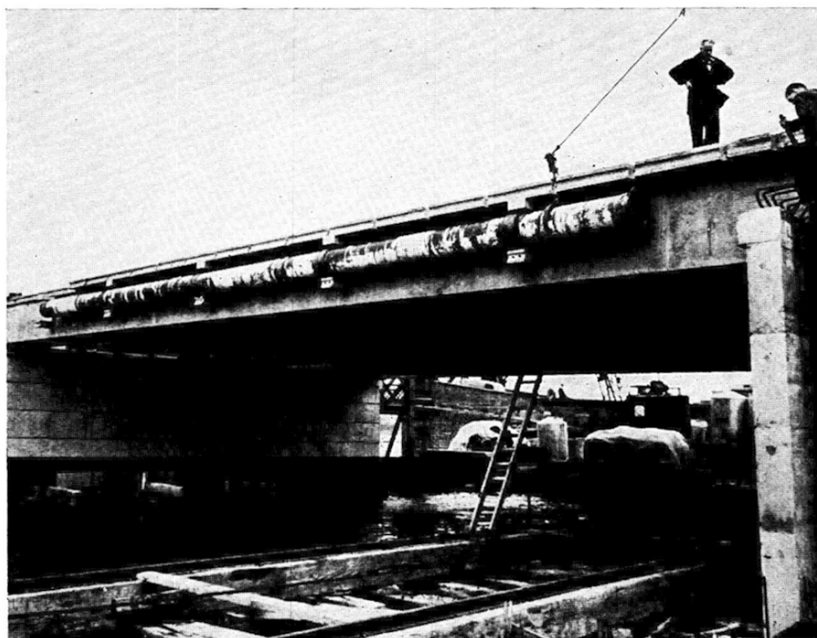
FIG. 18.—18-INCH GAS MAIN SLUNG IN POSITION

Fig. 18 showed one of the 18-inch gas mains slung over the side of the beam. Each pipe had been slung before the next beam was brought in. The slings consisted of mild-steel straps anchored well back into the deck; one of them could be seen at A. The straps had been so arranged that they remained in position holding the pipe clear of the diaphragms until all the transverse tensioning was completed, leaving just a small amount of concrete to be placed after the removal of the strap.

Mr A. Goldstein asked what would happen in the case of the 18-inch gas main if any replacement were required. His office had recently had occasion to discuss that matter with one of the provincial gas boards, and it appeared that those mains did sometimes leak. From the construction details given in the Paper it looked as if it might be difficult to get a faulty section of the main replaced without dismantling and removing a number of additional sections.

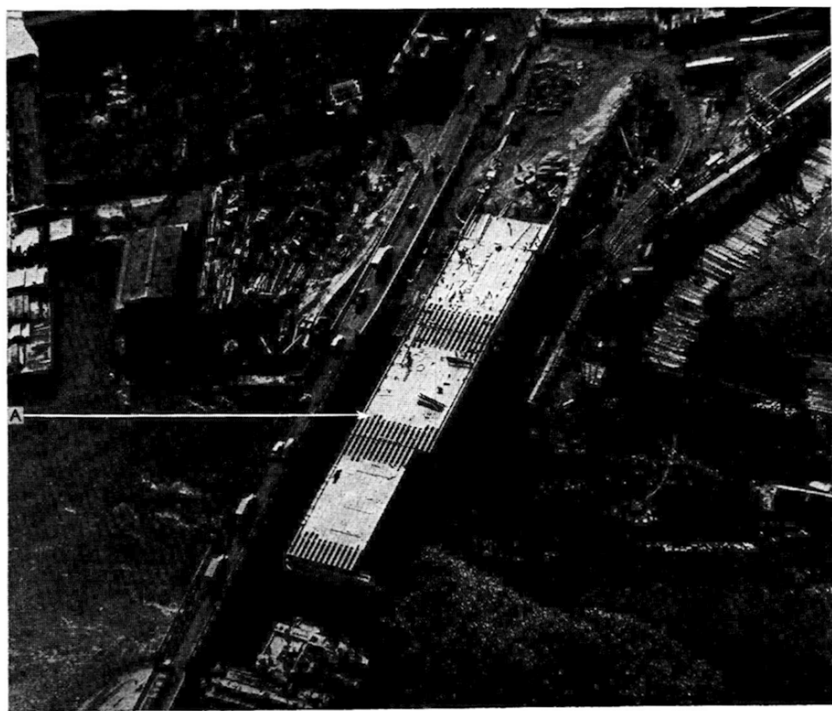
FIG. 19.—AERIAL VIEW OF PARTLY COMPLETED BRIDGE

Fig. 19 was an aerial view of the partly completed job. Mention was made in the Paper of the 24-foot width of the old bridge compared with the 65-foot width between parapets of the new bridge. Fig. 19 showed that difference clearly. As a partly-constructed job, there could be seen the gaps where the flanges of the beams were curtailed for the insertion of the continuity slabs over the pier-heads. The longer gaps (A) were to allow the insertion of manholes for access to the services which were laid beneath the deck.
