#### Discussion

**Professor A. H. Naylor** described the model investigations which had been started after the 1948 sea wall had been designed and was under construction. The questions to be answered in order of urgency were :—

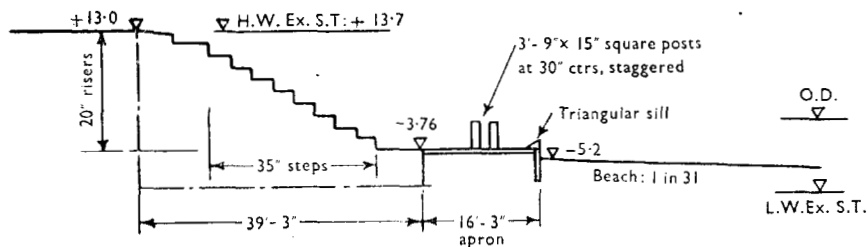
FIG. 37.—HALCROW WALL No. 2

Further experiments were made to discover the optimum wall design. The best proved to be that known as “Halcrow No. 2” (Fig. 37) with a toe protection similar to the optimum of the previous tests. Why was that design not adopted for the subsequent work?

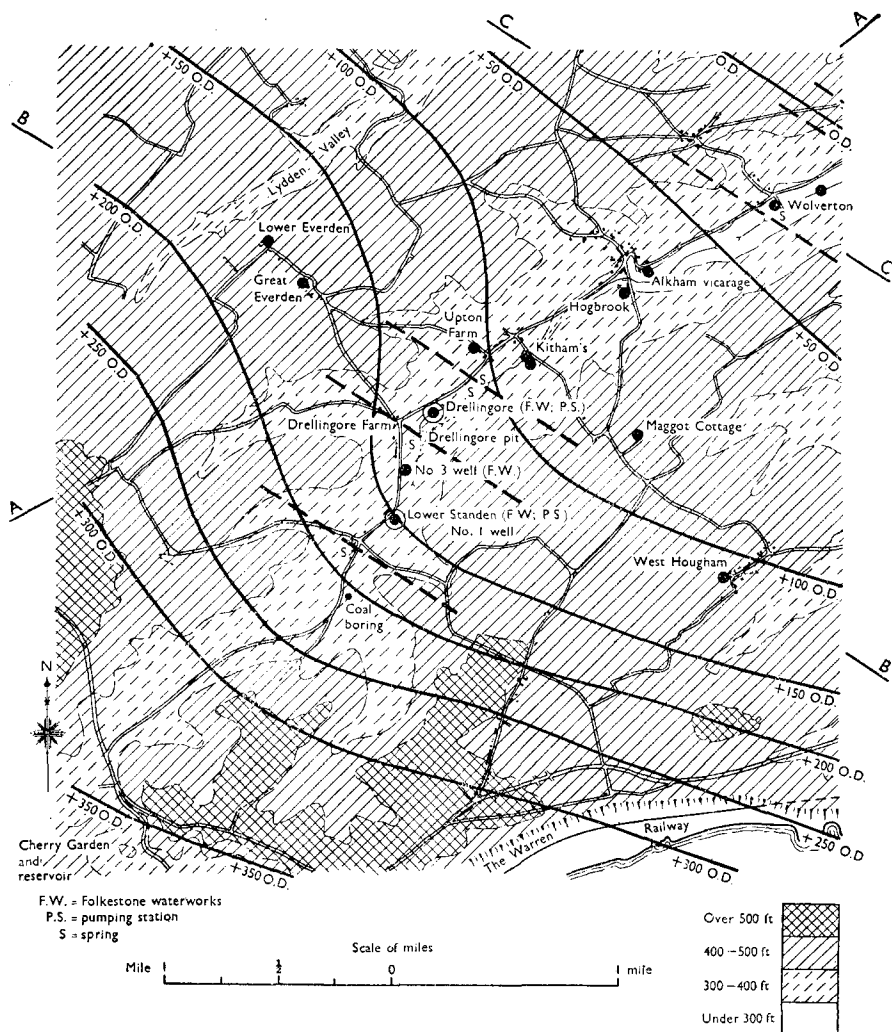
FIG. 39.—PORTION OF A MAP DEALING WITH UNDERGROUND WATER IN THE DOUR WATERSHED

Fig. 39 showed part of a map of the River Dour catchment (situated immediately to the north-north-east of the Warren) which had been prepared in connexion with a waterworks survey. The full heavy lines

running in the general direction north-west to south-east were contours of the base of the Middle Chalk formation (the top of the Plenus Marl). They showed a general dip to the north-east, but nearer the Warren it was to the north-north-east, and in dry conditions when water was not plentiful that was the direction in which water tended to move ; but it did not travel at the low levels, because the Chalk was almost completely impervious in its lower parts. Geologists had divided the Chalk into Upper, Middle, and Lower, but from the waterworks point of view the effective division was half-way down the Middle Chalk. Above that there was a great deal of percolation, but below half-way down the middle chalk it was almost completely impervious and the movement of water was confined to the fissures.

The fissures were of two kinds : those associated with faults and those which followed the bedding planes. In the absence of faulting, the fissures at the bedding plane did not seem to be very wide open. The heavy broken lines on the map were the supposed positions of important faults. There was insufficient evidence to plot them very far, but they had been identified in the adits at Drellingore and at wells Nos 1 and 3 at Lower Standen, and Mr Forster Brown had identified them in the coalfields as having the same general direction. There seemed good reason to believe that the water which got into the Chalk followed the dip until it reached one or other of the faults, at which the fissures were of greater size than anywhere else, and they conducted the water in a south-easterly direction towards the coast-line. In wet seasons the fissures were saturated and the water then headed up to the upper part of the Middle Chalk and higher, and could then travel north-eastwards with the dip.

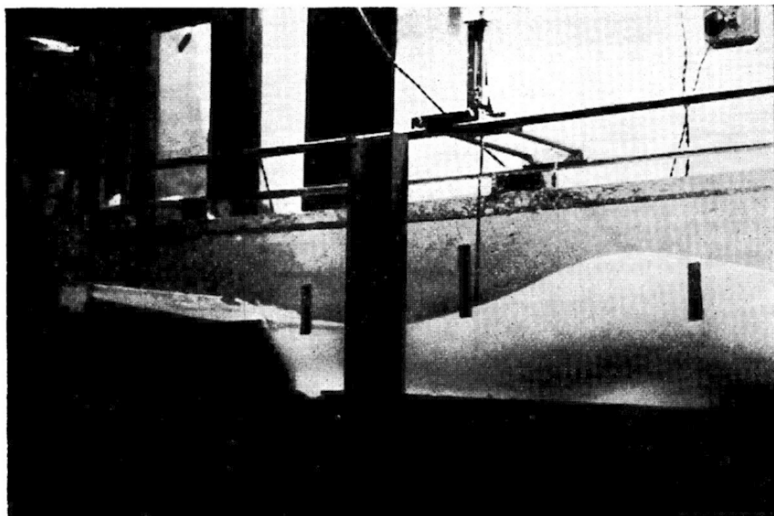
FIG. 29

The top covering was assumed to be terminated 50 feet back from the wall. Fig. 29\* showed a plain apron with a 4-foot-high end wall and Fig. 30 showed it to be inadequate to prevent overspill. Figs 31, 32, and 33 showed the effect of three 2-foot-square baffle walls. There was but little overspill.

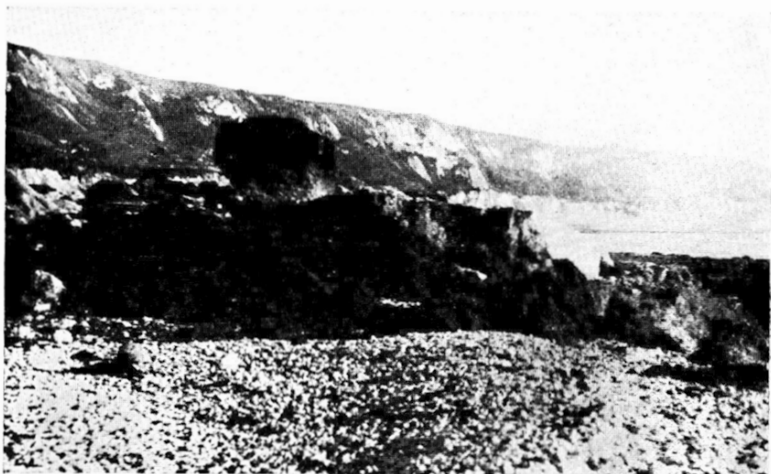
FIG. 43.—PHOTOGRAPH TAKEN IN 1896 SHOWING GAULT EXTRUDED THROUGH WESTERN FORESHORE

Fig. 43, facing p. 451, was reproduced from a photograph taken nearly 60 years ago, shortly after the 1896 slip. It showed a mass of material which had been squeezed up through the western side of the Warren foreshore. The dark patches were Gault amid the lighter chalk. At one point, 20 feet above the beach, was a seaweed-covered block of chalk which had been elevated prior to the slip. The notes accompanying the photograph stated that the slip had been heralded by that upheaval of material on the foreshore, and it might be added that the position of that upheaved mass was very near to that of the mass similarly pushed up just before the 1937 slip.

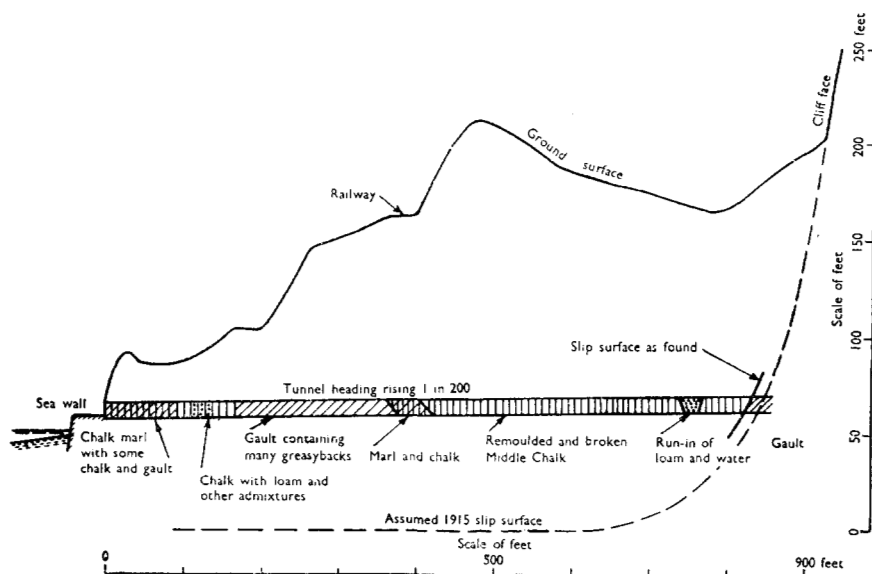
FIG. 41.—DISTORTED SECTION ON LINE OF CIRCULAR TUNNEL HEADING

Fig. 41 was a distorted longitudinal section of the new tunnel heading, showing the Gault barrier passed through before entering the Chalk. Relatively little water had been encountered until the loam pocket was struck, when there had been an uncontrollable " run-in " which delayed the work for about 3 weeks. Thereafter the heading passed through broken chalk until it struck the 2-to-3-inch-thick remoulded slip surface at the Chalk Gault contact face. Fig. 42 showed the strength of undisturbed samples prepared from large pieces of the Gault taken from the slip surface and at various distances behind it up to the termination of the shield chamber. The samples had been cut out by hand, not with a sampler tube, and carefully waxed up to prevent any loss of moisture before preparation for testing.
