Design and construction of deep water quays at Dar es Salaam and Mombasa

L. C. PHILLIPS

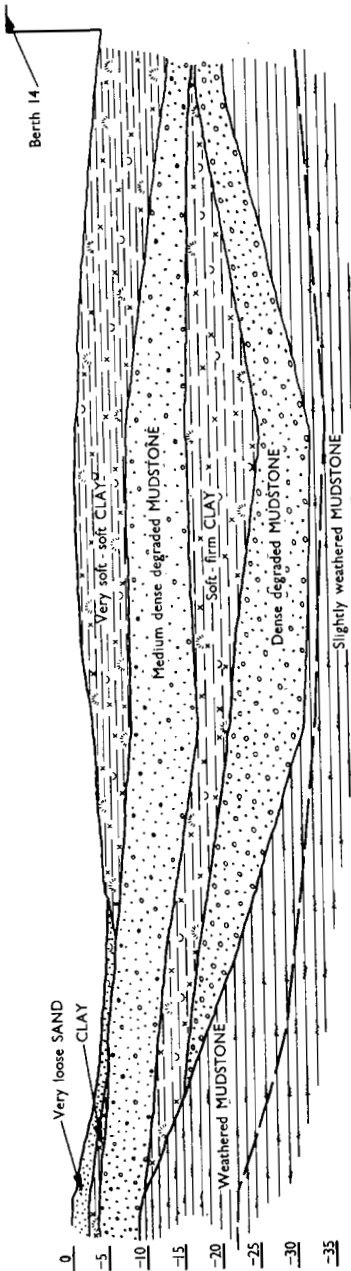
Fig. 13. Geological section : proposed berth 15

GEOLOGICAL SECTION AA

84. Figure 13 shows the geological formation at berth 15. The bedrock is mudstone (in the Paper this is described as shale and use of the term 'mudstone' is only a marginal preference) with a highly weathered layer above it. The surface layer represents the lowest point of erosion of the original formation. At Mombasa, as at Dar es Salaam, there have been rises and falls in the sea level over a period of geological time which have caused successive erosion and infilling. The layer immediately overlying the weathered mudstone we have described as 'degraded mudstone'. This material is very similar in appearance to the highly weathered mudstone but the presence of foreign matter suggests that it has been transported and not weathered in situ. Because of this its properties can be expected to differ and it will probably be weaker.

85. There is more material described as 'degraded mudstone' at a higher level. This exhibits rounded fragments of mudstone, unlike the lower formation which has angular fragments. The former suggests water transportation and the latter movement due to slips. There is a similar pattern at berth 19 (Fig. 14) although only one layer of 'degraded mudstone' is present.

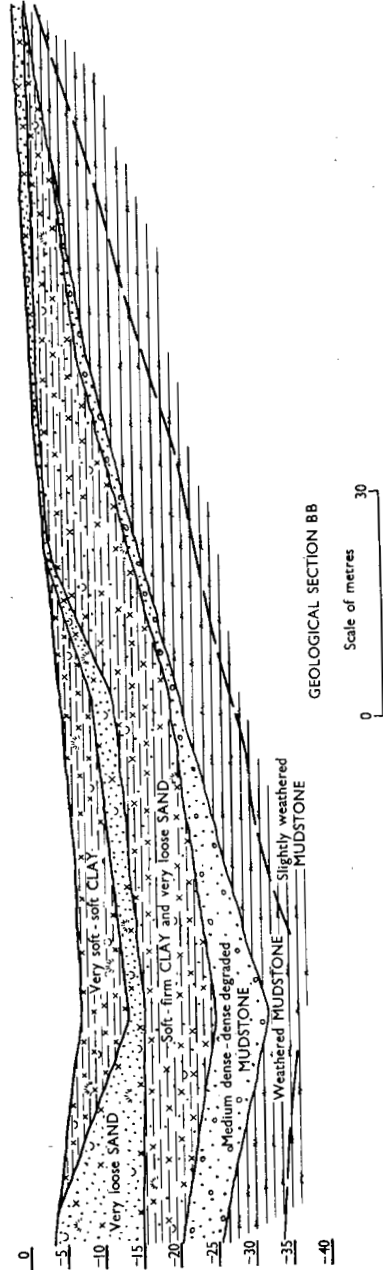
Fig. 14. Geological section : proposed berth 19

GEOLOGICAL SECTION BB
