## **Design and construction of the Northfleet Hope container terminal, Tilbury Docks**

**F. A. PAGE, R. C. CURTIS & H. G. J. MILLS**

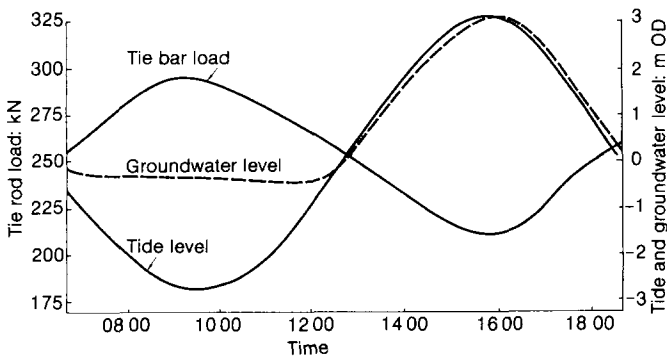
Fig. 23. Variation of groundwater level and tie-rod load with tide level: tie rod 3, quay end, 27 February 1978

82. Nine piezometer tubes were also installed to monitor movement of groundwater level. Only one of these continued to function throughout the construction period and this happened to be nearest to the instrumented sheet piles. A typical result is given in Fig. 23. This shows groundwater level following the rising tide very closely, which may not be entirely accurate, and could have been distorted by the presence of the piezometer tube itself. With the falling tide, groundwater level is held just below mid-tide and this is probably a true indication of the situation at this section. The design was based on groundwater being at mid-tide level and to that extent appears to be slightly conservative.

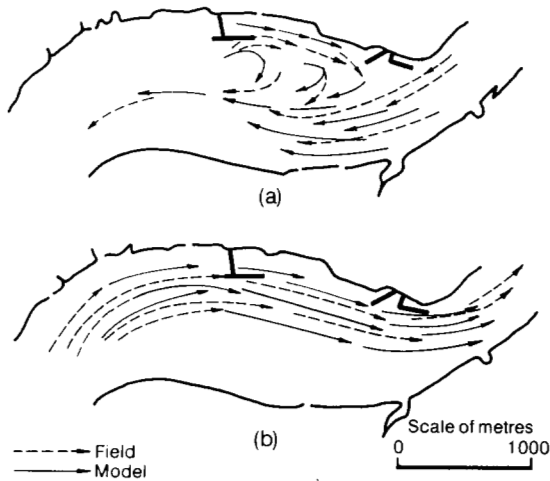
Fig. 24. Current direction: (a) flood; (b) ebb

98. Figure 24 compares field and model float-tracking results obtained at mid-flood and mid-ebb at the site of the container berth. The complex flow referred to is evident in the upper diagram which shows an eddy in the vicinity of the berth.

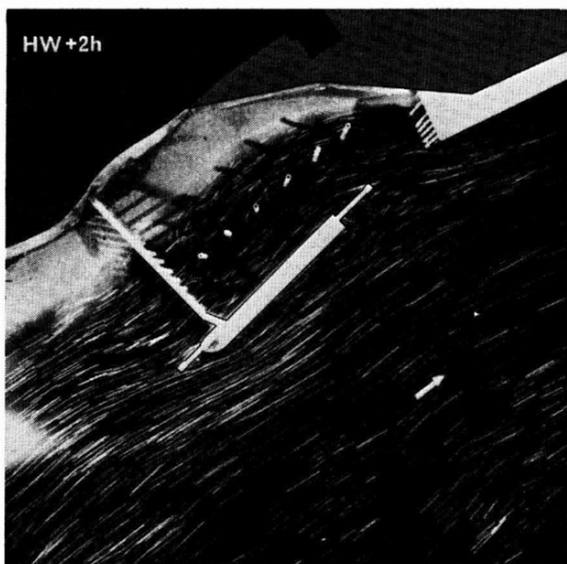
(a)

(b)

**Fig. 27. Tilbury grain terminal: (a) without bull-nose; (b) with bull-nose**

101. The third finding was that the flow separation which has always occurred at the downstream end of the grain terminal on the ebb, due to its misalignment with tidal flow, affected conditions at the up-river end of the container terminal when the latter was extended as proposed for the second stage of development. Mooring conditions for container ships would therefore not be very satisfactory. However, further model tests have shown that improvements could be obtained by the construction of an asymmetric cutwater, or bull-nose, at the up-river end of the grain terminal. This is demonstrated by the two photographs in Fig. 27, showing conditions along the face of the grain terminal and up-river end of the container berth before and after the addition of the bull-nose.
