Geotechnical aspects of Kielder Dam

J. P. Millmore and R. McNicol

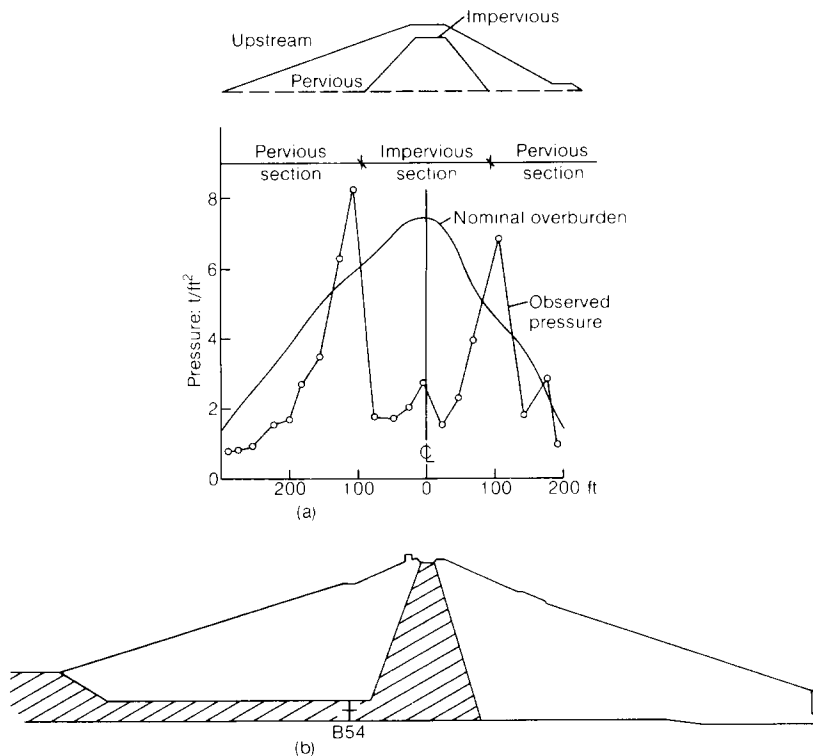
59. If it is assumed that the measured value of r_u is greater than 1, this may be accounted for by an increase of vertical stress above the overburden value caused by arching. Measured values of vertical stress at the John Martin Dam (Fig. 24)

Fig. 24. (a) Vertical stress values at the John Martin Dam; (b) position of piezometer B54 at Kielder

reveal a considerable increase of vertical stress in the fill on either side of the core. Piezometer B54 was in a region where this action could have caused a vertical stress at Kielder greater than the overburden.

The pore pressures found by the Authors were exceptional. The ratio pore pressure/overburden pressure r_u of 10.7 obtained from piezometer B54 (§ 27) is remarkably high. In 1951, I measured r_u values of 1.8 in the fill of Usk Dam^{1,2} but this was due to use of a coarse intake filter that allowed the piezometers to measure the pressure of air in the voids of the fill rather than pore water pressure.

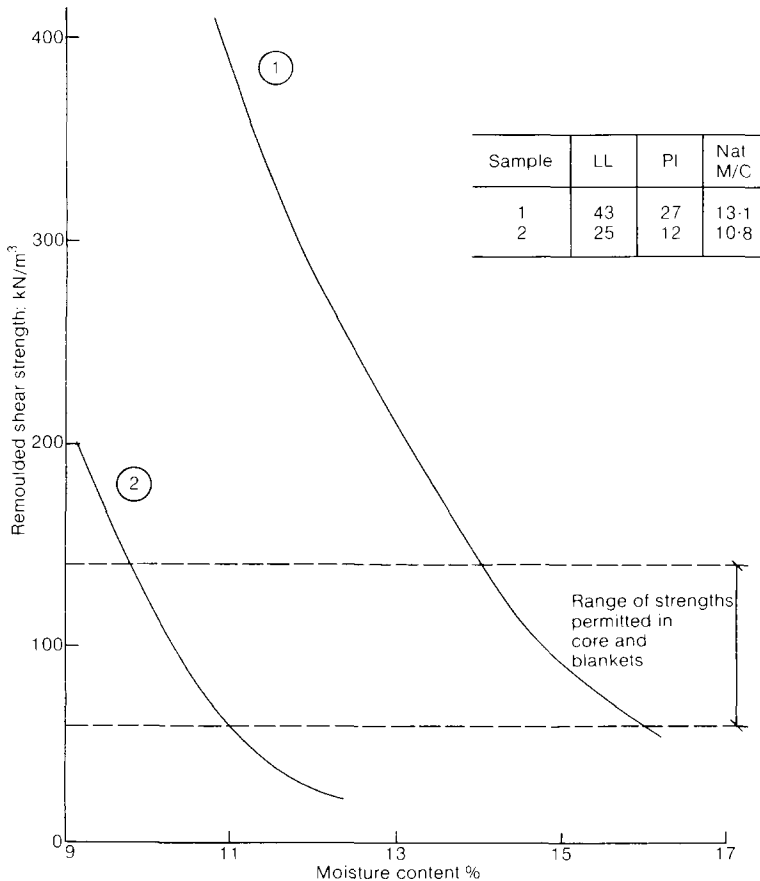
71. Problems were also met with the thick overburden of soft unusable material. In some cases about 5 m of very soft unusable material had to be taken to tip, and below that some fairly soft glacial till occurred. Fig. 11 shows the differing shear strength moisture content relationships that are present in Sandboard Knowe. Fig. 25 shows typical relationships. Sample 1 is a very sandy till, with a fairly steep shear strength moisture content relationship, and Sample 2 is a much more cohesive till. There is a much wider moisture content range for the core with

Fig. 25. Relationship between shear strength and moisture content for typical materials in Sandboard Knowe borrow pit

the more cohesive till than there is with the very sandy till, 2% compared with 1.2%. Both these materials were present in Sandboard Knowe mixed together, and it was very difficult to select one from the other.

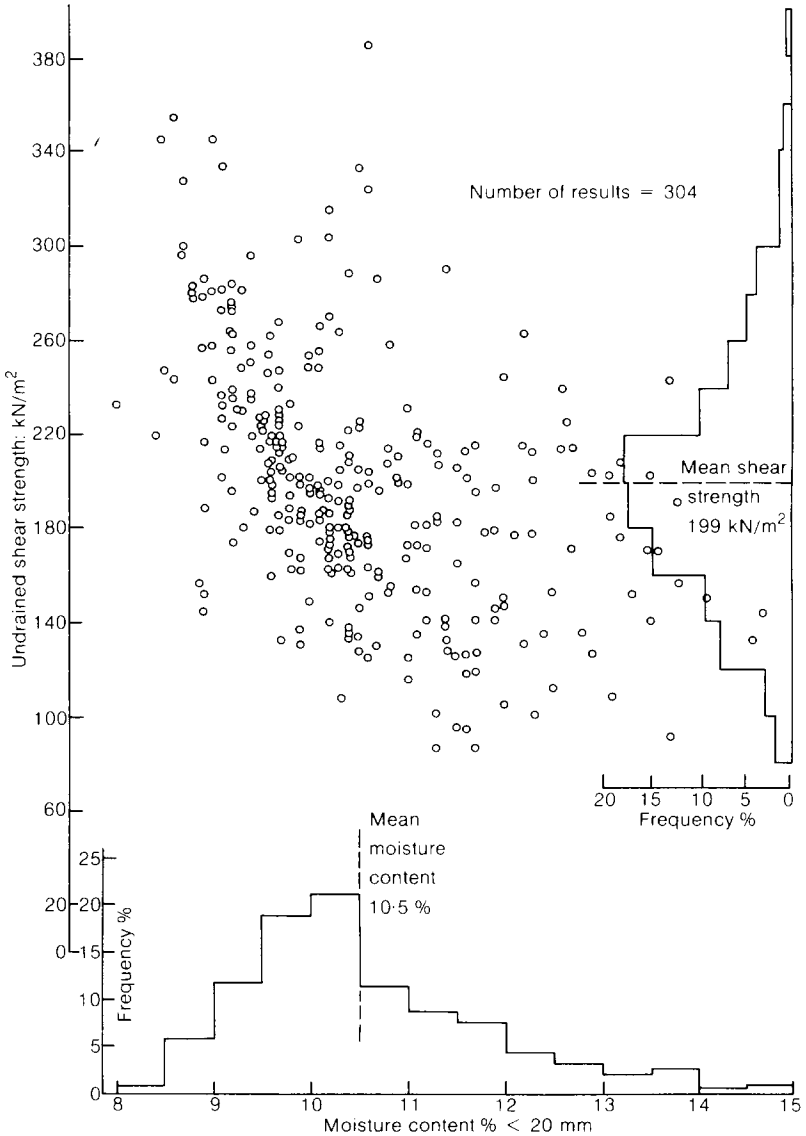
72. Figure 26 shows the range of in situ strengths in Sandboard Knowe, and the range of moisture contents. Both covered an enormous range, and there was no clear relationship between shear strength and moisture content. Because of these large differences in material type, some means had to be found to select materials best suited for either the core or shoulder of the dam. After a great deal of laboratory testing of materials taken from the borrow pit, the joint venture decided to place the more cohesive tills in the core and to place the dry sandier tills in the shoulders of the dam. All wet sandy tills were discarded as unusable.

Fig. 26. In situ shear strength against moisture content in Sandboard Knowe borrow pit

78. The glacial tills at Pea Croft were more consistent than those excavated at Sandboard Knowe with a much more uniform shear strength/moisture content relationship as can be seen from comparing Figs 26 and 27. As a result it was

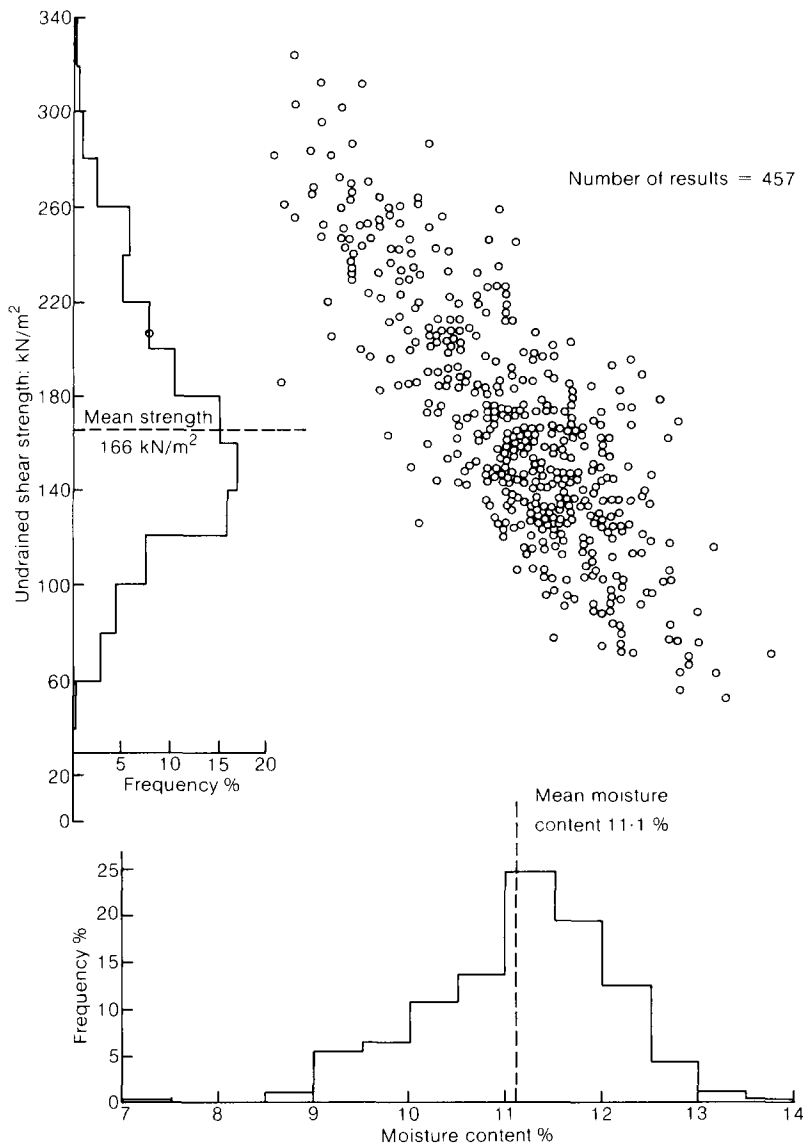
Fig. 27. *In situ shear strength against moisture content in Pea Croft borrow pit*

possible to use motor scrapers in Pea Croft and thus speed up the operation. Also the control of shear strength was much easier and this and changes in testing method allowed very high rates of compliance to be achieved.

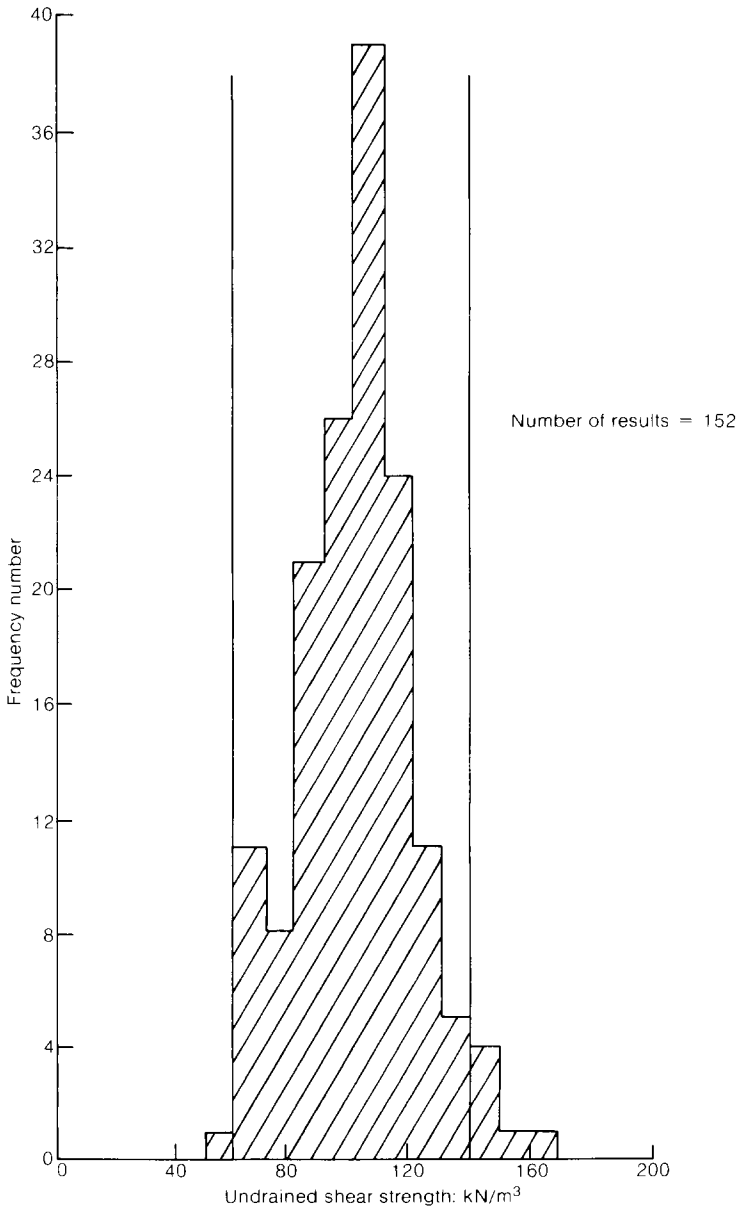
79. Tests carried out between ourselves and Sandberg, for the core using remoulded tests, are shown in Fig. 28. Similarly, the results for the shoulder of the

Fig. 28. Undrained shear strengths for core material excavated from Pea Croft borrow pit between 16 August 1979 and the end of 1980

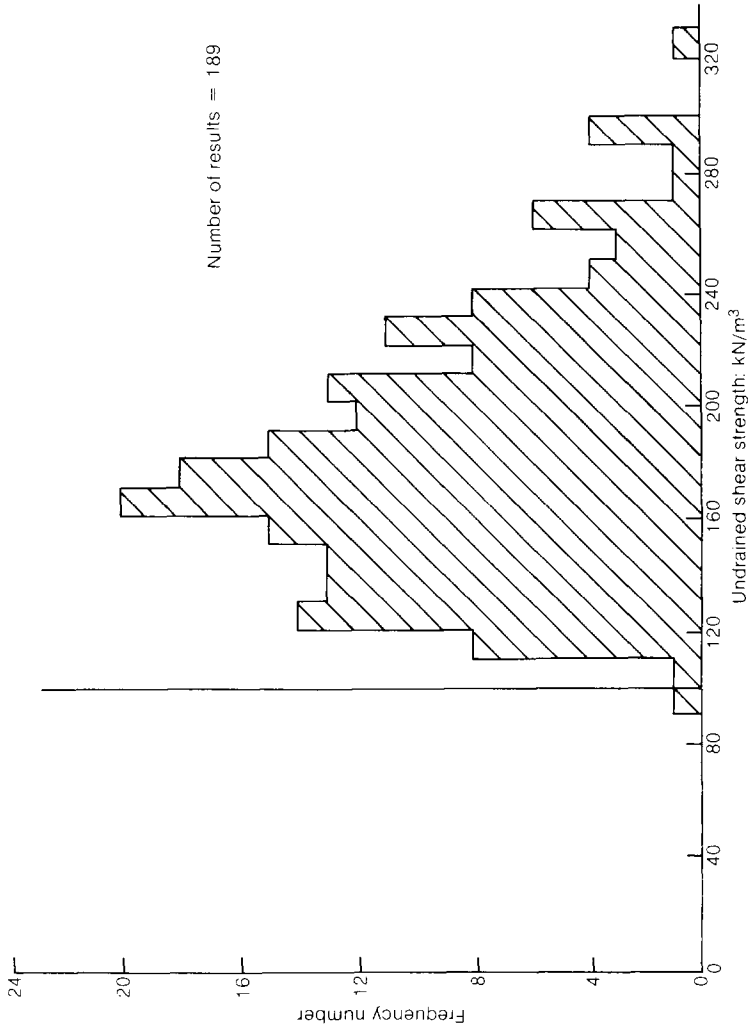
dam, for Pea Croft material excavated and placed in 1981, show almost 100% compliance with the specification (Fig. 29).

Fig. 29. Undrained shear strengths for shoulder material excavated from Pea Croft borrow pit in 1980

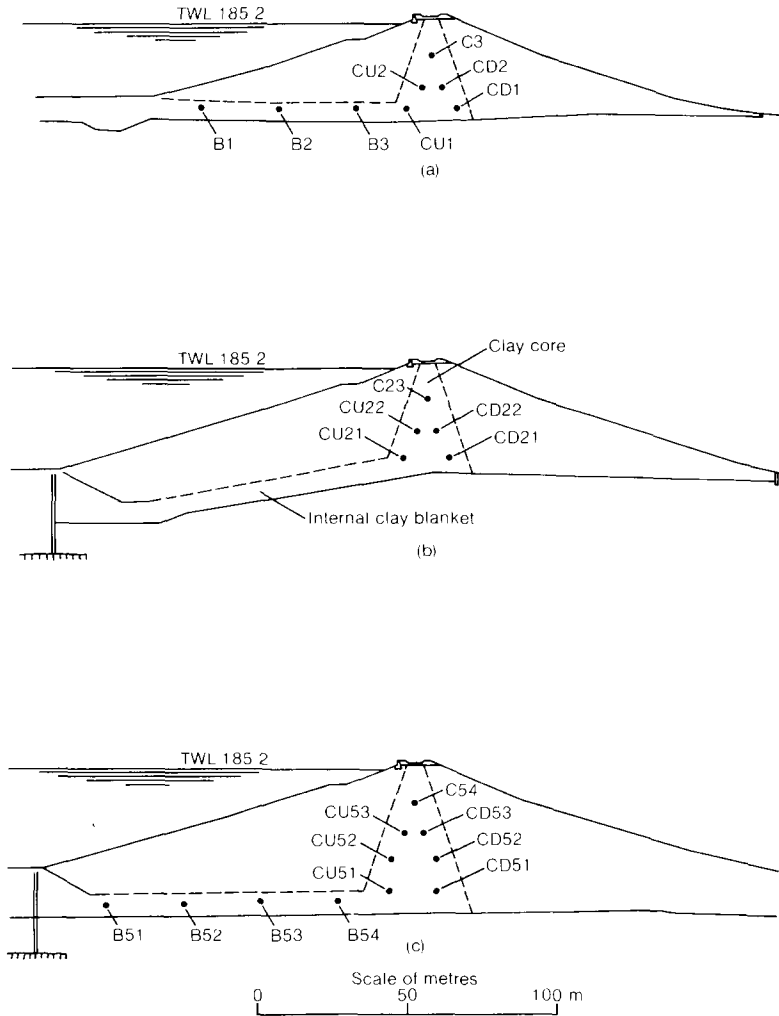
103. Most of the piezometers in the core and blanket shown in Fig. 30 indicated high pressures. However, the pore pressure at piezometer B54 was the highest measured in any piezometer in the embankment. Table 11 summarizes the maximum pore pressure values for all piezometers in the core and blanket during the final earth-filling season. From this table it can be seen that the pore pressure ratio r in piezometer B54 was 0.8, not 1.7, as indicated by *Dr Penman*. Paper 8703 stated that it was the ratio of increase in pore pressure to increase in weight of earth fill (B) which reached 1.7. As *Mr Ruffle* indicated, the B values measured at piezometers CU51 and CU52 were not as high as in piezometer B54. However, the pore water pressures in both piezometers were high and CU51 was only slightly lower than the adjacent B54.

Fig. 30. Cross-section of Kielder Dam showing the core and blanket piezometers: (a) south end of dam; (b) intermediate section (c) river valley

pressures as suggested by *Mr Kennard*. The blanket thickness was initially selected as 6 m on the basis of laboratory test results. In situ parameters subsequently dictated a thinner blanket of 5 m. We did not wish to incorporate a rolled clay blanket any thinner than 5 m since this formed part of the impervious zone in the dam. With hindsight, it may have been appropriate to construct the clay blanket a little drier than the core material by specifying a higher strength for the soil. This would have produced lower pore pressures.
