Paper No. 6223

**The design and construction of the Hindiya Bridge †**  
by  
**John Francis Causton Swansbourne, A.M.I.C.E.**

*Discussion*

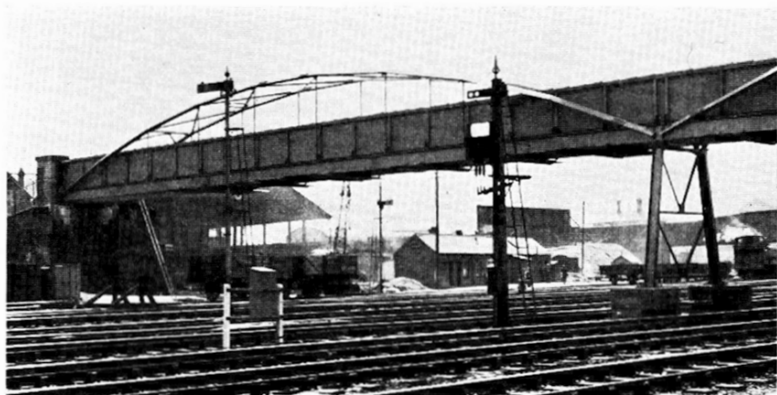
FIG. 19.—100-FT TIED-ARCH SPAN OF FOOTBRIDGE NEAR CARDIFF

**Mr P. S. A. Berridge** (Assistant Engineer (Bridges), British Railways, Western Region) referred to the tied arch form of construction chosen for the 100-ft span. The Author had given no details about the design of this span, which was the longest in the bridge. He had passed it off merely as being architecturally suitable and simple to erect. Agreeing with these views, Mr Berridge thought that emphasis should have been laid on the fact that a tied-arch girder required much less steel than a truss of equal strength for this length of span. He wondered why these tied-arch girders had been riveted when welded shop work, combined with high-strength bolts, for site joints would have shown appreciable economy. He instanced the reconstruction in 1951 of a footbridge over the railway east of Cardiff. There, two 100-ft-long riveted mild-steel parallel-chord Warren-truss spans had been replaced with tied-arch girders shop-welded and field bolted (Fig. 19, facing p. 464). Each of the truss spans had contained 17 tons of mild steel which compared with only 12 tons in one of the tied-arch spans. There was therefore a saving of 40% in favour of the tied arch at first cost and, of course, further economy in future painting and maintenance.

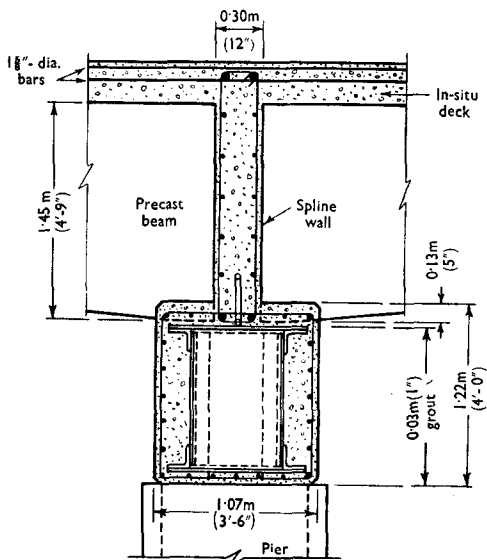
129. The articulation of the beam and pier system was questioned in §§ 55 and 61. Fig. 21 showed a section through the joint. The beams were continuous over the piers by tension steel in the deck and by concrete in compression in their soffits, which were carried through the thin spline walls surmounting the transverse box-girders. There was no compression steel. The spline walls were attached to the transverse girders with nominal reinforcement. Although the system appeared virtually monolithic the

FIG. 21.—SECTION THROUGH CROSS-BEAM AND SPLINE WALL

attachment of the beams and spline walls to the tops of the box-girders could actually be considered as a pin joint with certain minor limitations. In the Author's opinion it was justifiably assumed by the designers that a hinge would form at the bottom of the spline wall by a slight horizontal crack between the soffit of the beam and the transverse girder on the one side and a slight plastic yield due to compression in the same place on the other side. With the formation of this hinge and the inherent flexibility of the pier as a cantilever almost no resistance was offered to temperature movement in the bridge, and consequently the temperature stresses would be very small.

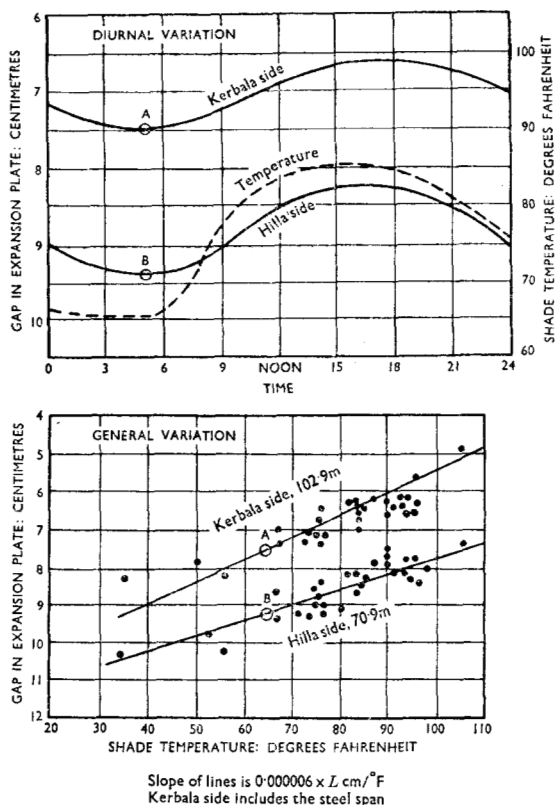
FIG. 22.—EXPANSION OF DECK

152. Mr Austin had referred to thermal movements. The Author had meant that the bridge responded closely to all changes in ambient temperature. If the temperature rose 20°F between morning and afternoon then the bridge extended by  $20 \times L \times 0.000006$ . The higher temperature of the deck surface from direct sunlight presumably balanced out the cooler temperatures within the body of the deck and girders. Fig. 22 indicated the diurnal and general variations encountered. The divergence of points from the line on the second graph might be partly due to the lagging effect when readings were taken on a rising and a setting sun. The temperature of the concrete had never been taken. All measurements were compared with shade temperature.
