# Thermo-mechanical behavior of CLT beam-to-girder assemblies connected with T-shaped dowelled connections before, during and after fire exposure

**Purpose** – 3-ply cross-laminated timber (CLT) is used to investigate the thermo-mechanical performance of intermediate-size assemblies comprised of T-shaped welded slotted-in steel doweled connections and CLT beams at ambient temperature (AT), after and during non-standard fire exposure.

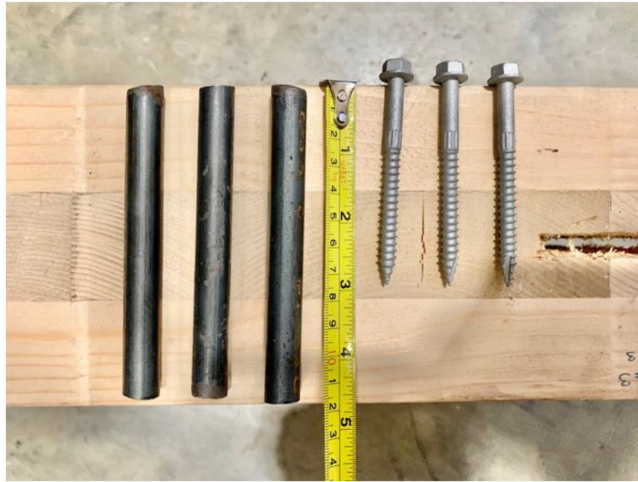
**Plate 1.**  
3-Ply CLT beam, full-length steel dowels and heavy-duty screws

**2.2.3 Steel dowels and fasteners.** The full-length dowels (120 mm) are cut from 12.7 mm diameter steel rods with similar material properties as the steel connection (ASTM A572 Gr 50). The 6.35 mm diameter heavy-duty hexagonal connector screws with 76.2 mm length and 50.8 mm thread are manufactured from low-carbon steel wire grade 1022. This fastener has 1,130 MPa bending yield strength, 6.36 kN allowable tensile capacity and 3.5 kN allowable shear capacity. Plate 1 shows the steel dowels and screws placed on top of the CLT beam.

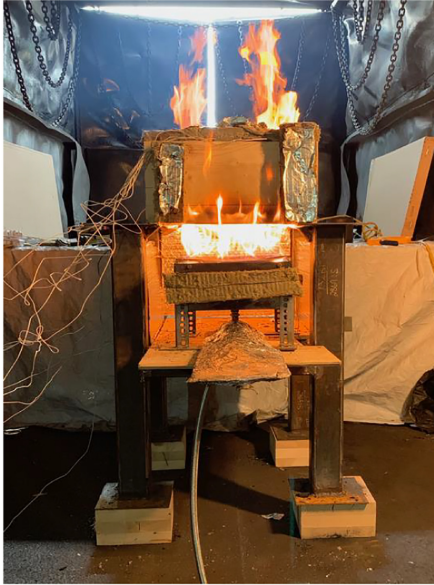
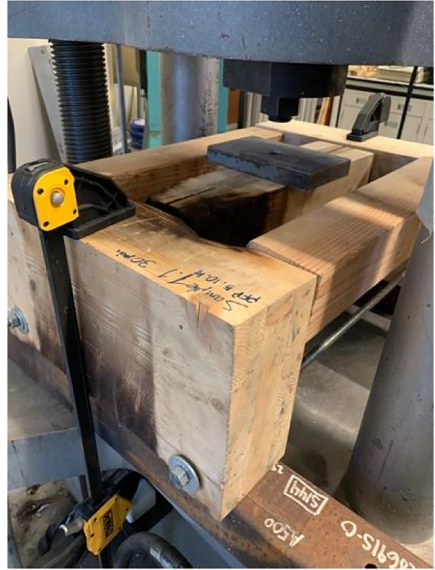
**Plate 3.**  
PFP30 test procedure:  
(a) non-standard fire test and  
(b) loading at ambient temperature

Plate 3 shows photos of the two-step PFP test, including 30 min of non-standard fire exposure of approximately 480 °C and subsequent cooling, followed by mechanical loading to failure.

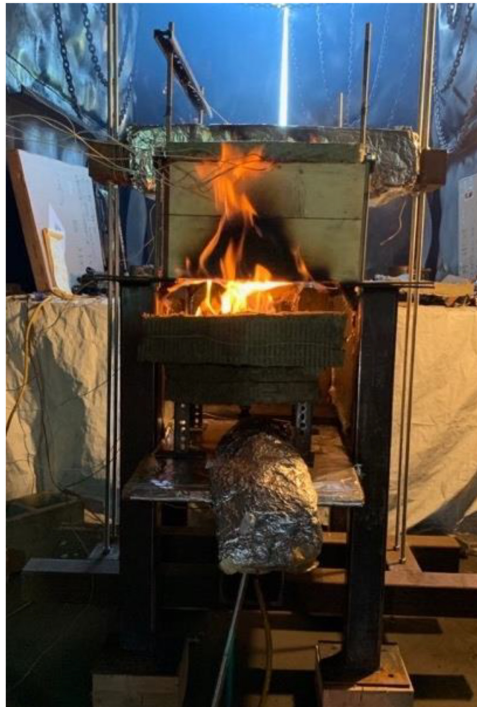
**Plate 4.**  
Fire-performance test  
of the CLT beam-to-  
girder assembly

Plate 4 shows a photo of the FP test, including the application of constant mechanical load equivalent to 66% of the AT assembly capacity along with non-standard fire exposure of approximately 480 °C until failure. This higher than usual mechanical load was prescribed to

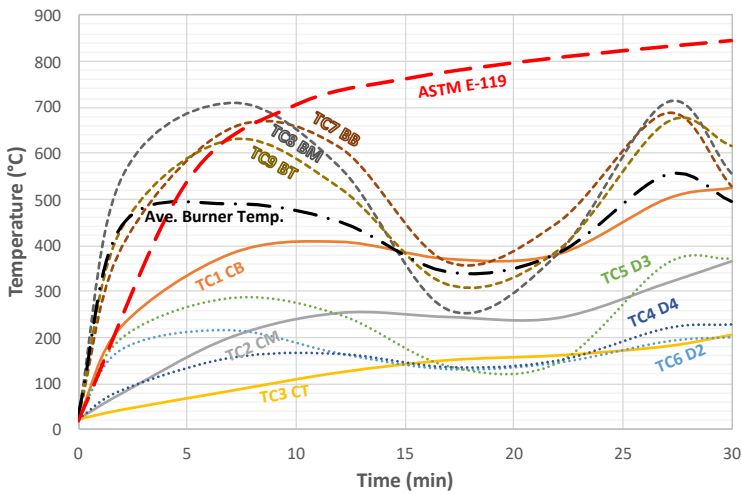
**Figure 8.**  
PFP30 test result; heat  
distribution along the  
exposed area

Figure 8 shows heat distribution along the sample during the 30 min fire exposure. The burner temperature rapidly increased for the first 3–4 min to approximately 480 °C and then ranged from approximately 340 °C–560 °C for the duration of the fire, with the slight fluctuations in temperature due to the manually control of the gas flow. The figure also shows the ASTM E119 standard fire curve for comparison.

The beam temperatures at the location of TCs 7, 8 and 9 (bottom, middle and top of the beam) reached the wood ignition temperature (300 °C) and then began to increase in comparison to the burner temperature after one minute. Plate 6 shows visual confirmation of ignition over the height of the beam 1 min into the fire test.

Temperature of the three lower dowels at their tips was recorded by TCs 4, 5 and 6. The temperature of the dowel tips followed the same fluctuation pattern as the beam and burner

and reached a maximum temperature of 370 °C. TCs 1, 2 and 3 recorded the temperature at the bottom, middle and top of the steel connection. After 30 min of fire exposure the maximum temperature in the bottom of the connection was 525 °C and the difference between bottom, middle and top of the connection was approximately 140 °C. According to the former studies (Lee *et al.*, 2012; Sajid and Kiran, 2019) the post-fire mechanical properties of ASTM A572 Gr

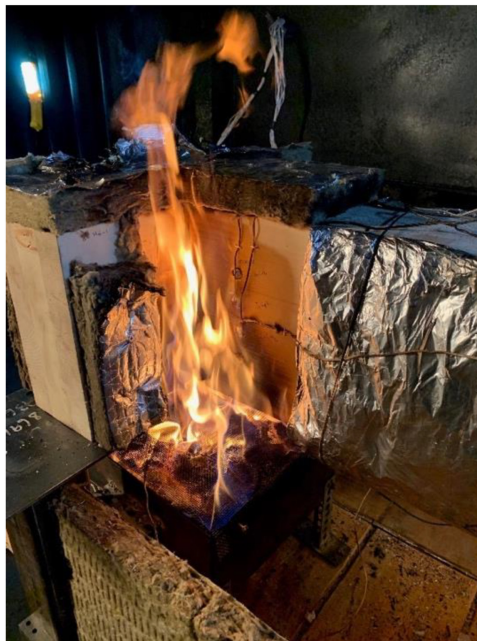
**Plate 6.**  
CLT beam ignited in  
the beginning of the  
fire test

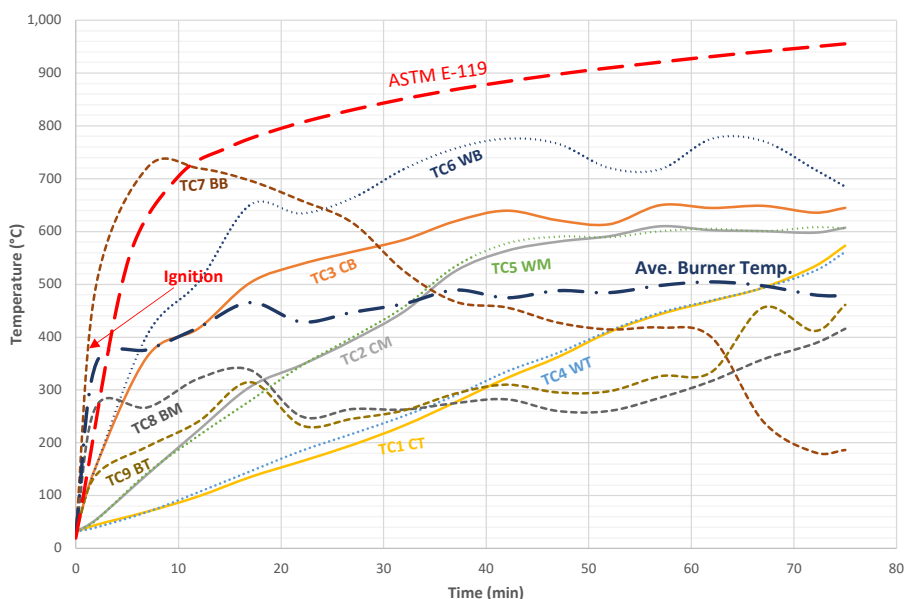
**Figure 10.**  
Heat distribution along  
the exposed area  
during the fire-  
performance test

Figure 10 shows the heat distribution along the exposed area during the FP test. According to the recorded heat distribution, the bottom of the CLT beam ignited after 2 min.

This statement is confirmed by the visual observations and recorded videos. The beam bottom temperature increased until the 9th minute and then decayed for the remainder of the fire loading. The connection temperature reached its maximum temperature of 760 °C after 40 min in the bottom (at the middle and along the edge of the weld). Between minutes 40 and 75 the temperature of the middle and top of the connection increased significantly, and the steel connection reached nearly 595 °C at the end of the test. At these temperatures, a reduction in strength and stiffness of the steel connection is expected. However, due to the reserve strength of the capacity during design, the steel connection itself does not experience failure.

Returning to Figure 10, the temperature of the connection at the time of failure at 55 min was nearly 650 °C at the bottom of the connection. At 650 °C the steel is expected to maintain only 35% of its AT yield strength. Failure, however, was not observed in the steel connection itself, but instead in the timber elements. This is attributed to the extensive charring that occurred in the timber which in turn weakened the timber and led to the embedment failure in the beam.
